## Midland Bay Landing

### Assessment of Shoreline Conditions and Treatments

prepared by  
**Shoreplan  
Engineering Limited**

**November 2017**

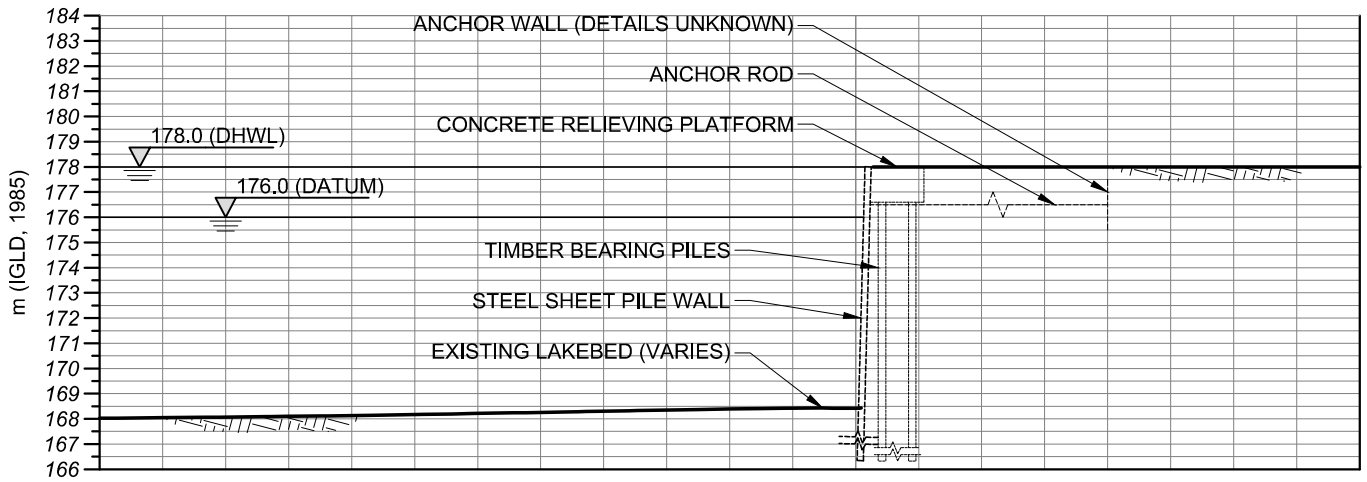
EXISTING SECTION 1

Within the east part of the reach, the SSP wall is still standing. A typical section through this part is shown as Section 1 on Figure 3-3. The SSP sheets appear to be leaning slightly towards the east. This likely originated from the construction of the wall and the original driving of the sheets. Broken and bent fender brackets remain attached to the wall along some sections. An example of this is visible in Photo 2.

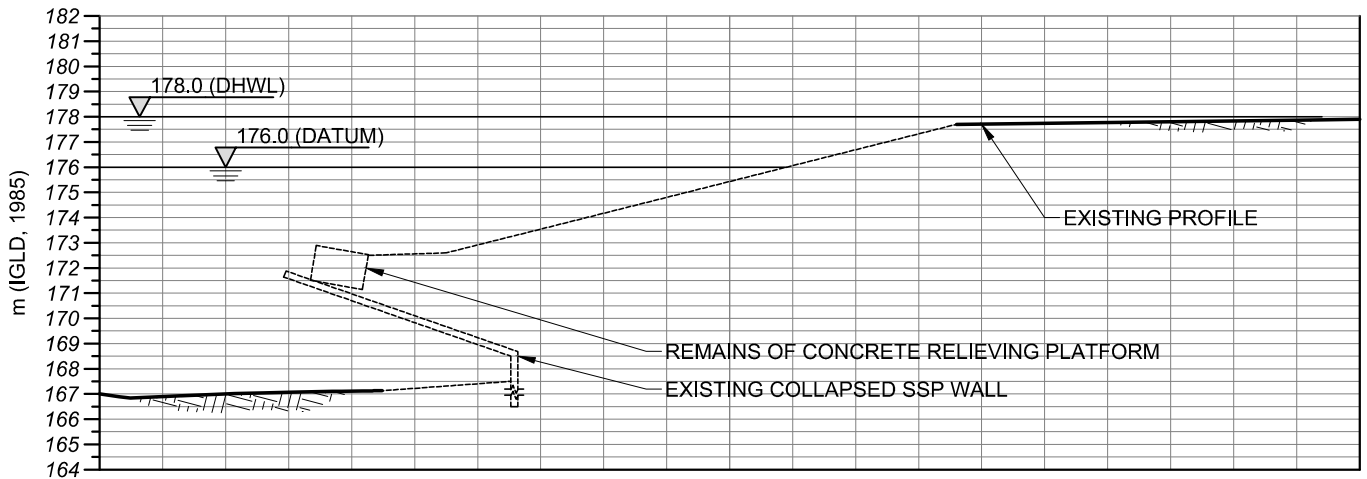
EXISTING SECTION 2

A typical section through the collapsed SSP portion is shown as Section 2 on Figure 3-3. Throughout the collapsed SSP section, the SSP wall was observed along the lake bottom. The toe of the SSP wall is still embedded in the lakebed. The SSP is vertical at the lakebed and has been bent over above the lakebed. The sheets are leaning out into the lake at an average angle of approximately 45 degrees (Photo 8). Remains of the concrete relieving platform were observed sitting on the back of the collapsed SSP (Photo 9 and Photo 10). The SSP is continuous across the washed out area. Timber piles which would have supported the concrete platform were not found behind the SSP wall underwater.

The collapsed SSP wall is still acting to retain some fill material. The diver noted that the lake bottom was 10 m below water on the lakeside of the SSP wall and 6 m on the landside of the collapsed wall. The lakebed behind the collapsed SSP wall gently slopes up to the shoreline. The shoreline behind the collapsed SSP wall section is shown in Photo 11. The shoreline is naturally vegetated with scattered concrete rubble and stone. Several timber piles were observed close to the shoreline. The top of the piles were close to the water level. The piles were not in line with the original installation of the SSP wall and therefore they do not appear to

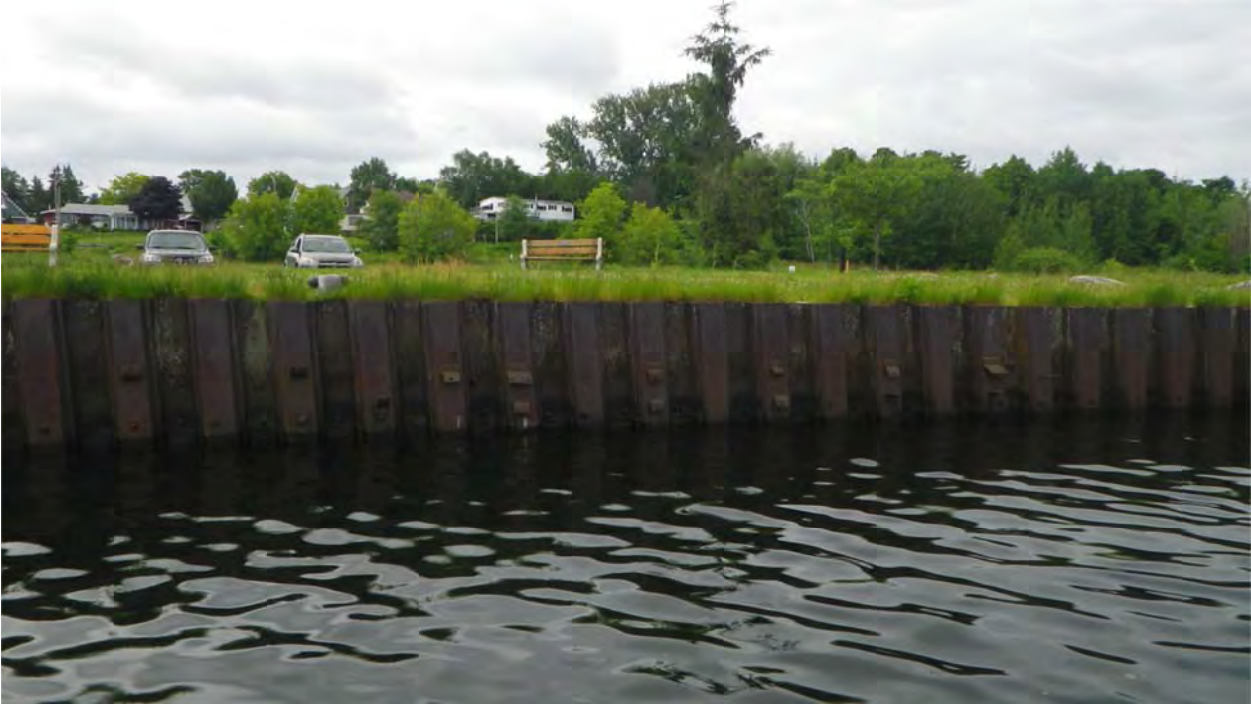
**Photo 2: SSP Wall, East Reach**

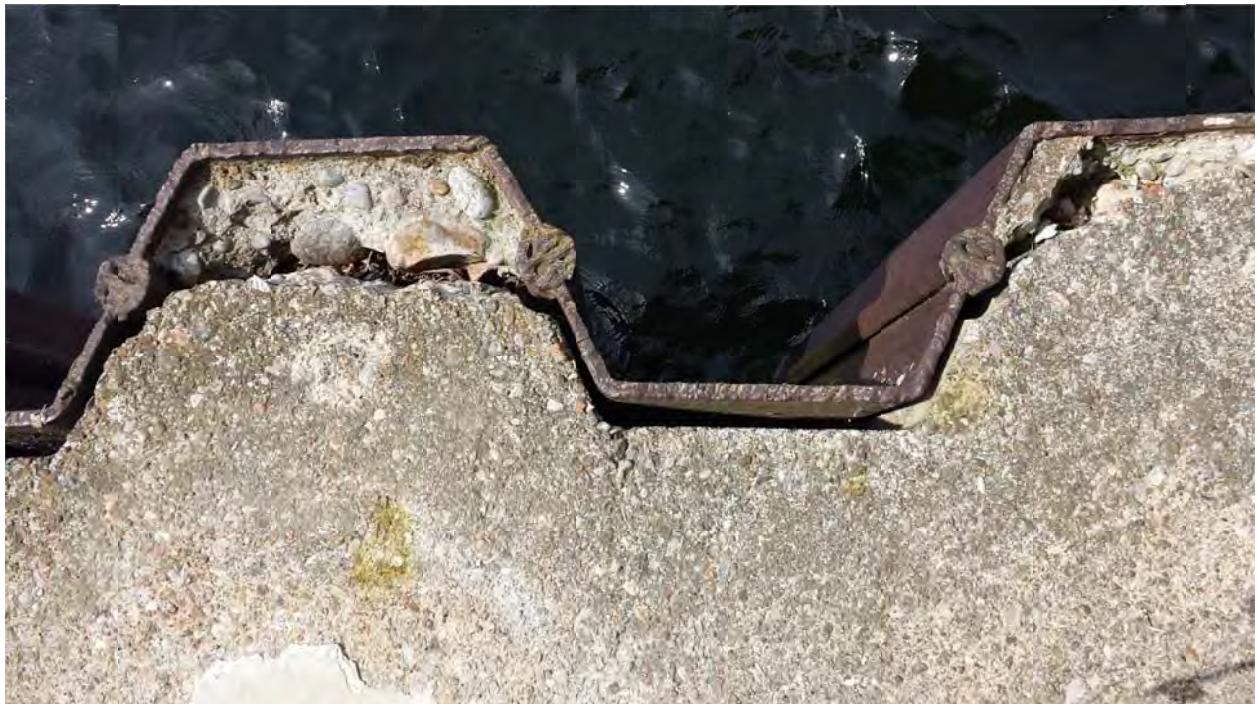
**Photo 6: SSP separated from concrete relieving platform, East Reach**

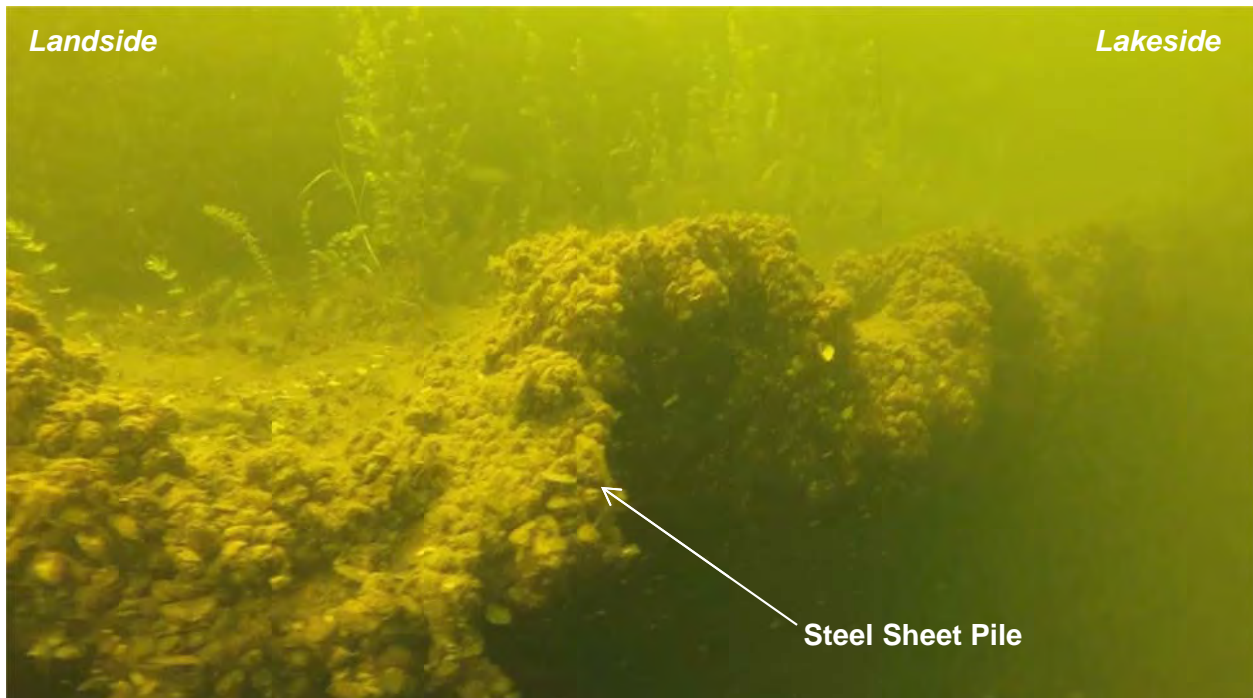
**Photo 8: Collapsed SSP under water (Day 1 Dive 1, 1:12:39)**

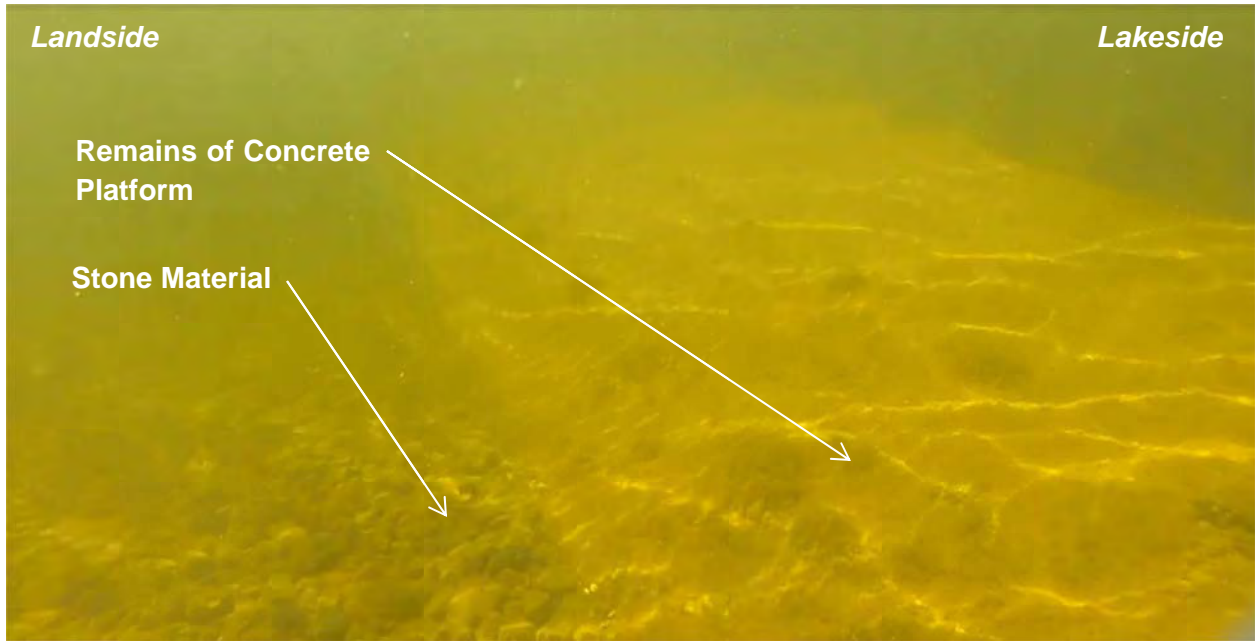
**Photo 9: Remains of Collapsed Concrete Relieving Platform underwater (Day 1, Dive 1, 1:23:13)**

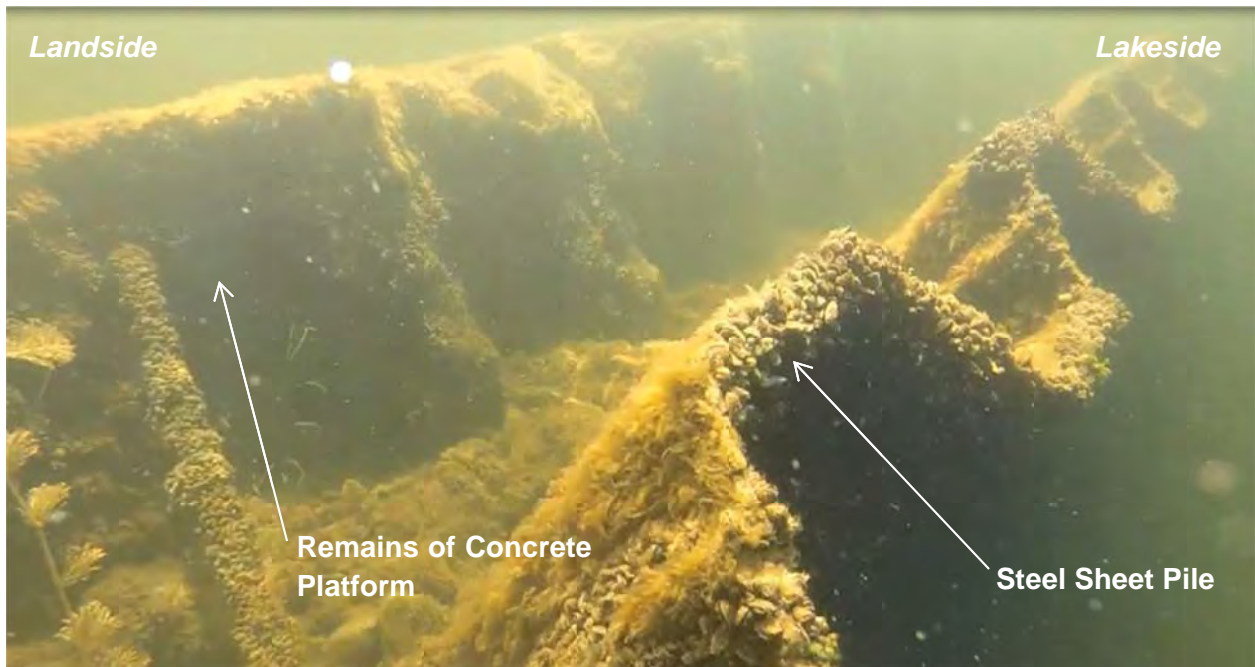
**Photo 10: Collapsed SSP and Concrete Relieving Platform underwater (Day 1, Dive 1, 1:23:53)**

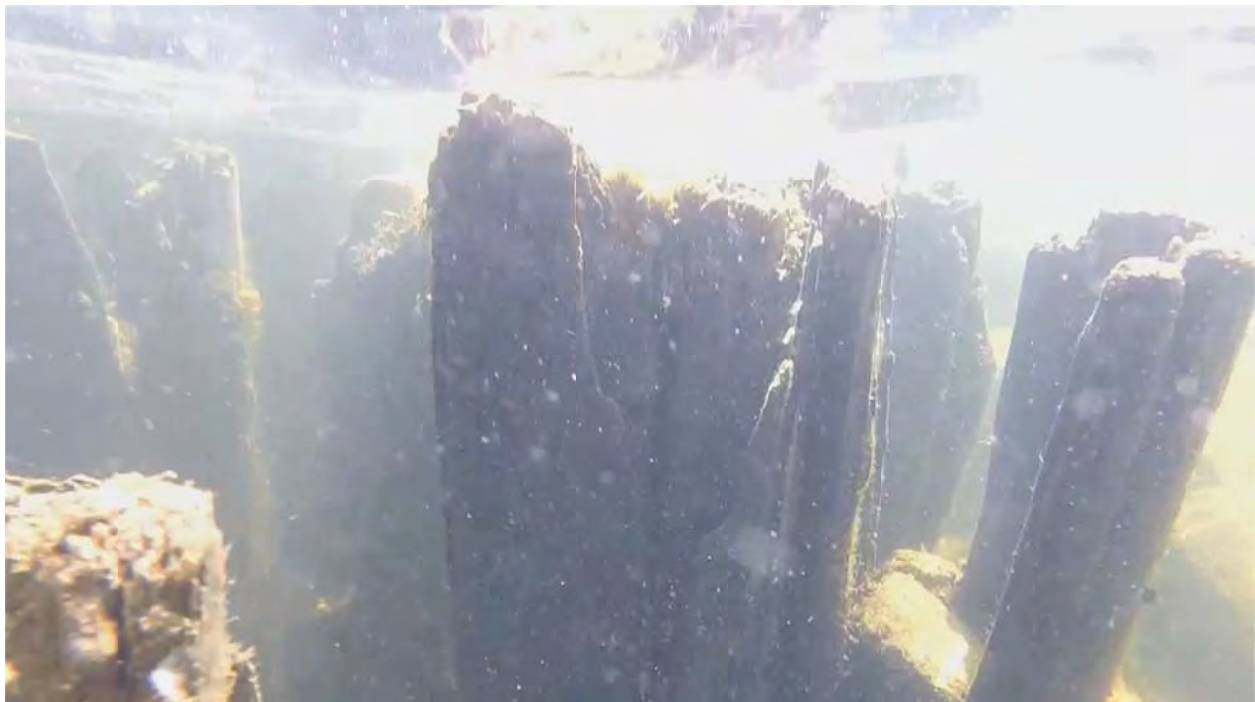
Closely spaced timber piles were observed at the west end of this section of standing wall (Photo 14). The timber piles are in line with the timber bearing piles supporting the concrete platform. They extend a few metres to the west of the end of the concrete relieving platform and SSP wall. The piles terminated just below the water level on the day of the inspection.

**Photo 14: Timber piles at west end of East Reach (Day 1, Dive 1, 1:33:37)**

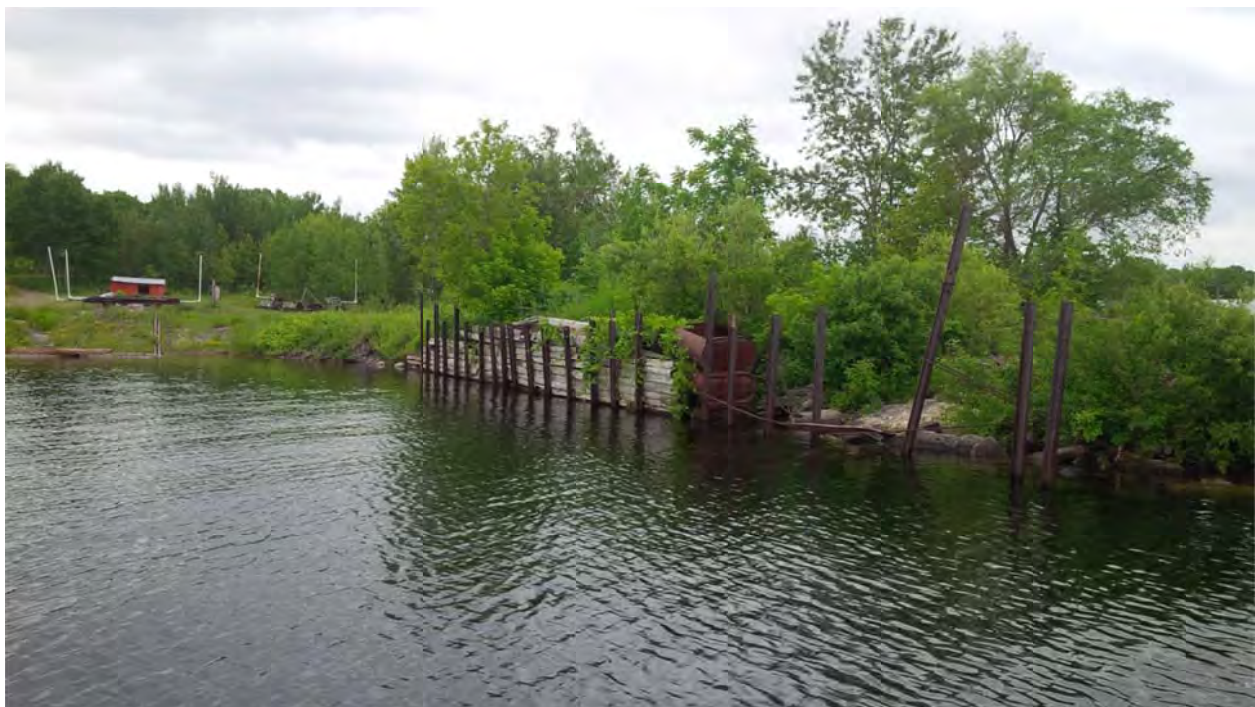
The remains of a pier are located to the west of the marine railway (Photo 22 and Photo 23). The pier appears to have been constructed of vertical rail driven into the lake bottom and horizontal timbers placed behind them. The timbers are only visible above water on the east side and stop just below the waterline. Large stones are visible behind the pier wall below the level of the timbers on the east side. Voids, up to approximately 1.2 m deep, were observed in the structure. The remains of an approximately 0.3 m high diamond pattern grating were visible along the toe of the wall. Most of the horizontal timbers on the end and west side are no longer visible above water. A few timbers were observed underwater. Below the water level on the end and west side, the sides of the pier are sloping and consist of randomly placed stones. The lakebed here consists of silts, zebra mussel shells and rock. Some stone was observed at the toe of the pier wall.

**Photo 22: Remains of Pier, West side, Centre Reach**

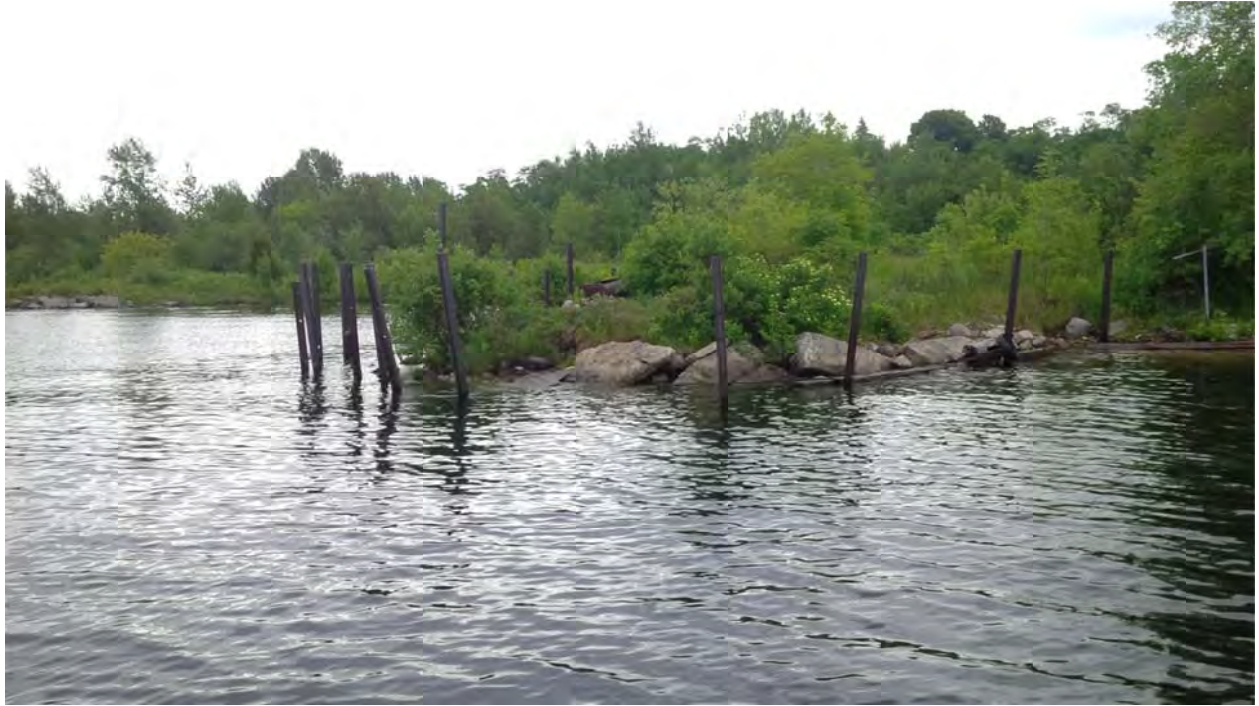
**Photo 23: Remains of Pier, East side, Centre Reach**

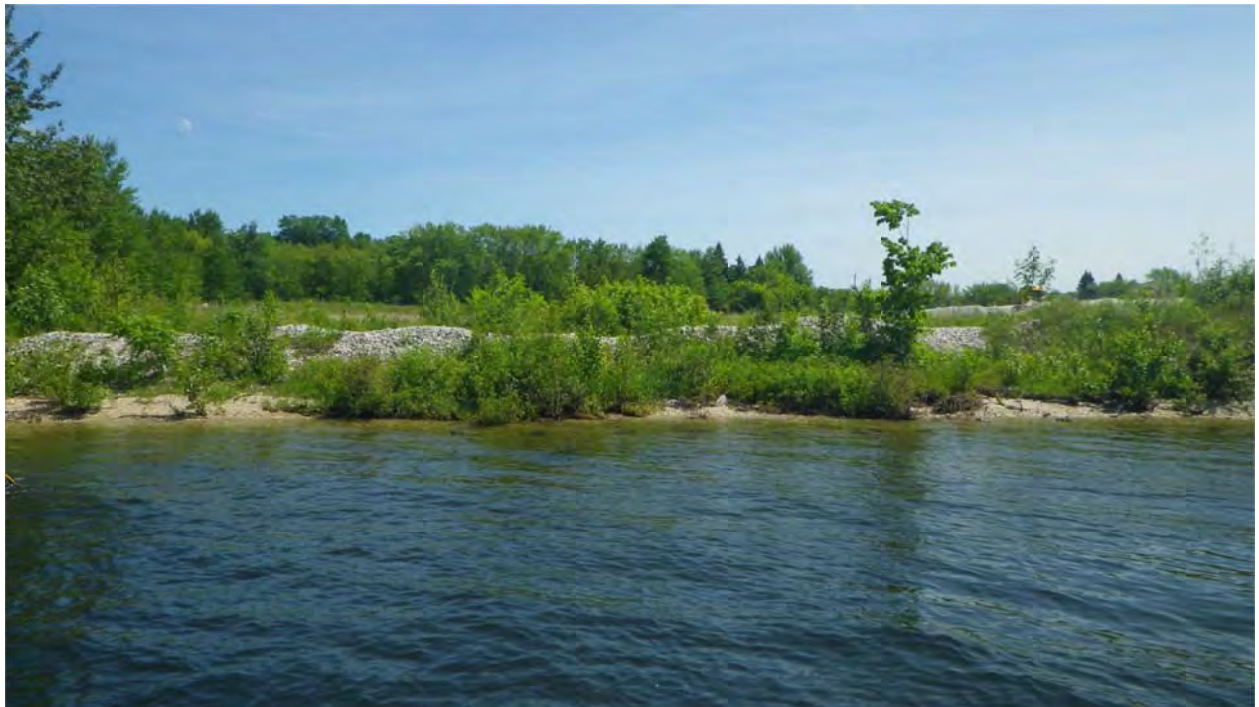
The west sub-reach extends west of the pier. It consists of approximately 56 m of unprotected shoreline (Photo 24). A typical section through this stretch of shoreline is shown as Section 6 on Figure 3-5. Two rows of timber piles, running parallel to the shoreline, were observed along this section of shoreline. The two rows were approximately 1.5 m apart, with the landward piles having a smaller diameter. The spacing between the piles was estimated to be approximately 1.2 metres. The timber piles terminated just below the water line. The lake bottom in this section consisted mainly of sand and gravel.

**Photo 24: West end of Centre Reach**

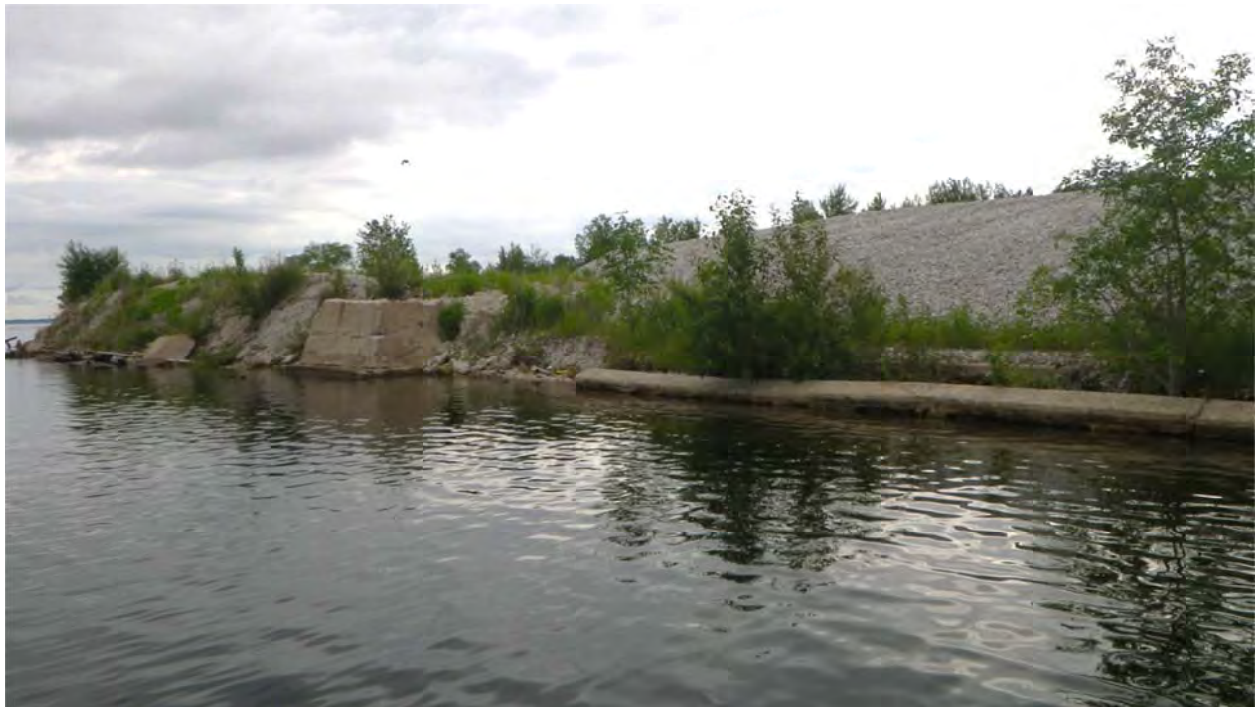
The remains of a concrete foundation were observed approximately 50 m from the east end of the west reach (Photo 26). The approximate location is identified on Figure 3-6. In the west part of the reach, the stone fill slopes up from the front row of timber piles. West of the concrete foundation, a plateau was observed underwater on the landside of the timber piles. The plateau consists of stone fill and concrete rubble between the timber piles and the existing shoreline and is approximately 2 to 3 metres wide. The stone fill is approximately level with the top of the timber piles in some sections and slightly lower in other locations. An approximately 0.6 m wide concrete curb was observed at the landside of the plateau. Other than a few missing sections,

**Photo 26: Large concrete foundation in east part of West Reach**

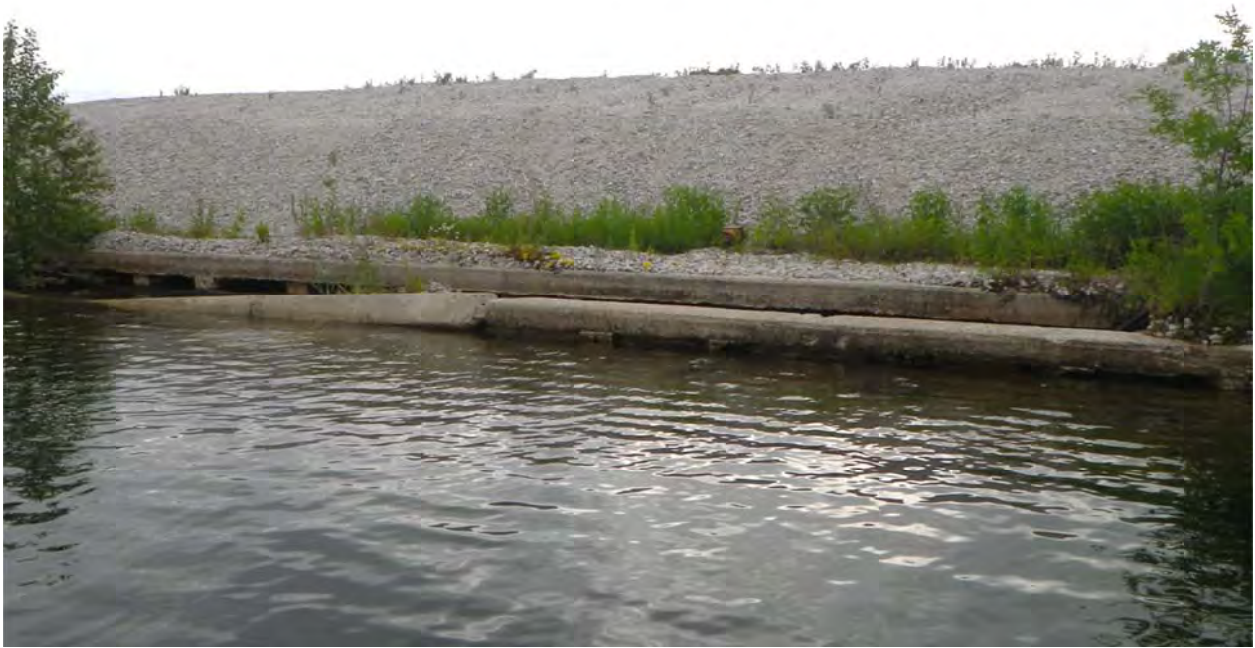
The concrete curb has shifted and exposed the underside of a concrete deck behind it in an area approximately 100 m to 115 m west of the east end of the reach (Photo 27). Along this part of the shore the deck was observed to be supported by concrete beams running the width of the deck and perpendicular to the shore. The concrete beams were sitting on timber piles. In other locations, the concrete deck appeared to be sitting directly on timber piles. The presence of the same concrete deck design along the entire reach was not confirmed.

**Photo 27: Exposed underside of concrete deck, west reach**

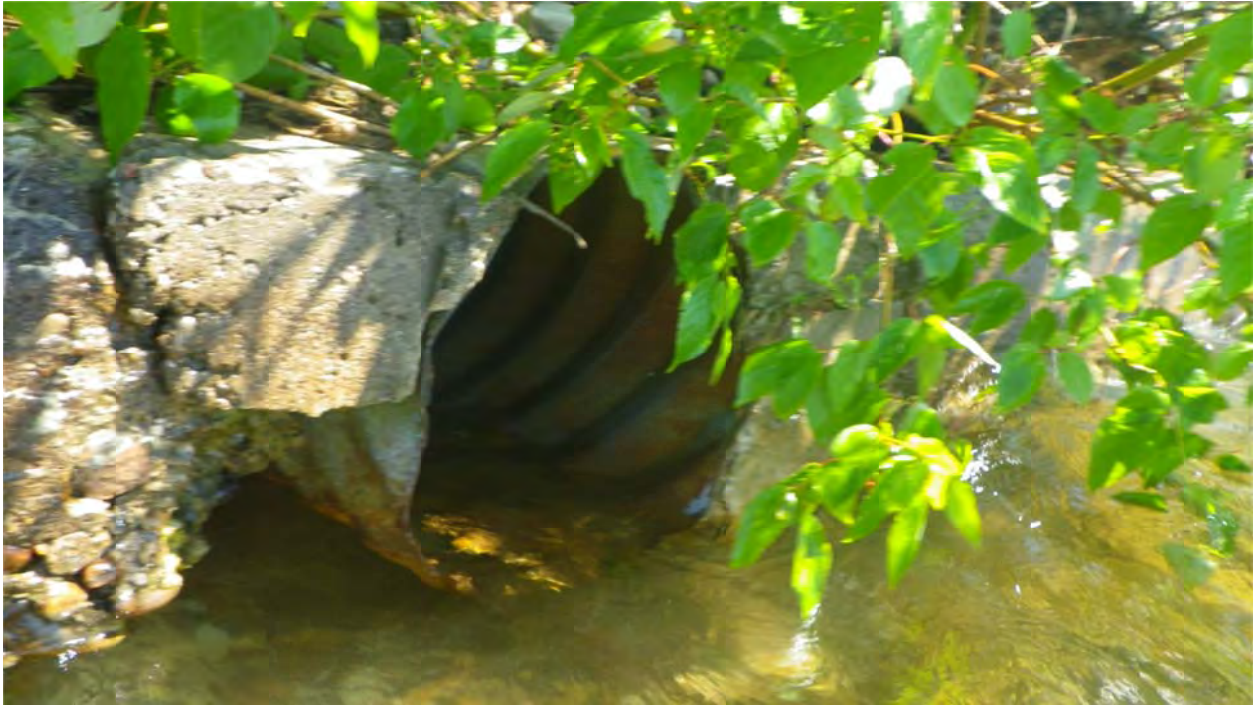
A 300 mm diameter corrugated steel pipe (CSP) was observed approximately 120 m from the east start of this reach (Photo 29). Its approximate location is indicated on the site plan, Figure 3-6. The CSP has been cast into the concrete curb. The invert elevation of the pipe is approximately 176.8 m.

**Photo 29: Corrugated Steel Pipe in West Reach**

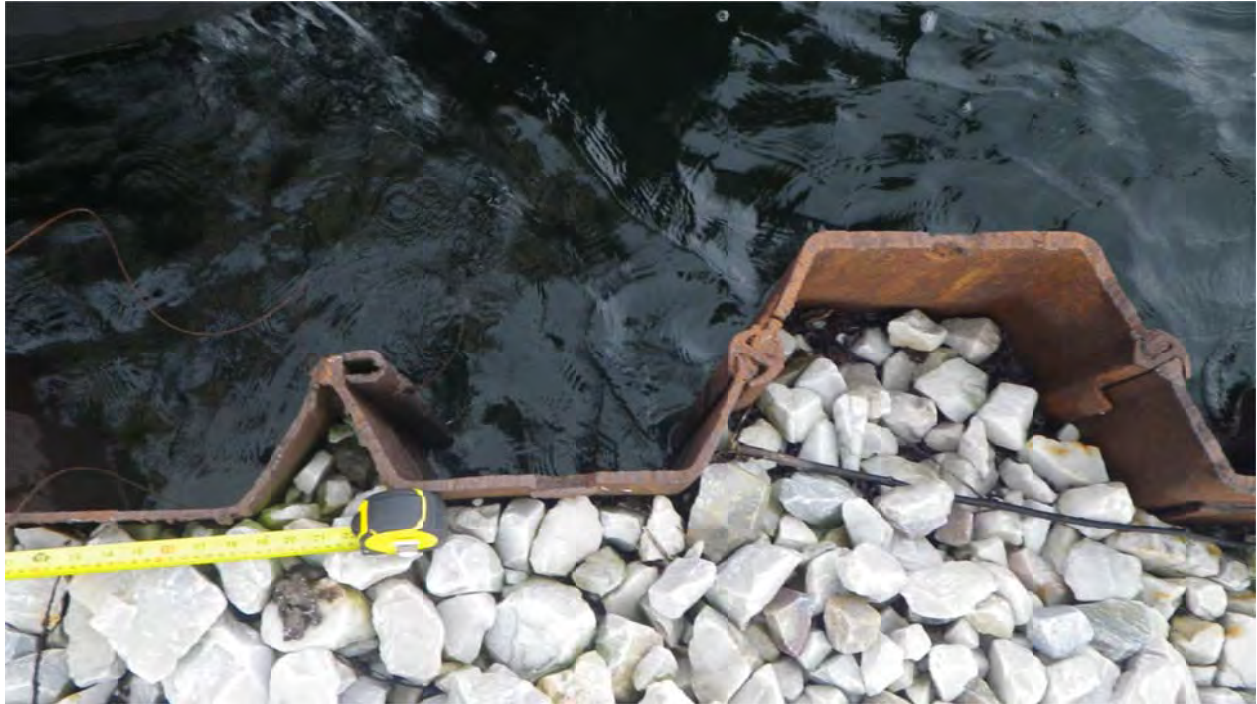
The U-series wall appears to be more recent than the Algoma wall. At the interface between the two wall types, the ball of the Algoma sheet has been wedged into the knuckle of the first U-series sheet (see Photo 31). The two sheets are welded together at the top. A welded connection below the waterline was not confirmed. No loss of material at the interface was observed underwater. The U-series SSP wall turns the corner into the adjacent marina. The wale, which is two back to back channels, was observed 0.4 m below the top of the wall. It runs parallel along both sections of the wall and at the corner an additional section of wale runs on a diagonal between the two sections of wall. This diagonal wale likely accommodates an anchor rod. The location of the anchors was not observed. Excavation behind the wall is required to determine the anchor location.

**Photo 31: Interface between U-series and Algoma SSP wall, West Reach**
