May 24, 2019
Revised August 21, 2019

Re: Hydrogeological Study and Water Balance Analysis
265 Whitfield Crescent, Town of Midland

Geotechnical Investigation Report 1000 William Street & 265 Whitfield Crescent, Midland, Ontario

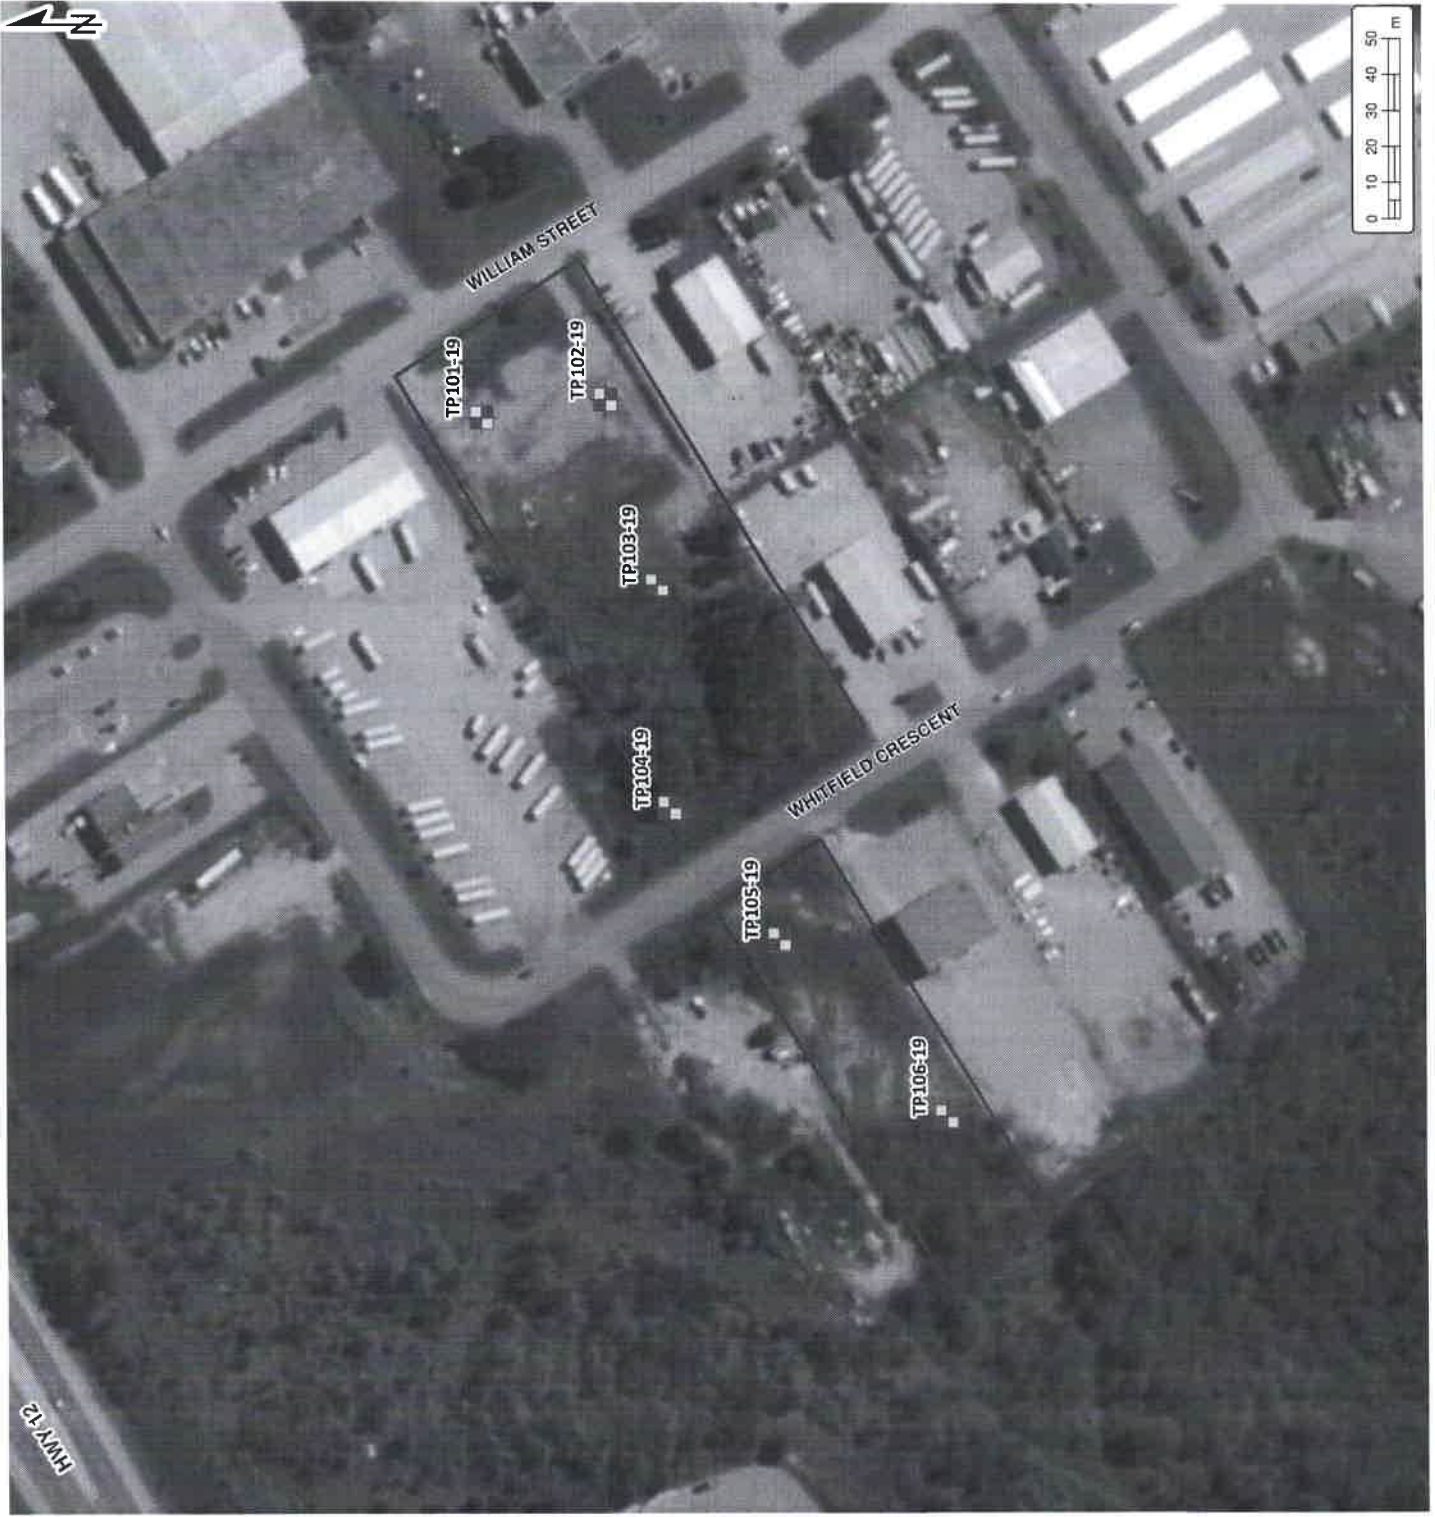
TEST PIT LOCATION PLAN

The geotechnical investigation was required to confirm the subsurface conditions at the Site in order to provide geotechnical design parameters as input into the design and construction of the proposed storage development. A Site Plan, including test pit locations, is included as Figure 1 of this report.

Project No.:	8679-001	Date:	March 2019
Scale:	1:2,000	Projection:	NAD 1983 UTM Zone 17N
Created by:	SH	Checked by:	RG
		Figure:	1

A test pit investigation was completed on February 27th, 2019, to assess subsurface conditions at the Site. A total of six (6) test pits, designated as TP101-19 through TP106-19, were advanced throughout each of the properties. All of the test pits were terminated at depths ranging from 1.8 m to 3.1 m below ground surface (mbgs). The test pit locations were selected and laid out in consultation with the Client. Test pits TP101-19 through TP104-19 were advanced throughout the William Street property, generally adjacent to proposed structures. Test pits TP105-19 and TP106-19 were advanced at the eastern and western ends of the Whitfield Crescent property to classify the native soils present at the site.

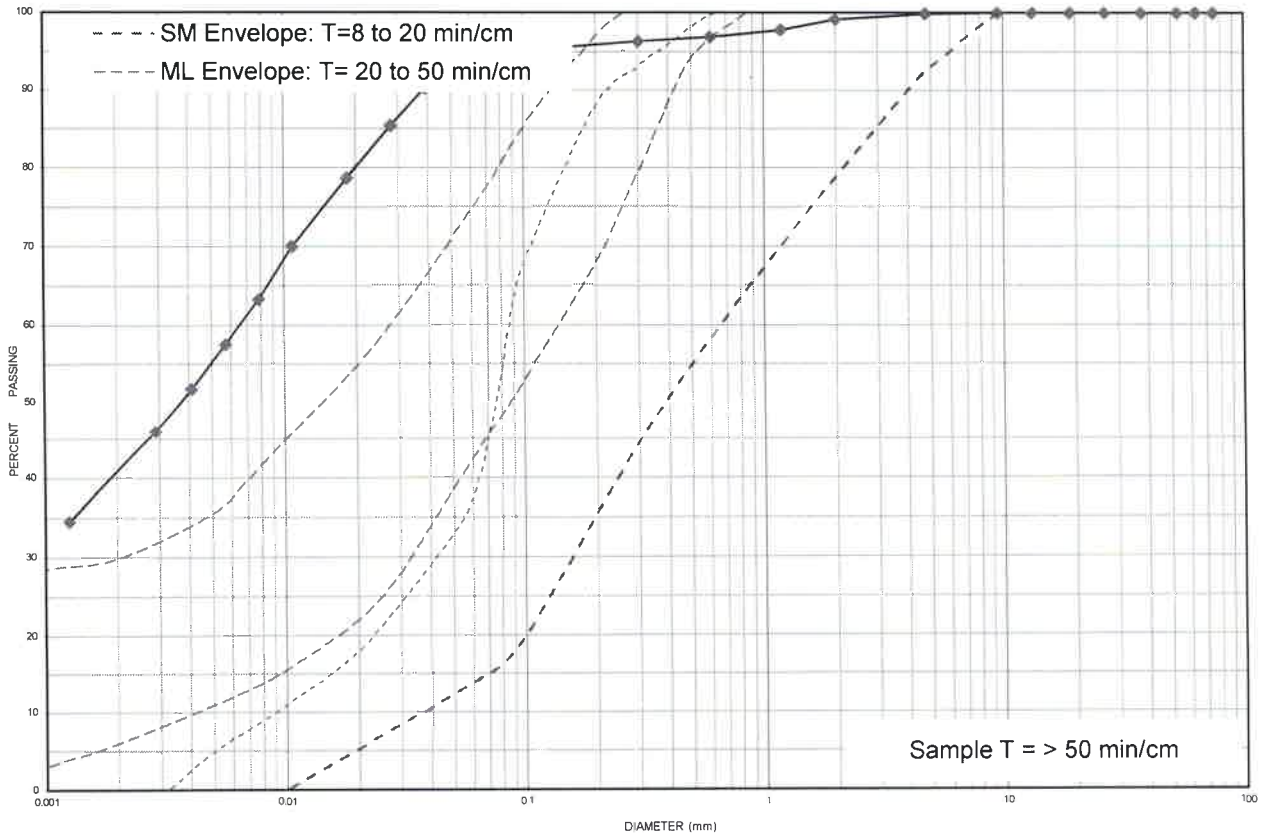
Project Number: 8679-001 **Client:** Jason Redman
Project Name: 1000 William Street, Midland, ON
Sample Date: February 27, 2019 **Sampled By:** Alex Griffin - Cambium Inc.
Hole No.: TP 1 GS 2 **Depth:** 2.1 m **Lab Sample No:** S-19-0123

Borehole No.	Sample No.	Depth	Gravel	Sand	Silt	Clay	Moisture
TP 1	GS 2	2.1 m	0	5	95		42.6
Description		Classification	D ₆₀	D ₃₀	D ₁₀	C _u	C _c
Silt and Clay trace Sand		ML-CL	0.0066	-	-	-	-
