Traffic Data Analysis

Fifth St

Northbound and Southbound

Town of Midland Engineering Department July 26th, 2022

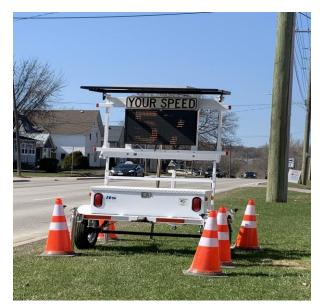
Figure 1 - Traffic Trailer

The traffic trailer used was model ATS-3 as shown in Figure 1. The traffic trailer is set to show the speed of the approaching vehicle and display short messages depending on the speed. The data is collected and grouped into one-hour intervals.
