Traffic Data Analysis

William St.

Northbound and Southbound

Town of Midland
Engineering Department

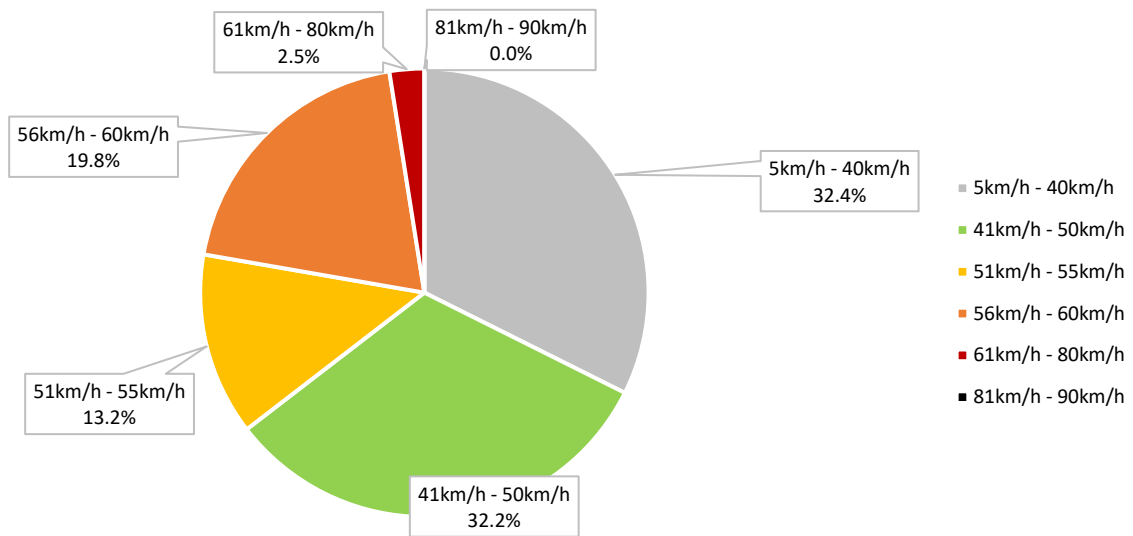
Figure 2. William St. Northbound (speed limit: 40km/h)

Figure 2 represents when William St is 40km/hr for the community safety zone and shows that 32.4% of vehicles were travelling below the school times speed limit, 32.2% of vehicles were travelling between 41-50 km/h, and 35.5% of vehicles were travelling above 50km/h. When we consider the accepted speed limit is 10km/h over the school times speed limit, we find that a total of 64.6% of vehicles were travelling within the accepted speed limit.

Figures 2 and 3 below are the speed summary for the northbound traffic.

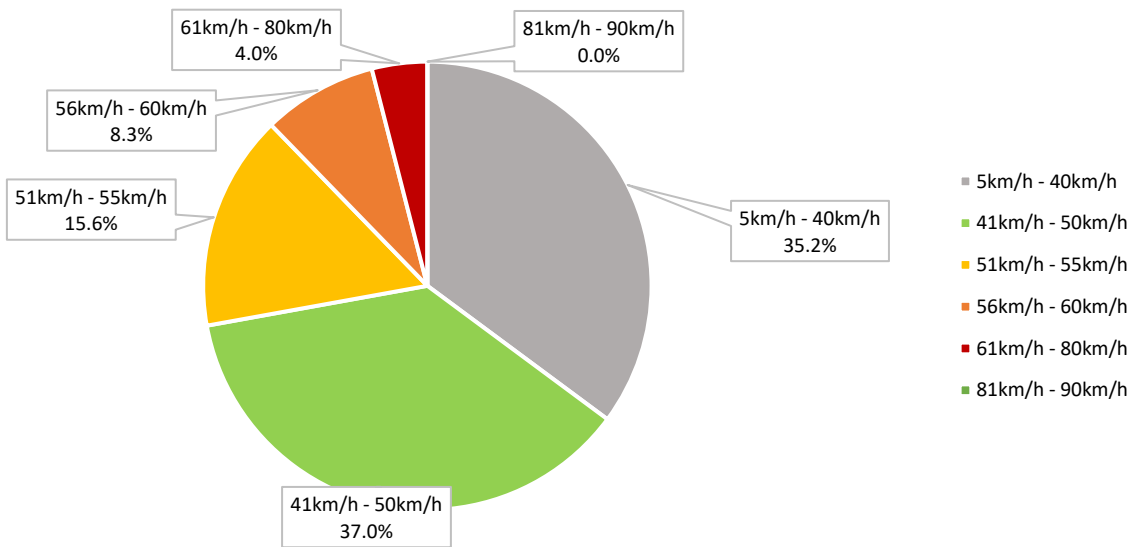
Figure 3. William St. Northbound (speed limit: 50km/h)

Figure 3 represents when William St is 50km/hr and shows that 72.2% of vehicles were travelling below the posted speed limit, 23.9% of vehicles were travelling between 51-60 km/h, and 12.3% of vehicles were travelling above 60km/h. When we consider the accepted speed limit is 10km/h over the posted speed limit, we find that a total of 96.1% of vehicles were travelling within the accepted speed limit.

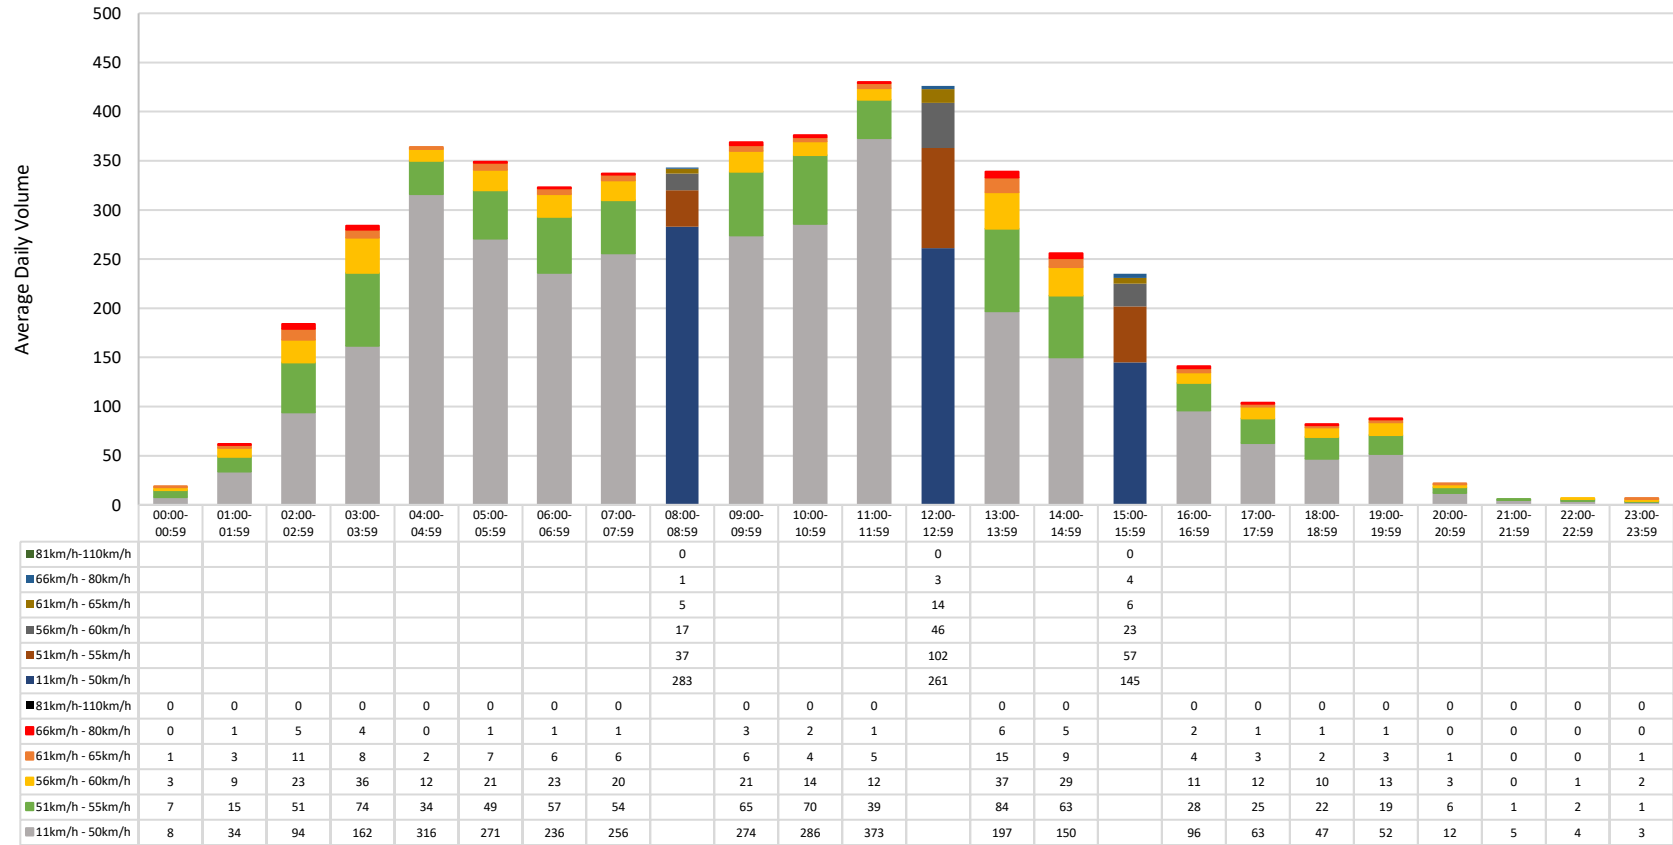
Figure 4. Speed by Hour Analysis for Northbound (weekday)

Figure 4 is the speed by hour graph in the northbound direction from September 29th to October 7th (weekday).

Figures 4 and 5 are the speed by hour graph for weekdays (September 29th and 30th and October 1st, 4th to 6th) and the weekend (October 2nd and 3rd) in the northbound direction.

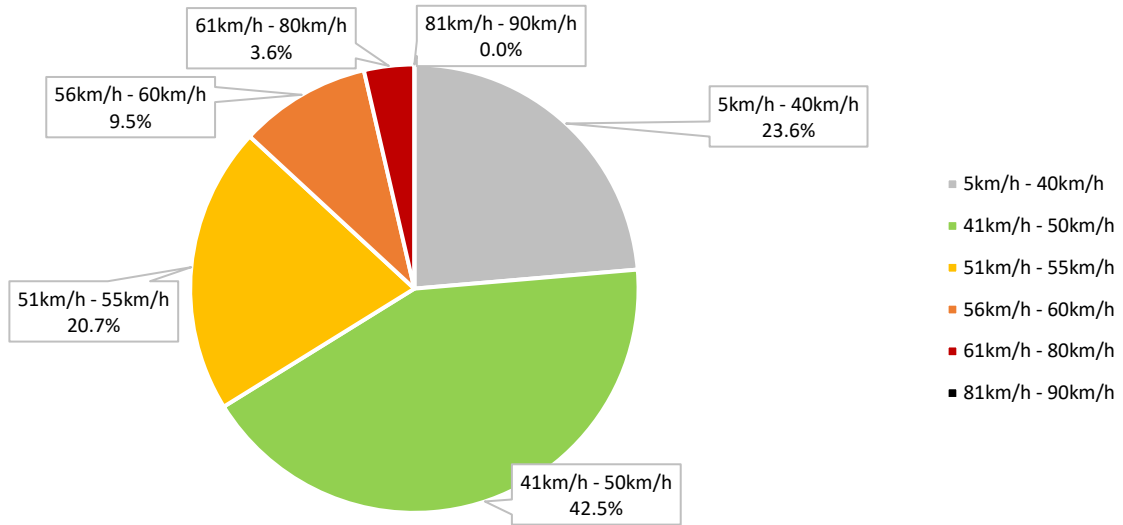
Figure 6. William St. Southbound (speed limit: 40km/h)

Figure 6 above shows that 23.6% of vehicles were travelling below the school times speed limit, 42.5% of vehicles were travelling between 41-50 km/h, and 33.8% of vehicles were travelling above 50km/h. When we consider the accepted speed limit is 10km/h over the school times speed limit, we find that a total of 66.1% of vehicles were travelling within the accepted speed limit in the community safety zone.

Figures 6 and 7 below are the speed summary for the southbound traffic.

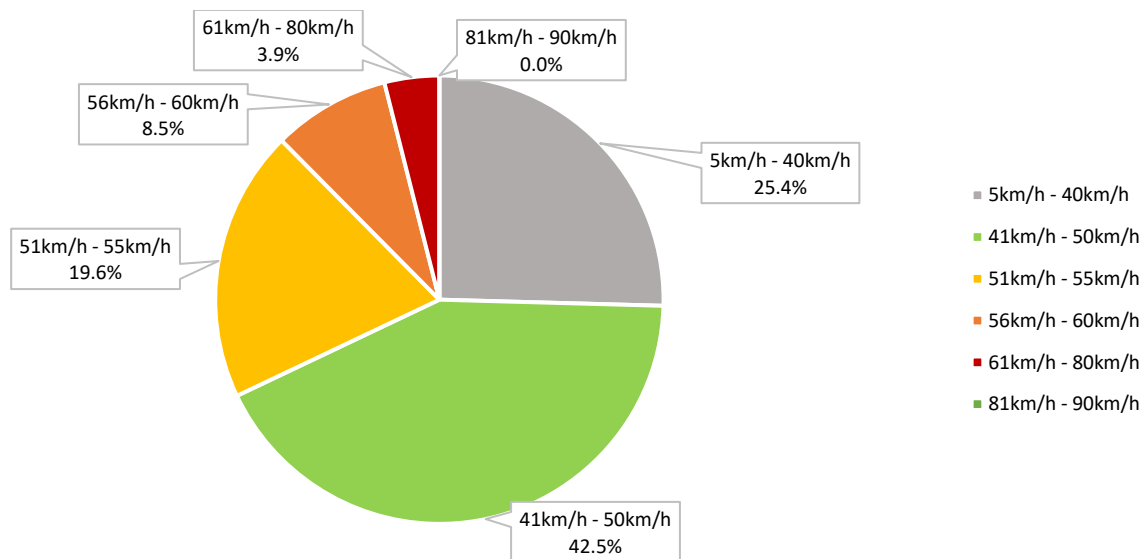
Figure 7. William St. Southbound (speed limit: 50km/h)

Figure 7 above shows that 67.9% of vehicles were travelling below the posted speed limit, 28.1% of vehicles were travelling between 51-60 km/h, and 3.9% of vehicles were travelling above 60km/h. When we consider the accepted speed limit is 10km/h over the posted speed limit, we find that a total of 96% of vehicles were travelling within the accepted speed limit.

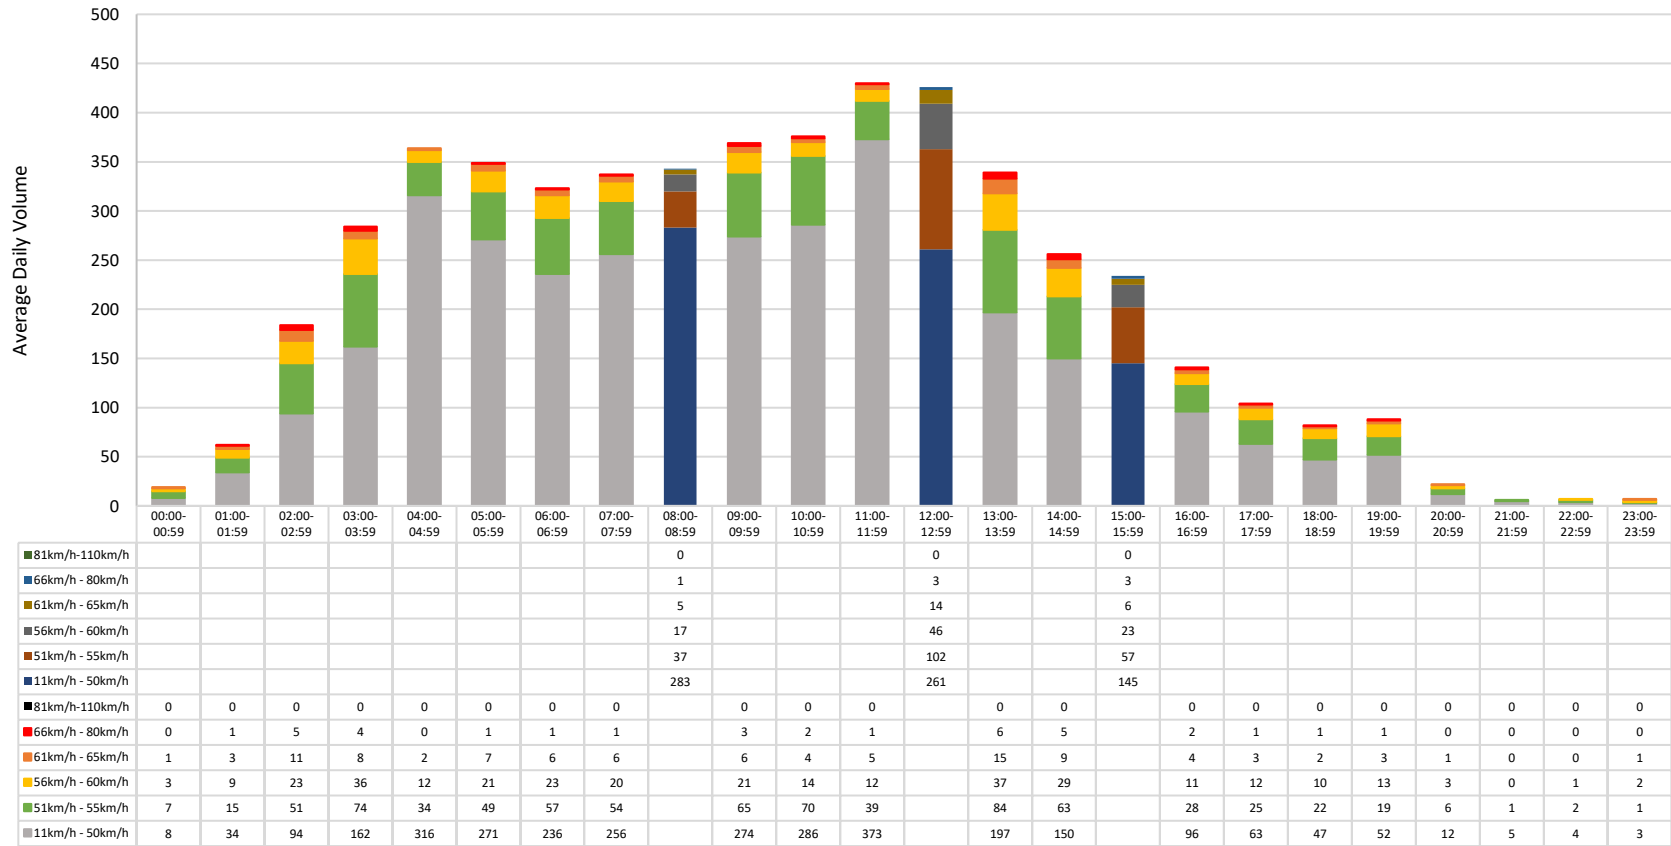
Figure 8. Speed by Hour Analysis for Southbound (weekday)

Figures 8 and 9 below are the speed by hour graph for weekdays (September 24th, 27th, 28th, 29th and 30th) and the weekend (September 25th and 26th) in the southbound direction.

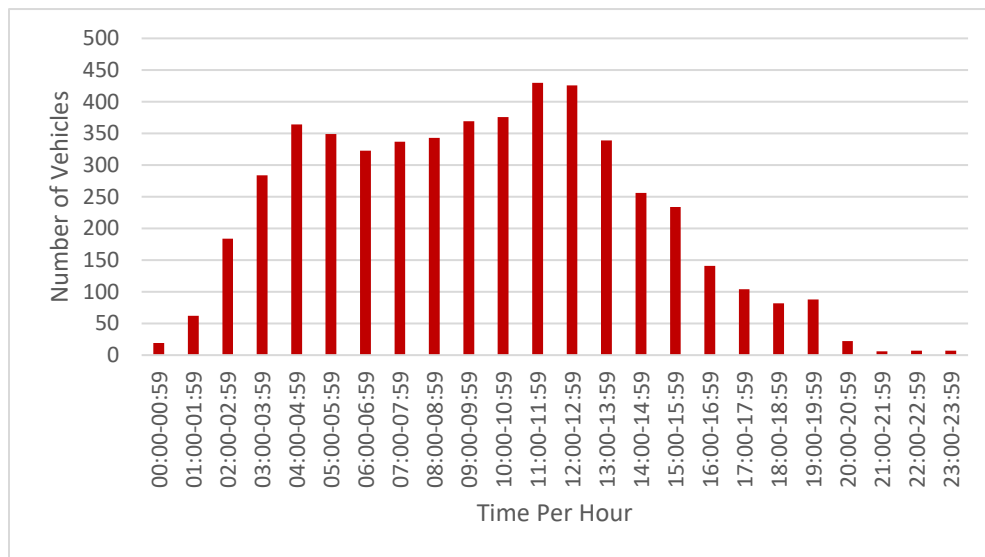
Figure 10. Average Volume by Hour on September 29th and 30th, October 1st, 4th, 5th, and 6th (weekday)

Figure 10 shows the average volume of vehicles travelling northbound on William St on September 29th and 30th, October 1st, 4th, 5th, and 6th (weekday). It is noticed that the peak traffic occurs at typical morning and evening rush hours on a weekday in the northbound direction with a spike around 4am.

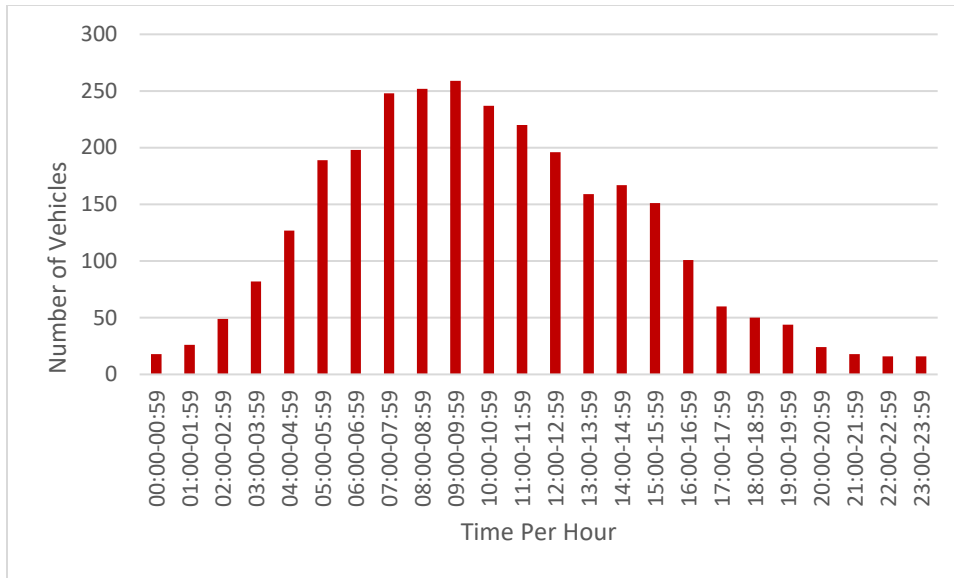
Figure 11. Average Volume by Hour on October 2nd and 3rd (weekend)

Figure 11 shows the average traffic volume on the weekend from October 2nd and 3rd. It is noticed that the traffic volume pattern is quite different from a weekday. The volume of the traffic on the weekend continues to increase, peak at 9am and decrease in the late morning and afternoon.

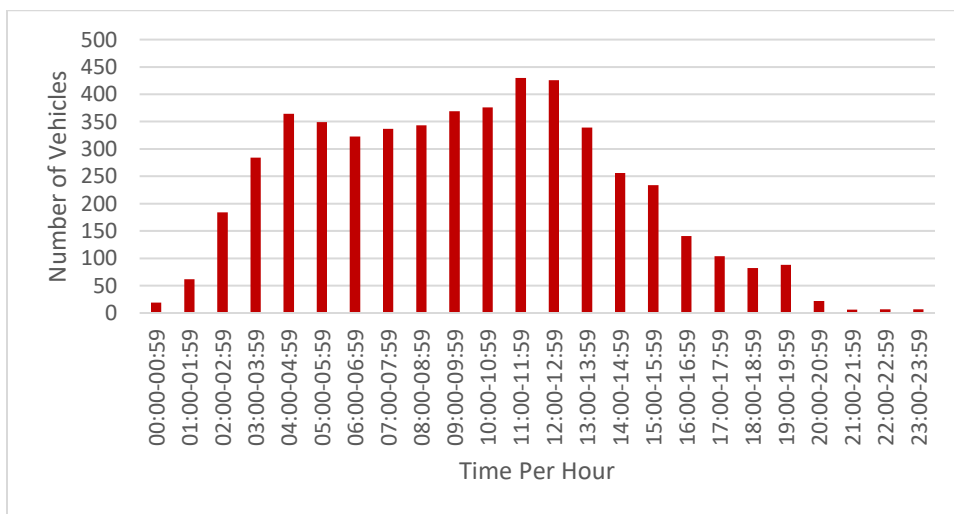
Figure 12. Volume by Hour on September 23rd to 24th and from the 27th to the 29th (Weekday)

The data collected between September 23rd to 24th and from the 27th to the 29th is used to analyze the traffic volume by hour on a weekday in the southbound direction as shown in Figure 12. The school hours at the Sacred Heart Catholic School is from 08:45 to 15:00, and it appears that the peak traffic in the southbound direction occurs at 11 and 12pm and has a spike at 4am.

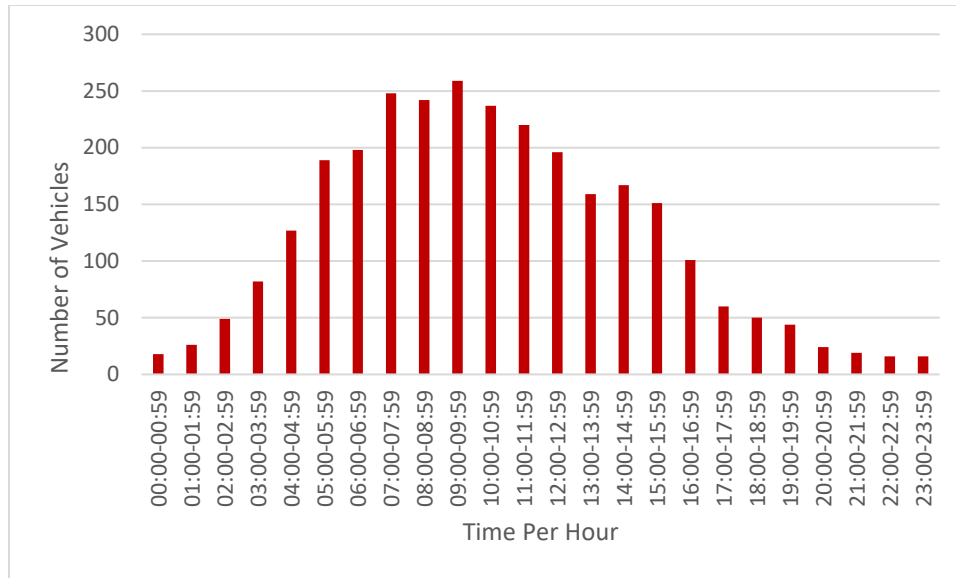
Figure 13. Average Volume by Hour on September 25th and 26th (Weekend)

Figure 13 shows the average traffic volume on the weekend from September 25th and 26th. It is noticed that the traffic volume pattern is quite different from a weekday. The volume of the traffic on the weekend continues to increase, peak at 9am and decrease in the late morning and afternoon.
