## Midland Bay Landing

### Assessment of Shoreline Conditions and Treatments

prepared by  
**Shoreplan  
Engineering Limited**

**November 2017**

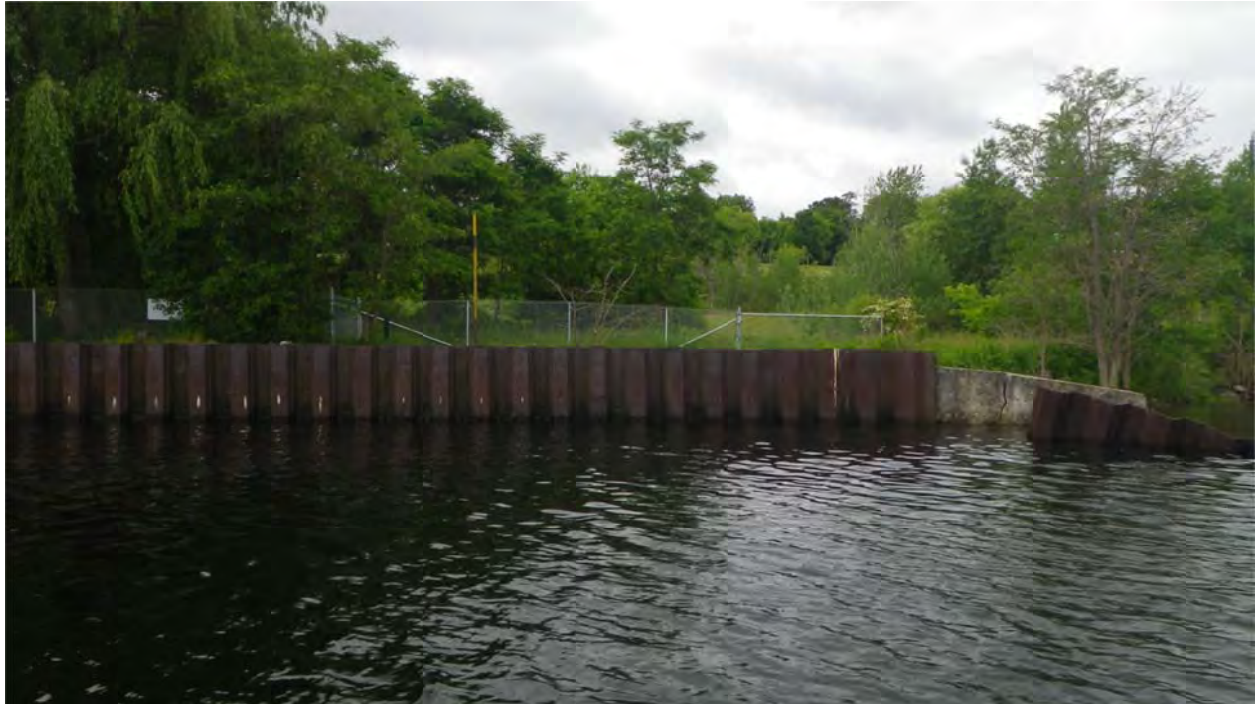
At the transition between the standing SSP wall and the collapsed SSP wall, a section of the SSP wall has detached from the concrete relieving platform and is leaning out into the lake (Photo 3). Fill from under and behind the concrete platform has been washed away (Photo 4). The concrete platform is unstable on the timber piles. To the west of this transition, the SSP wall has collapsed and the shoreline behind has washed out.

**Photo 3: SSP wall at east end of collapsed section, East Reach**

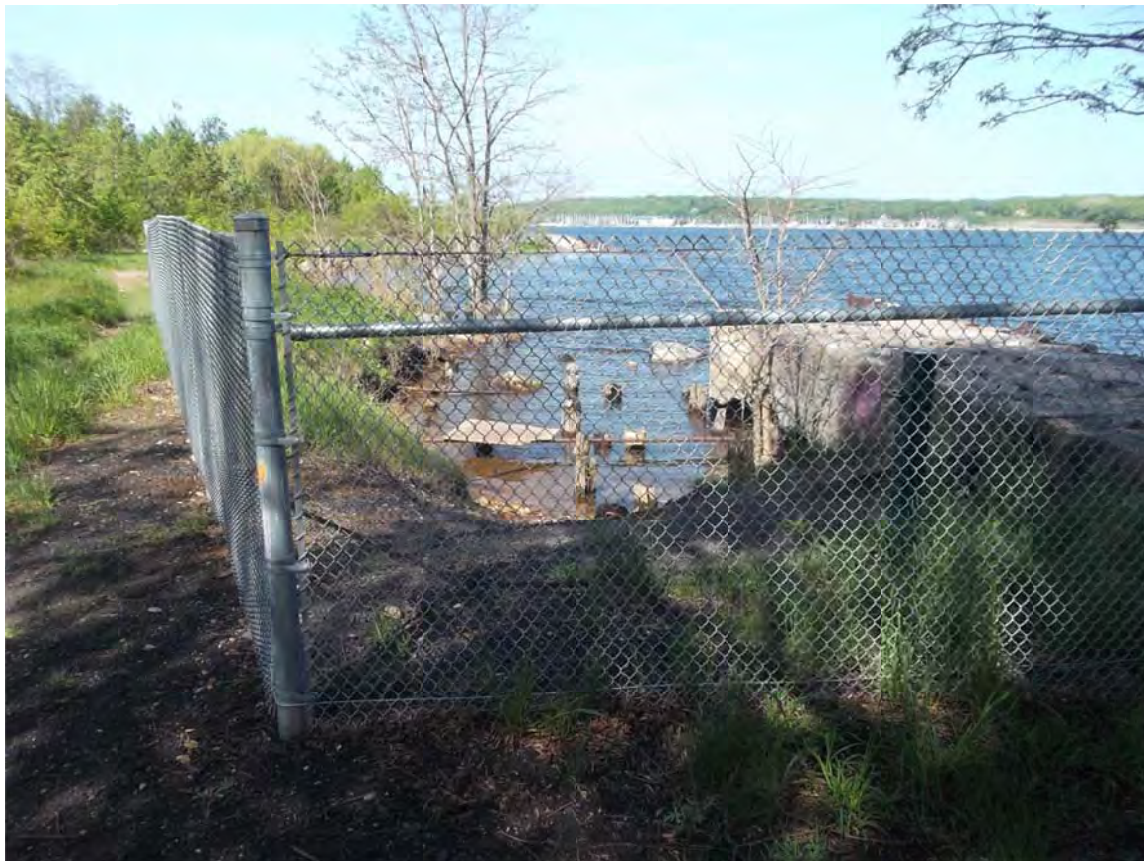
**Photo 4: East end of collapsed SSP wall section, East Reach**

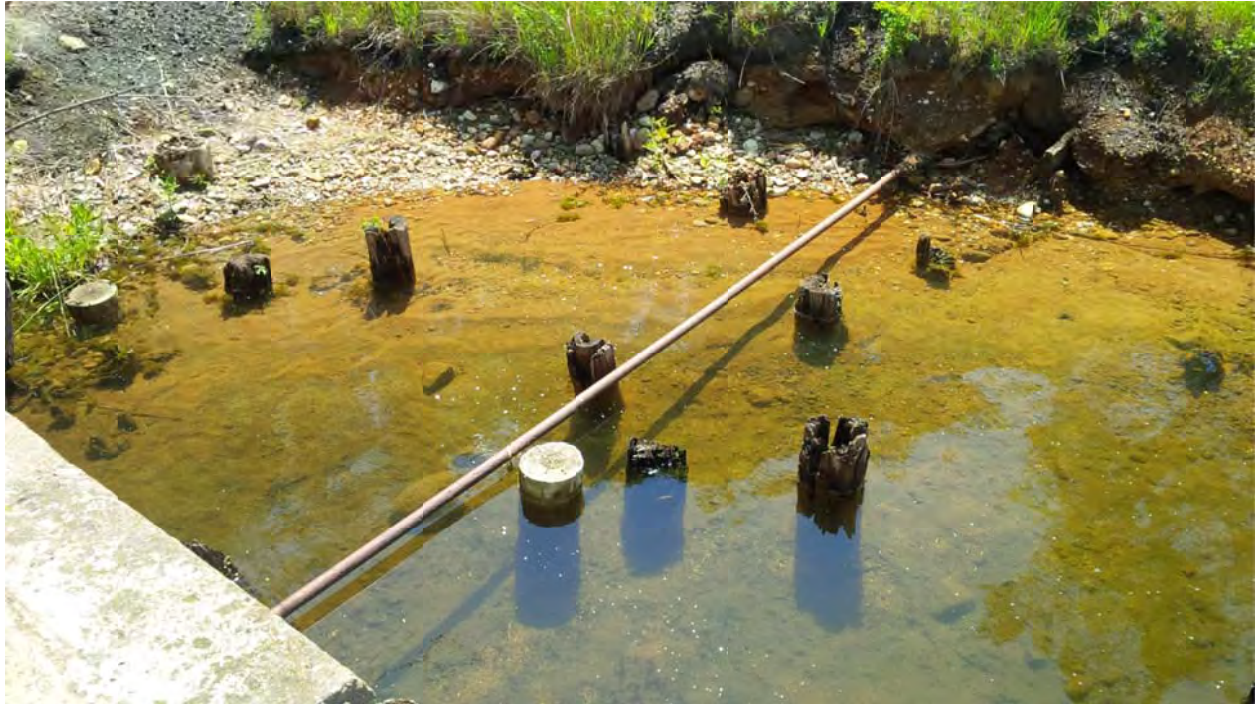
**Photo 5: East end of collapsed SSP wall section, East Reach**

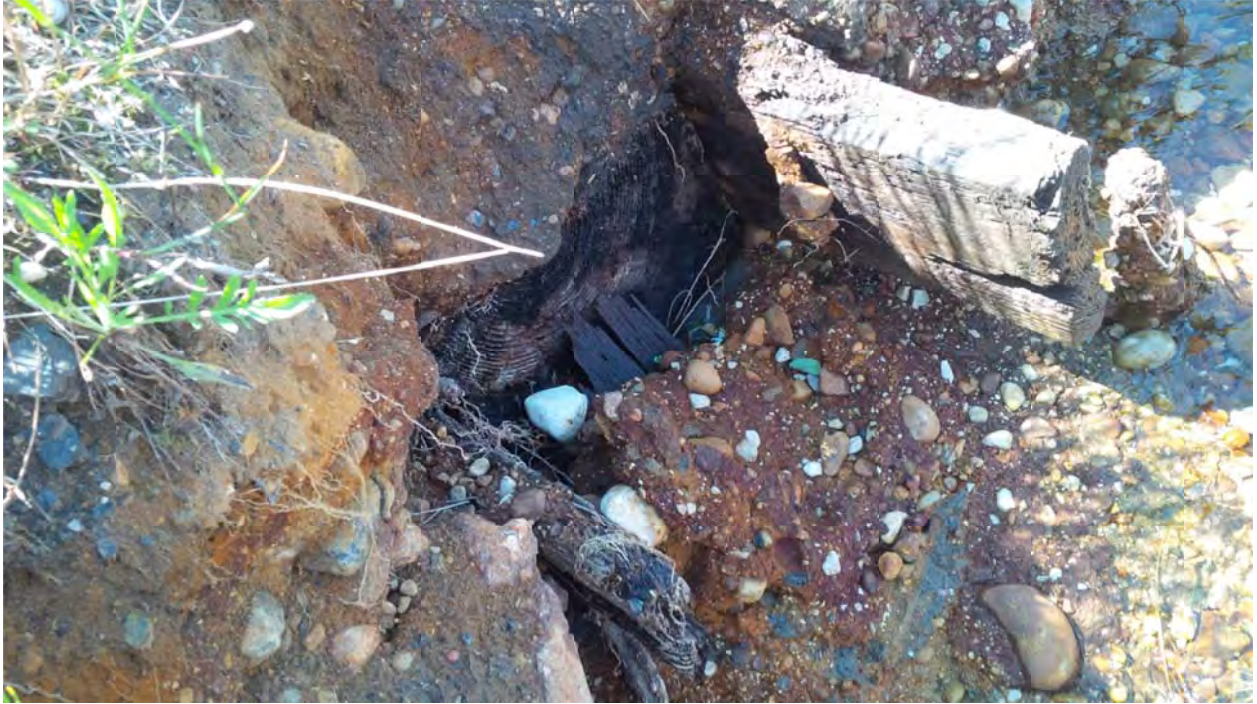
**Photo 7: Remains of timber structure exposed in bank at east end of collapsed SSP wall section, East Reach**

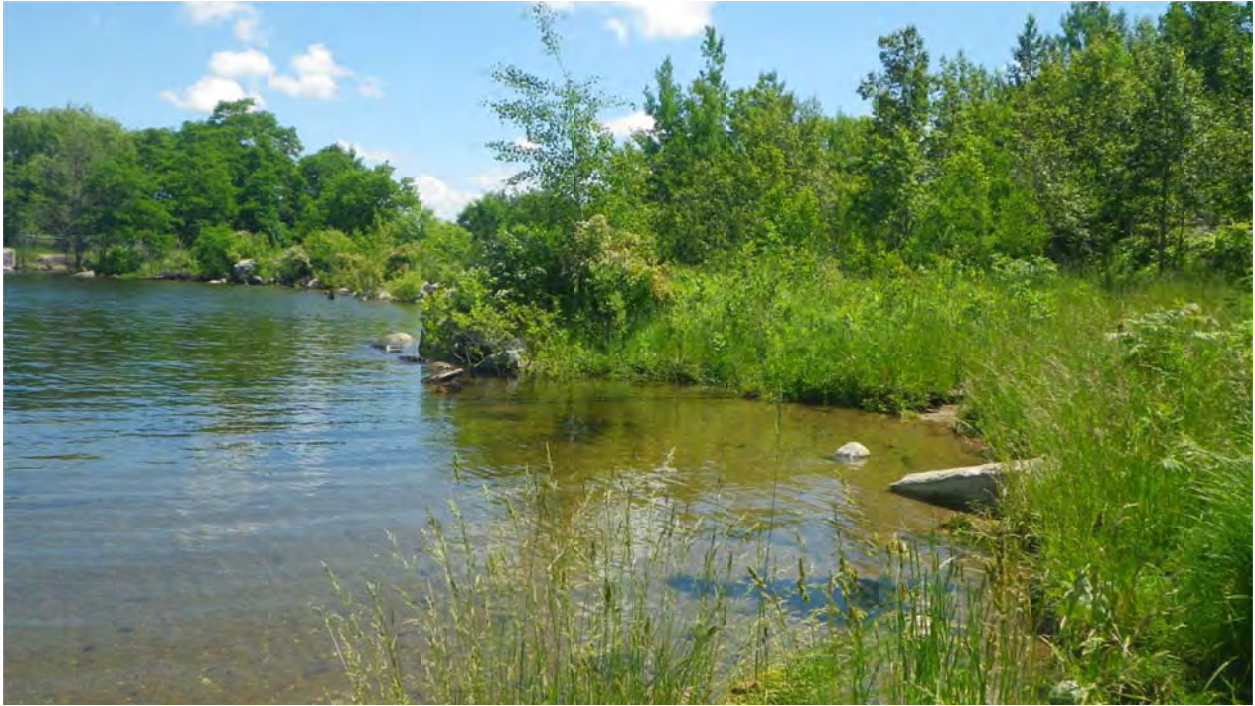
**Photo 11: Shoreline behind collapsed SSP wall, East Reach**

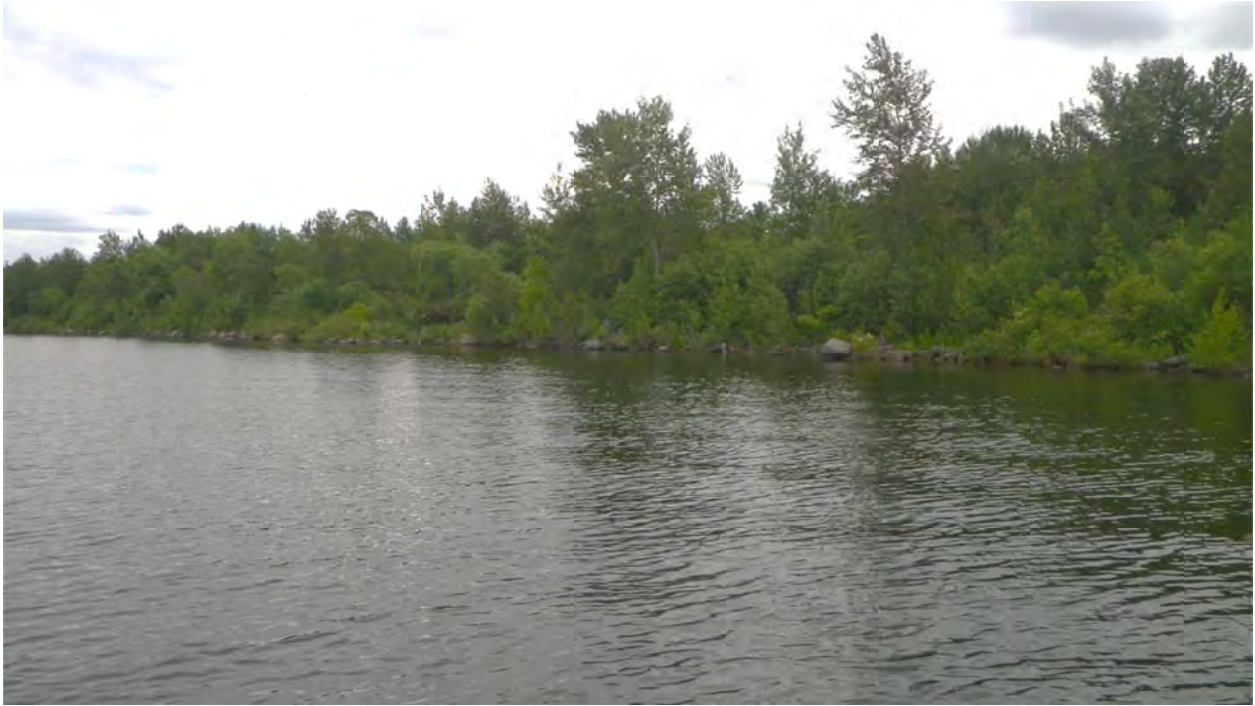
**Photo 15: East end of Centre Reach**

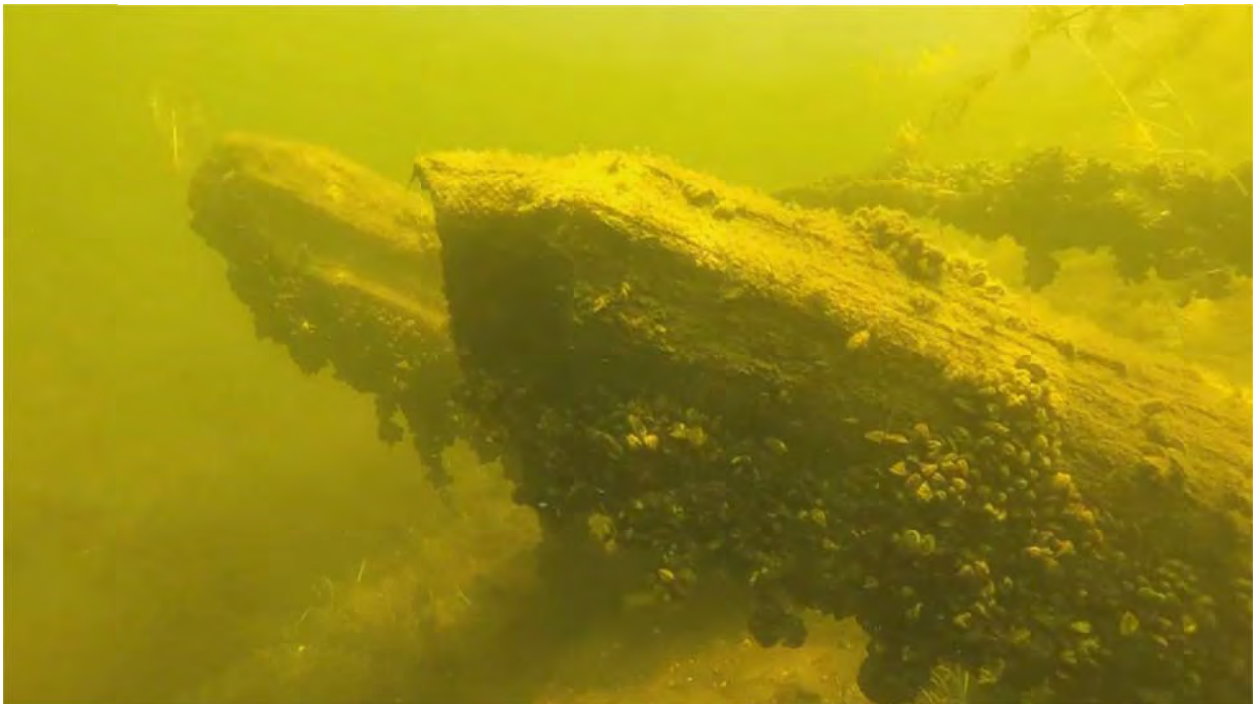
**Photo 16: Timber Piles in Centre Reach (Day 1, Dive 1, 1:49:37)**

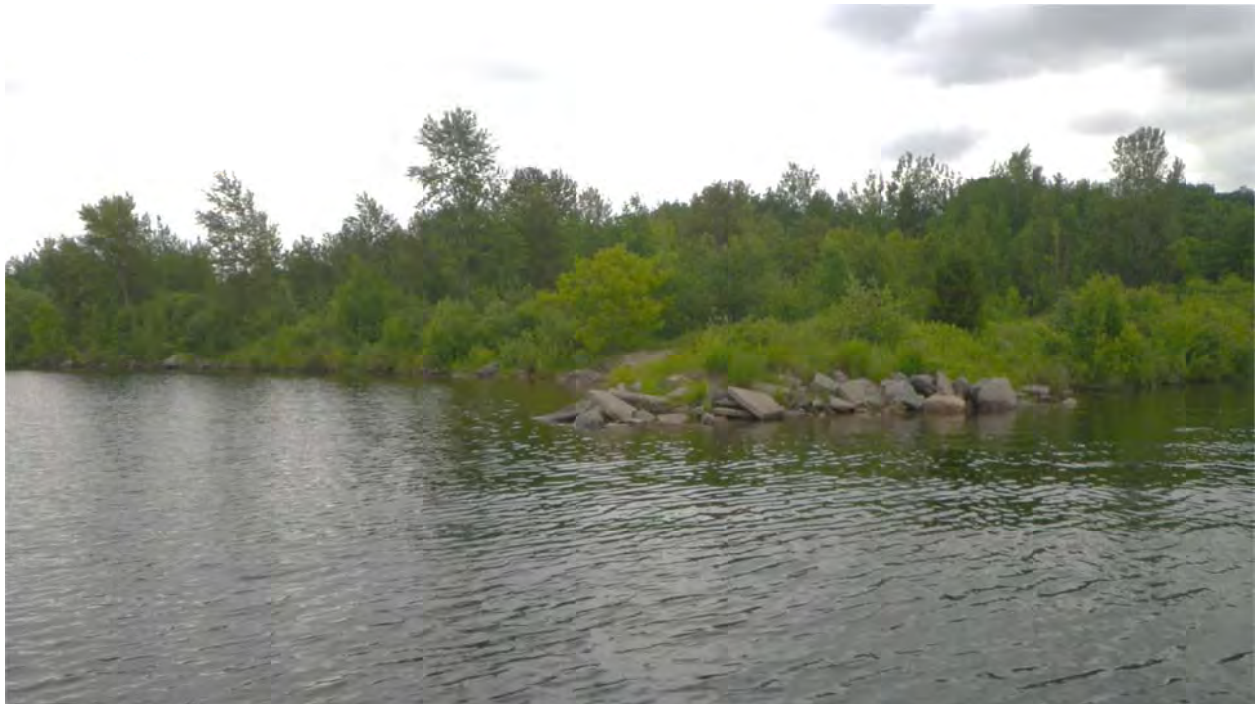
**Photo 18: Concrete rubble and armour stone headland in Centre Reach**

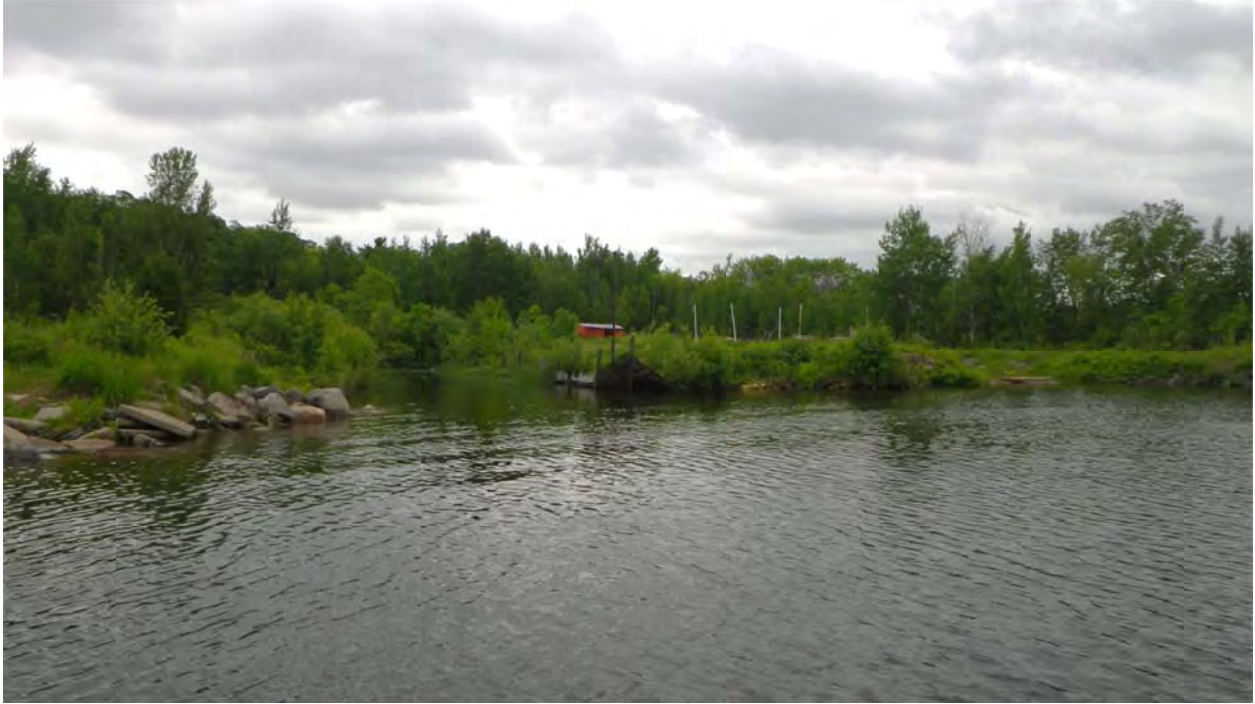
**Photo 19: Embayment and Collapsed deck and light standard, Centre Reach**

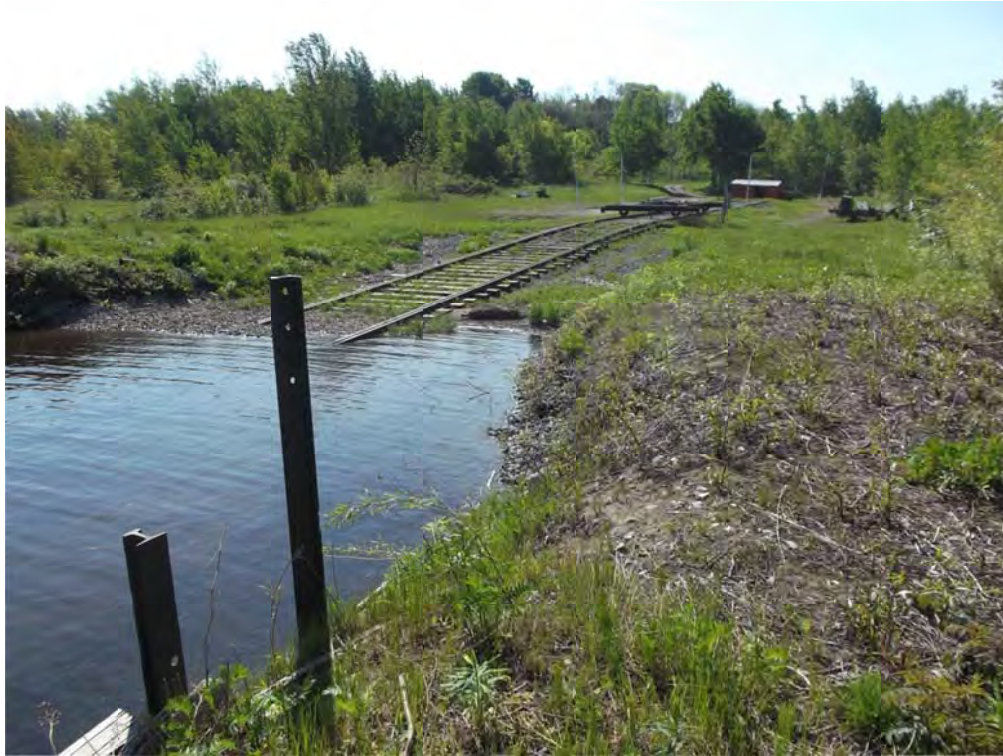
**Photo 21: Marine Railway, Centre Reach**

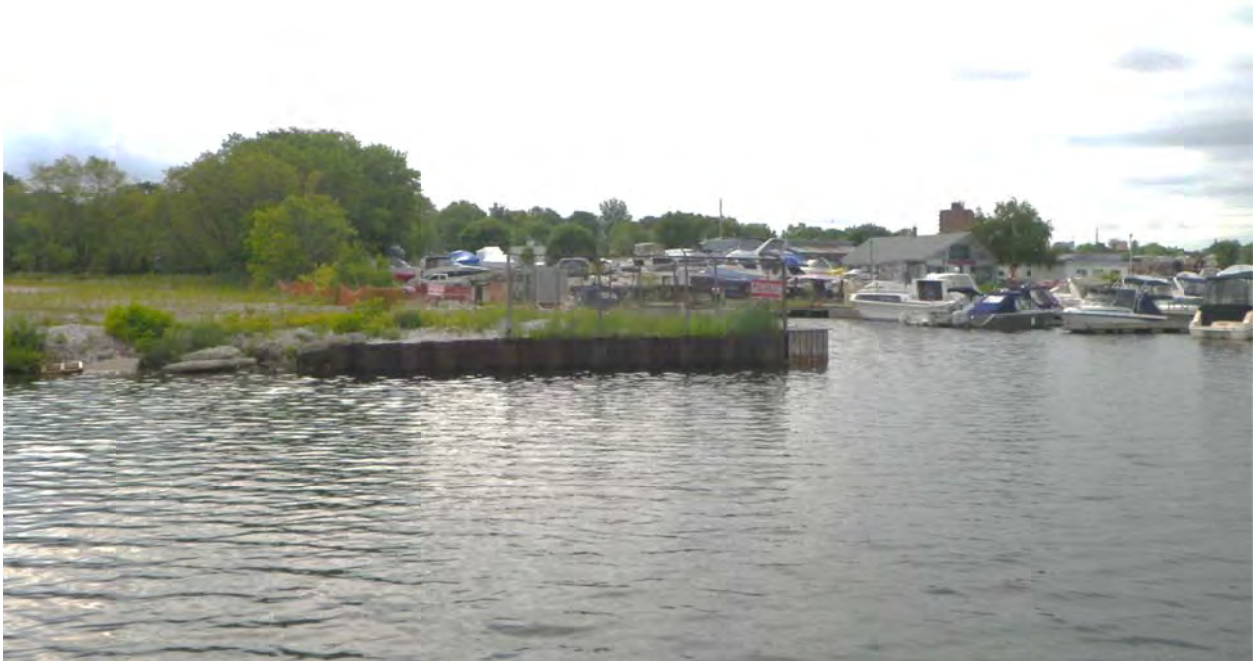
An approximately 11 metre long section of SSP wall is located at the west end of the reach (Photo 30). The top of the SSP wall varies between approximately 177.2 and 177.3 m. In the centre of the SSP wall section, the wall was leaning in towards land at an angle of approximately 2 degrees. The water depth in front of the SSP wall was approximately 6 metres on the day of the inspection. The lakebed in front of the wall consisted of a soft layer of silt and zebra mussel shells overlaying harder material. A typical section through the SSP wall is shown as Section 9 on Figure 3-7.

**Photo 30: SSP wall at west end of site, West Reach**

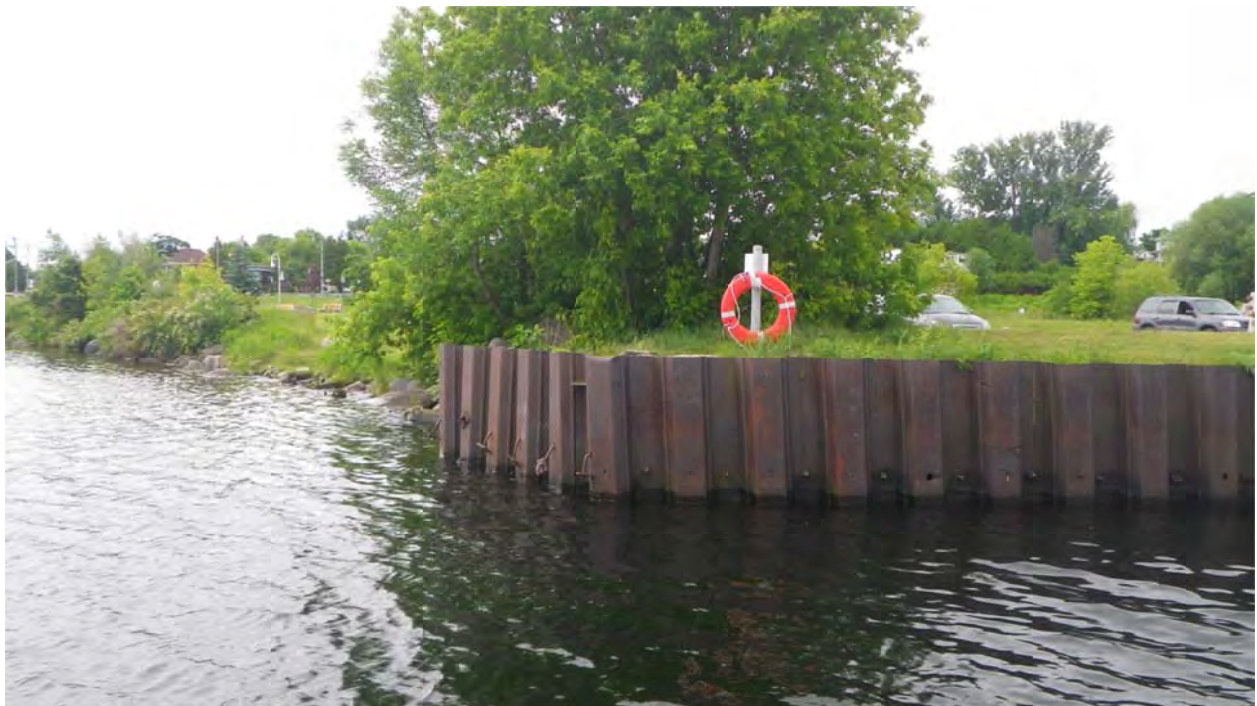
**Photo 32: East end of SSP wall, East Reach**

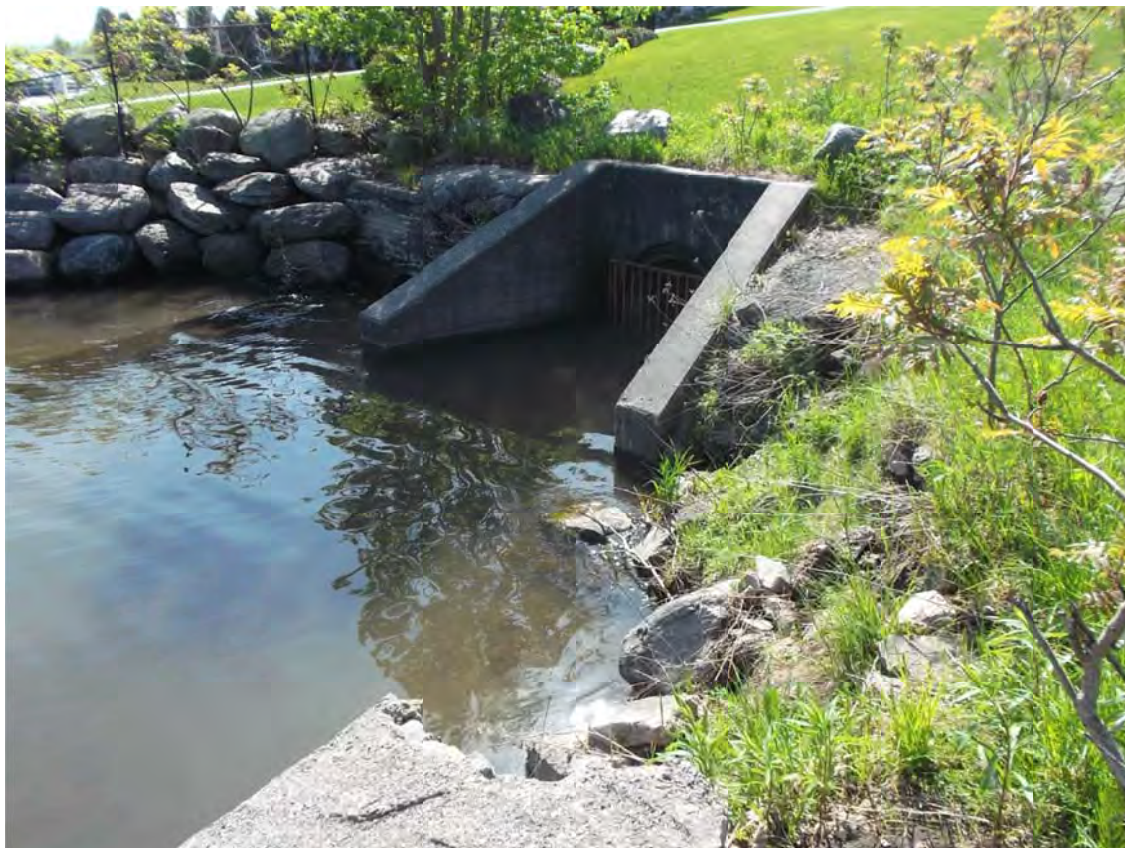
**Photo 34: Outfall at east end of property**
