Phase Two Conceptual Site Model Midland Bay Landing 420 Bayshore Drive, Midland, Ontario

Cambium Reference No.: 6820-001

2019-04-01

Prepared for: The Town of Midland

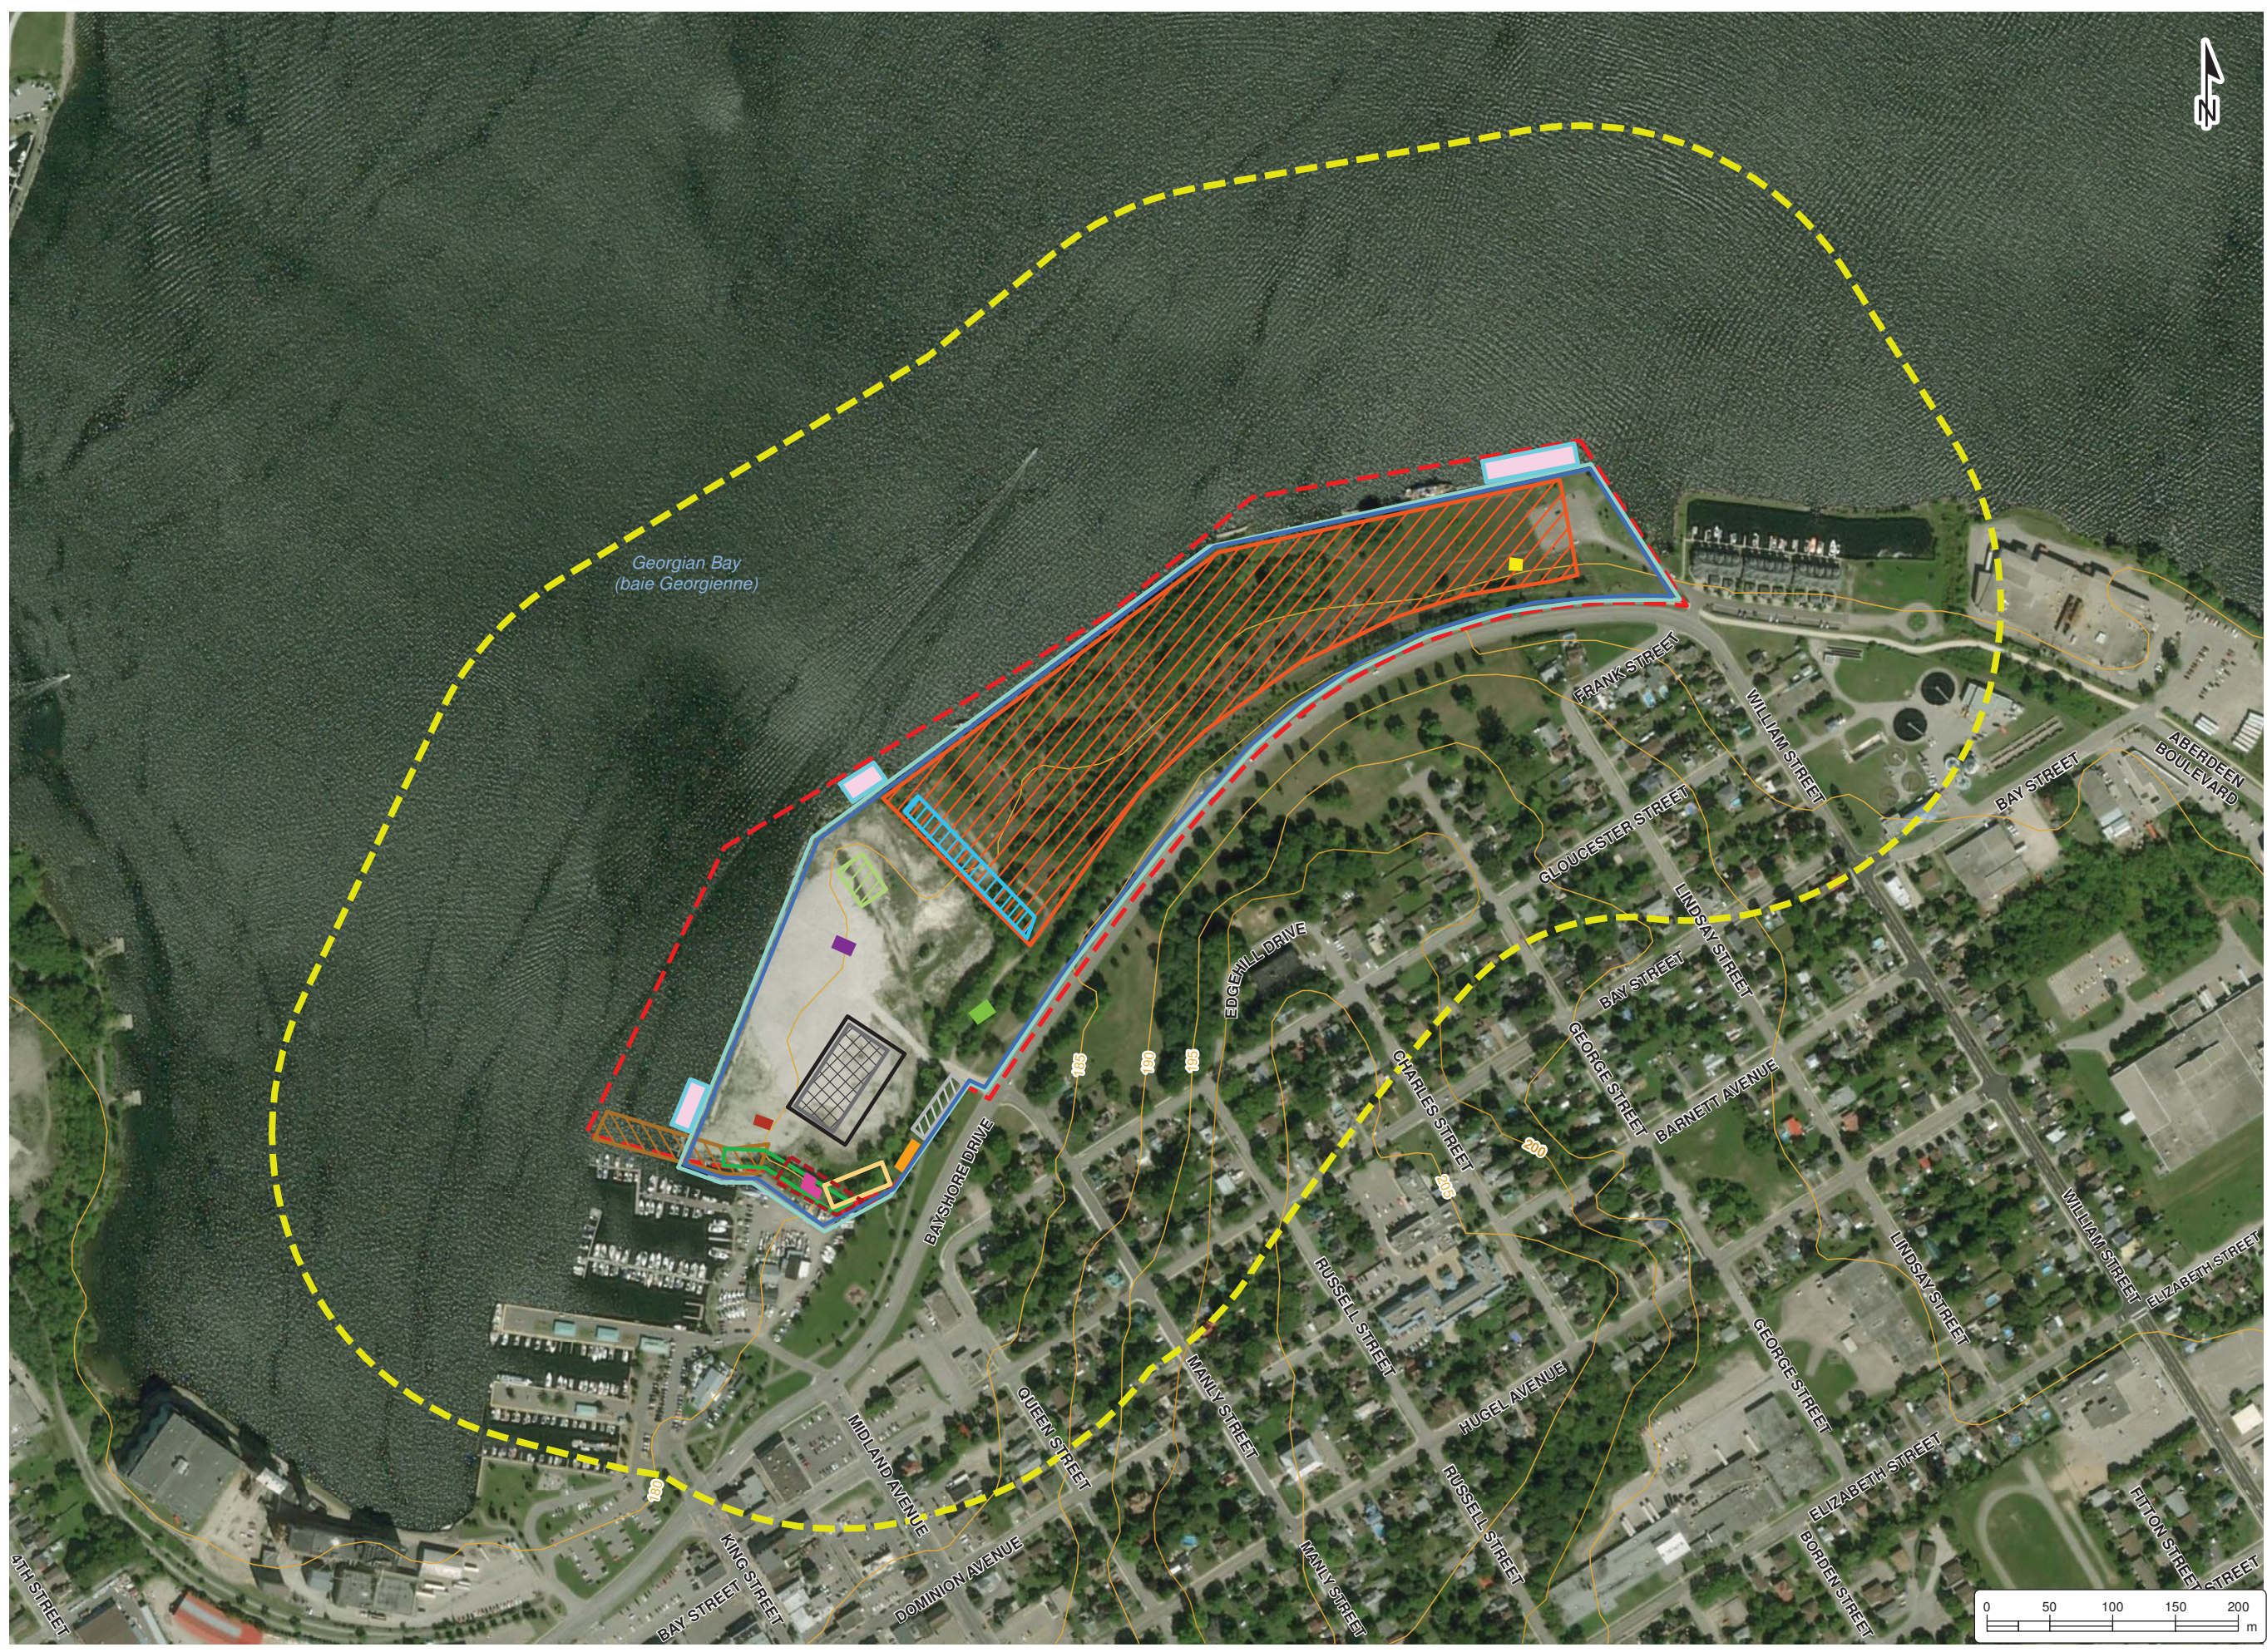
| Figure: 6 | |

C:\GIS\project_MXDs\6820-001 Midland Bay Landing\2019-02-05 P2 Fig 6 - Conceptual Site Model - Areas of Potential Environmental Concern.mxd

The following 20 APECs were identified at the Site. The APECs are shown on Figure 6.

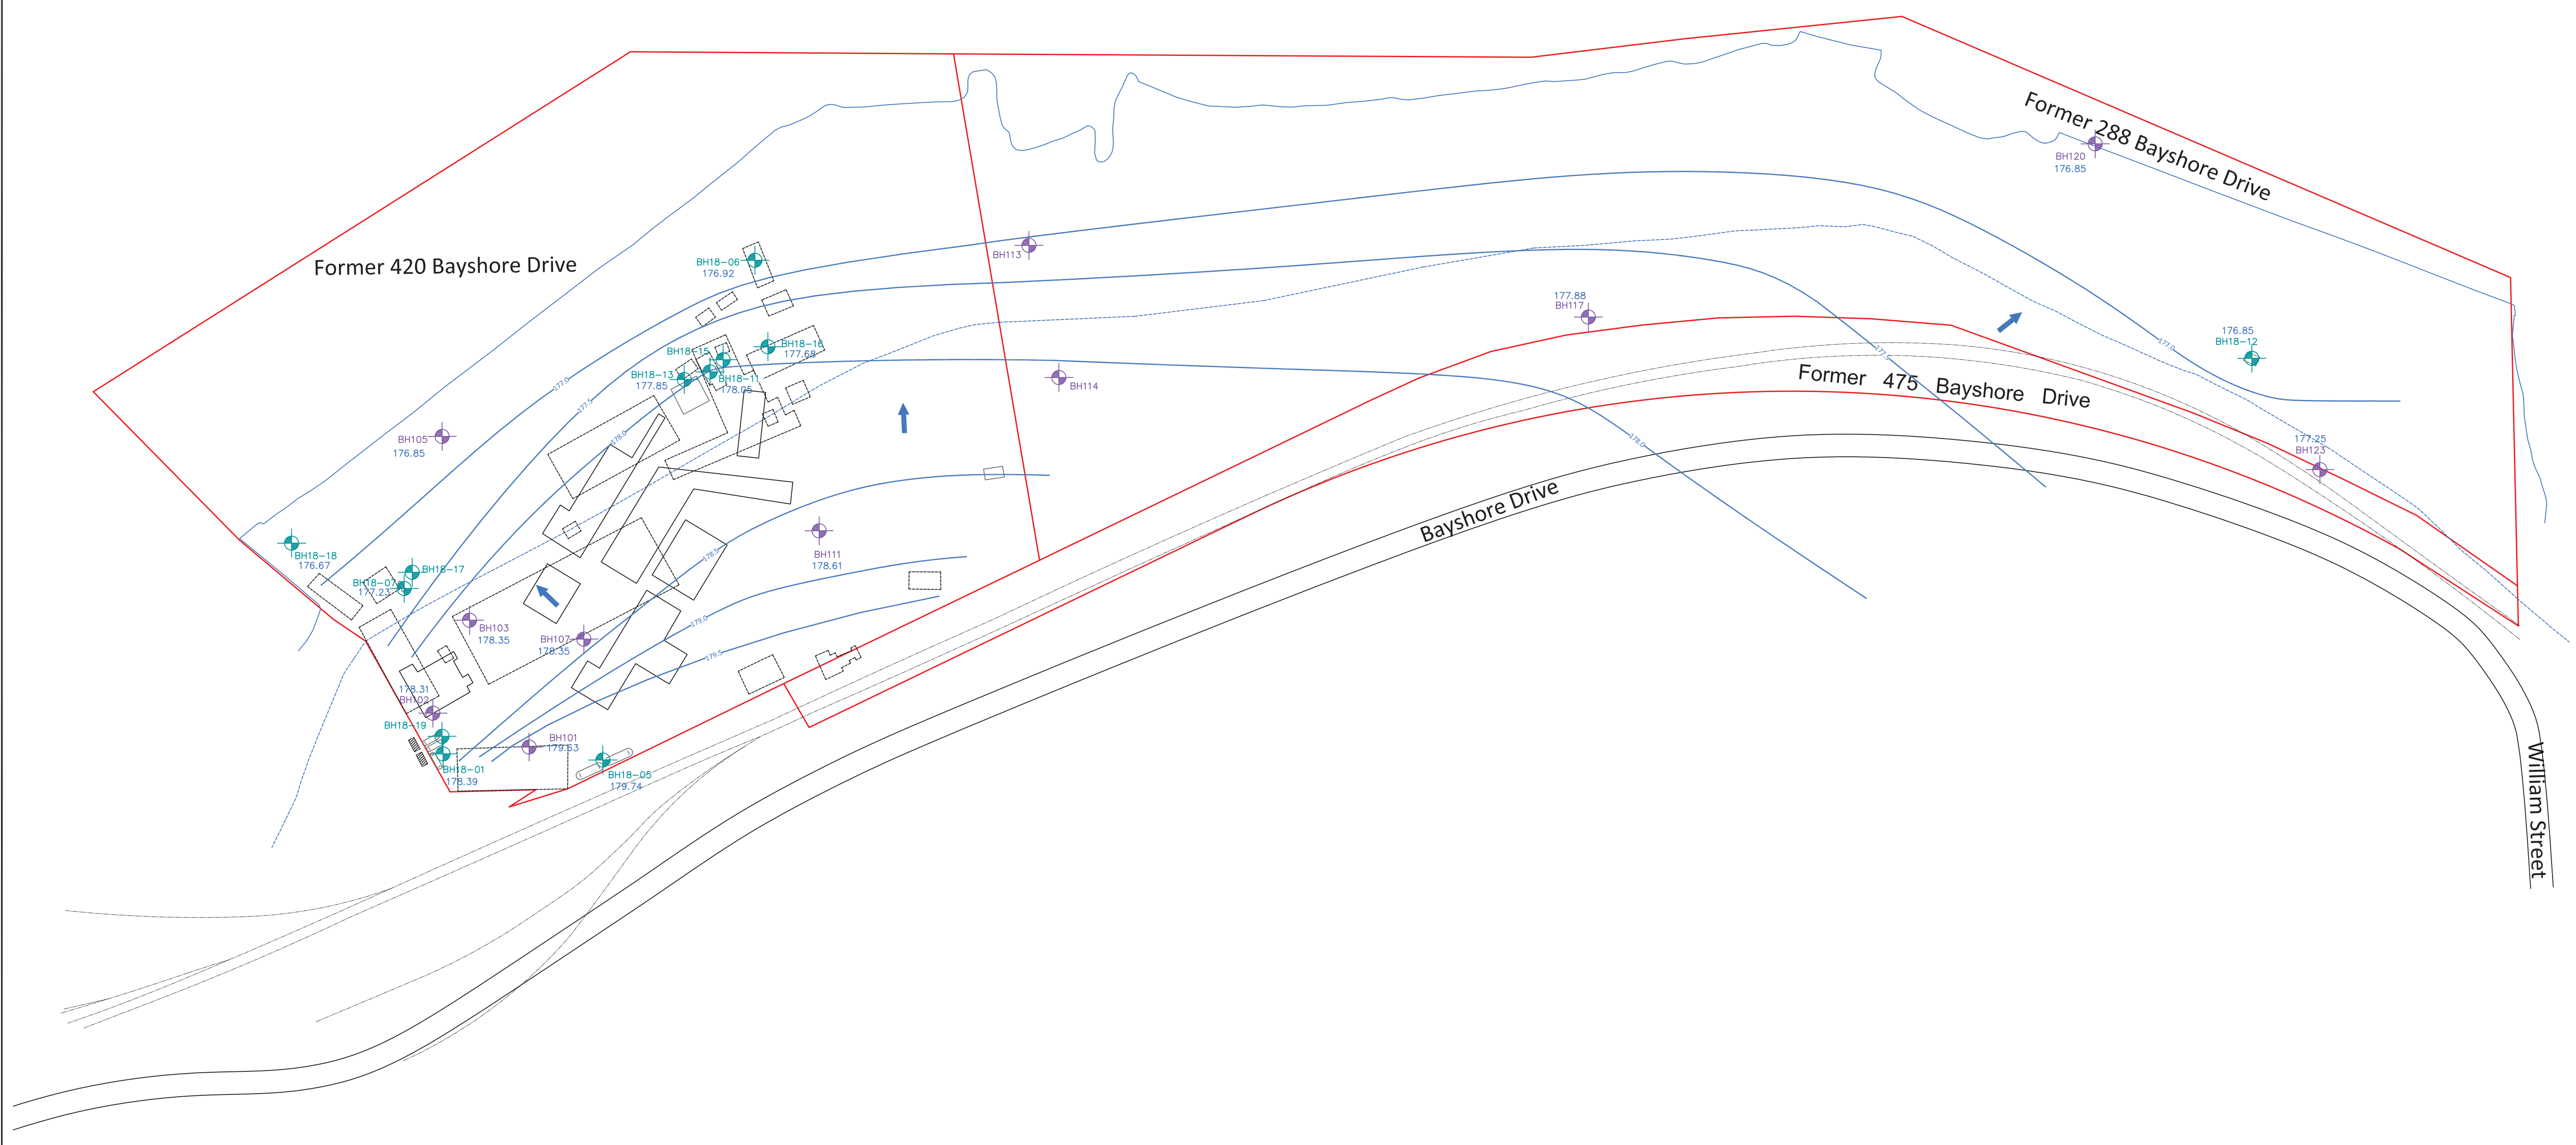
| Figure: | 7 | | |

- LEGEND**
- 176.87 SHALLOW GROUNDWATER ELEVATION (February 15, 2019)
 - SHALLOW GROUNDWATER CONTOUR (February 15, 2019)
 - SHALLOW GROUNDWATER FLOW DIRECTION (February 15, 2019)
 - WATER'S EDGE (Feb. 17, 2015)
 - ORIGINAL WATER'S EDGE (APPROXIMATE)
 - PROPERTY LINE
 - FORMER RAIL LINE
 - UNDERGROUND STORAGE TANK
 - AST
- PINCHIN LTD.**
- MONITORING WELL
- CAMBIUM**
- MONITORING WELL
- BUILDING FOOTPRINTS**
- RECENT
 - FROM 1917 AND 1946 FIRE INSURANCE PLANS

February 2019 elevation data was used to generate flow direction figures for shallow groundwater (Figure 7) and deep (Figure 8) groundwater. Groundwater flow direction in both the shallow and deeper wells was northerly toward Midland Bay.

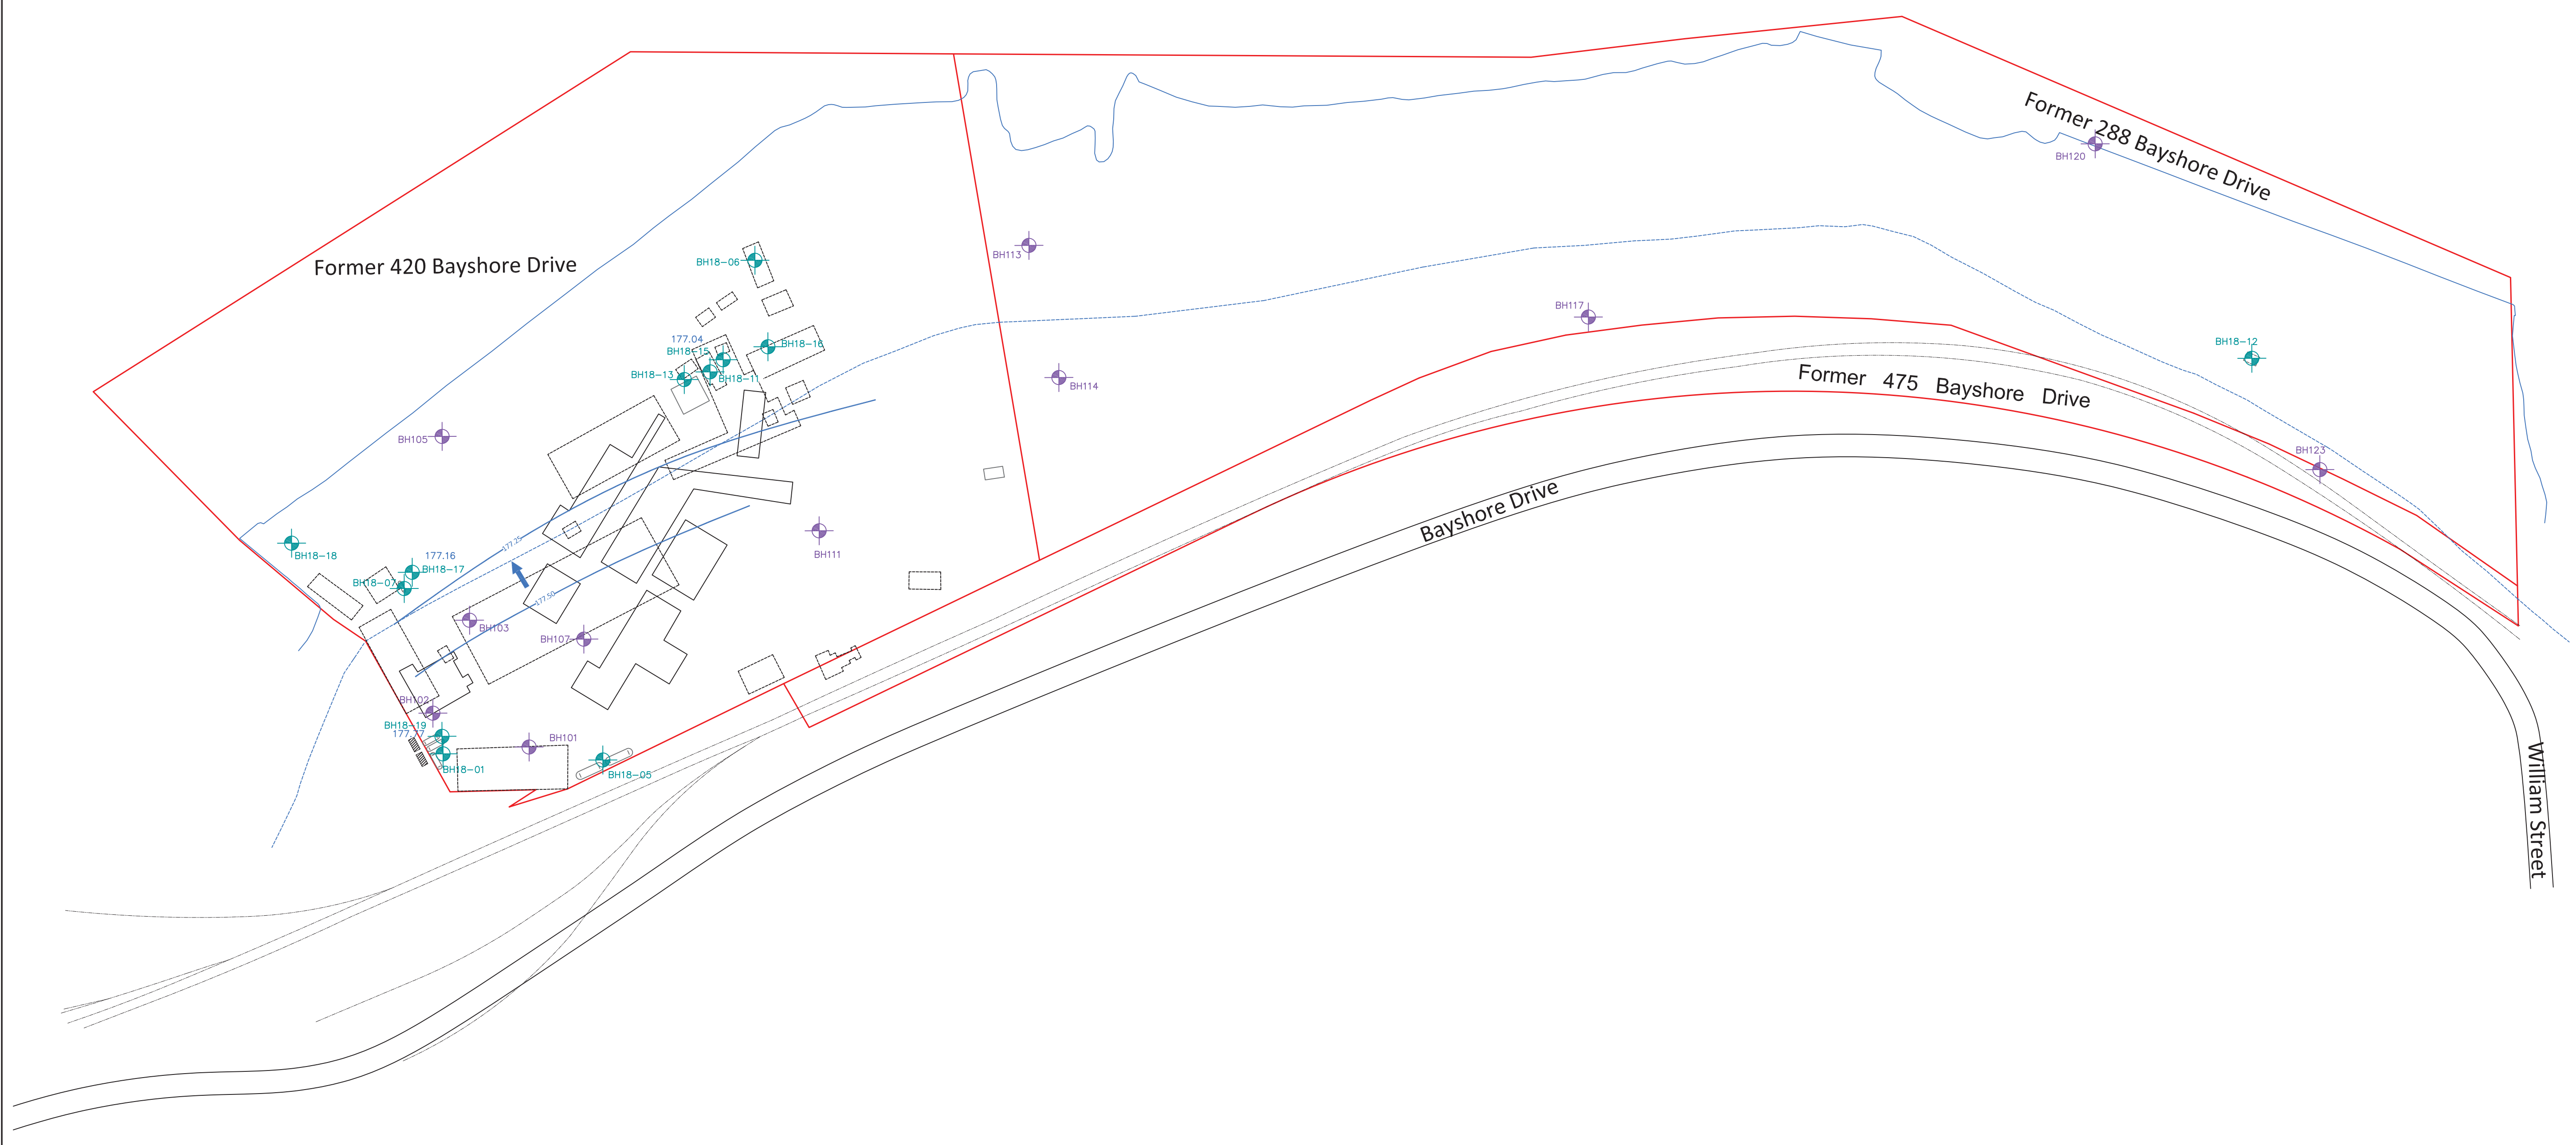
| Figure: 8 | |

- LEGEND**
- 176.87 DEEP GROUNDWATER ELEVATION (February 15, 2019)
 - DEEP GROUNDWATER CONTOUR (February 15, 2019)
 - DEEP GROUNDWATER FLOW DIRECTION (February 15, 2019)
 - WATER'S EDGE (Feb. 17, 2015)
 - ORIGINAL WATER'S EDGE (APPROXIMATE)
 - PROPERTY LINE
 - FORMER RAIL LINE
 - UNDERGROUND STORAGE TANK
 - AST
- PINCHIN LTD.**
- MONITORING WELL
- CAMBIUM**
- MONITORING WELL
- BUILDING FOOTPRINTS**
- RECENT
 - FROM 1917 AND 1946 FIRE INSURANCE PLANS

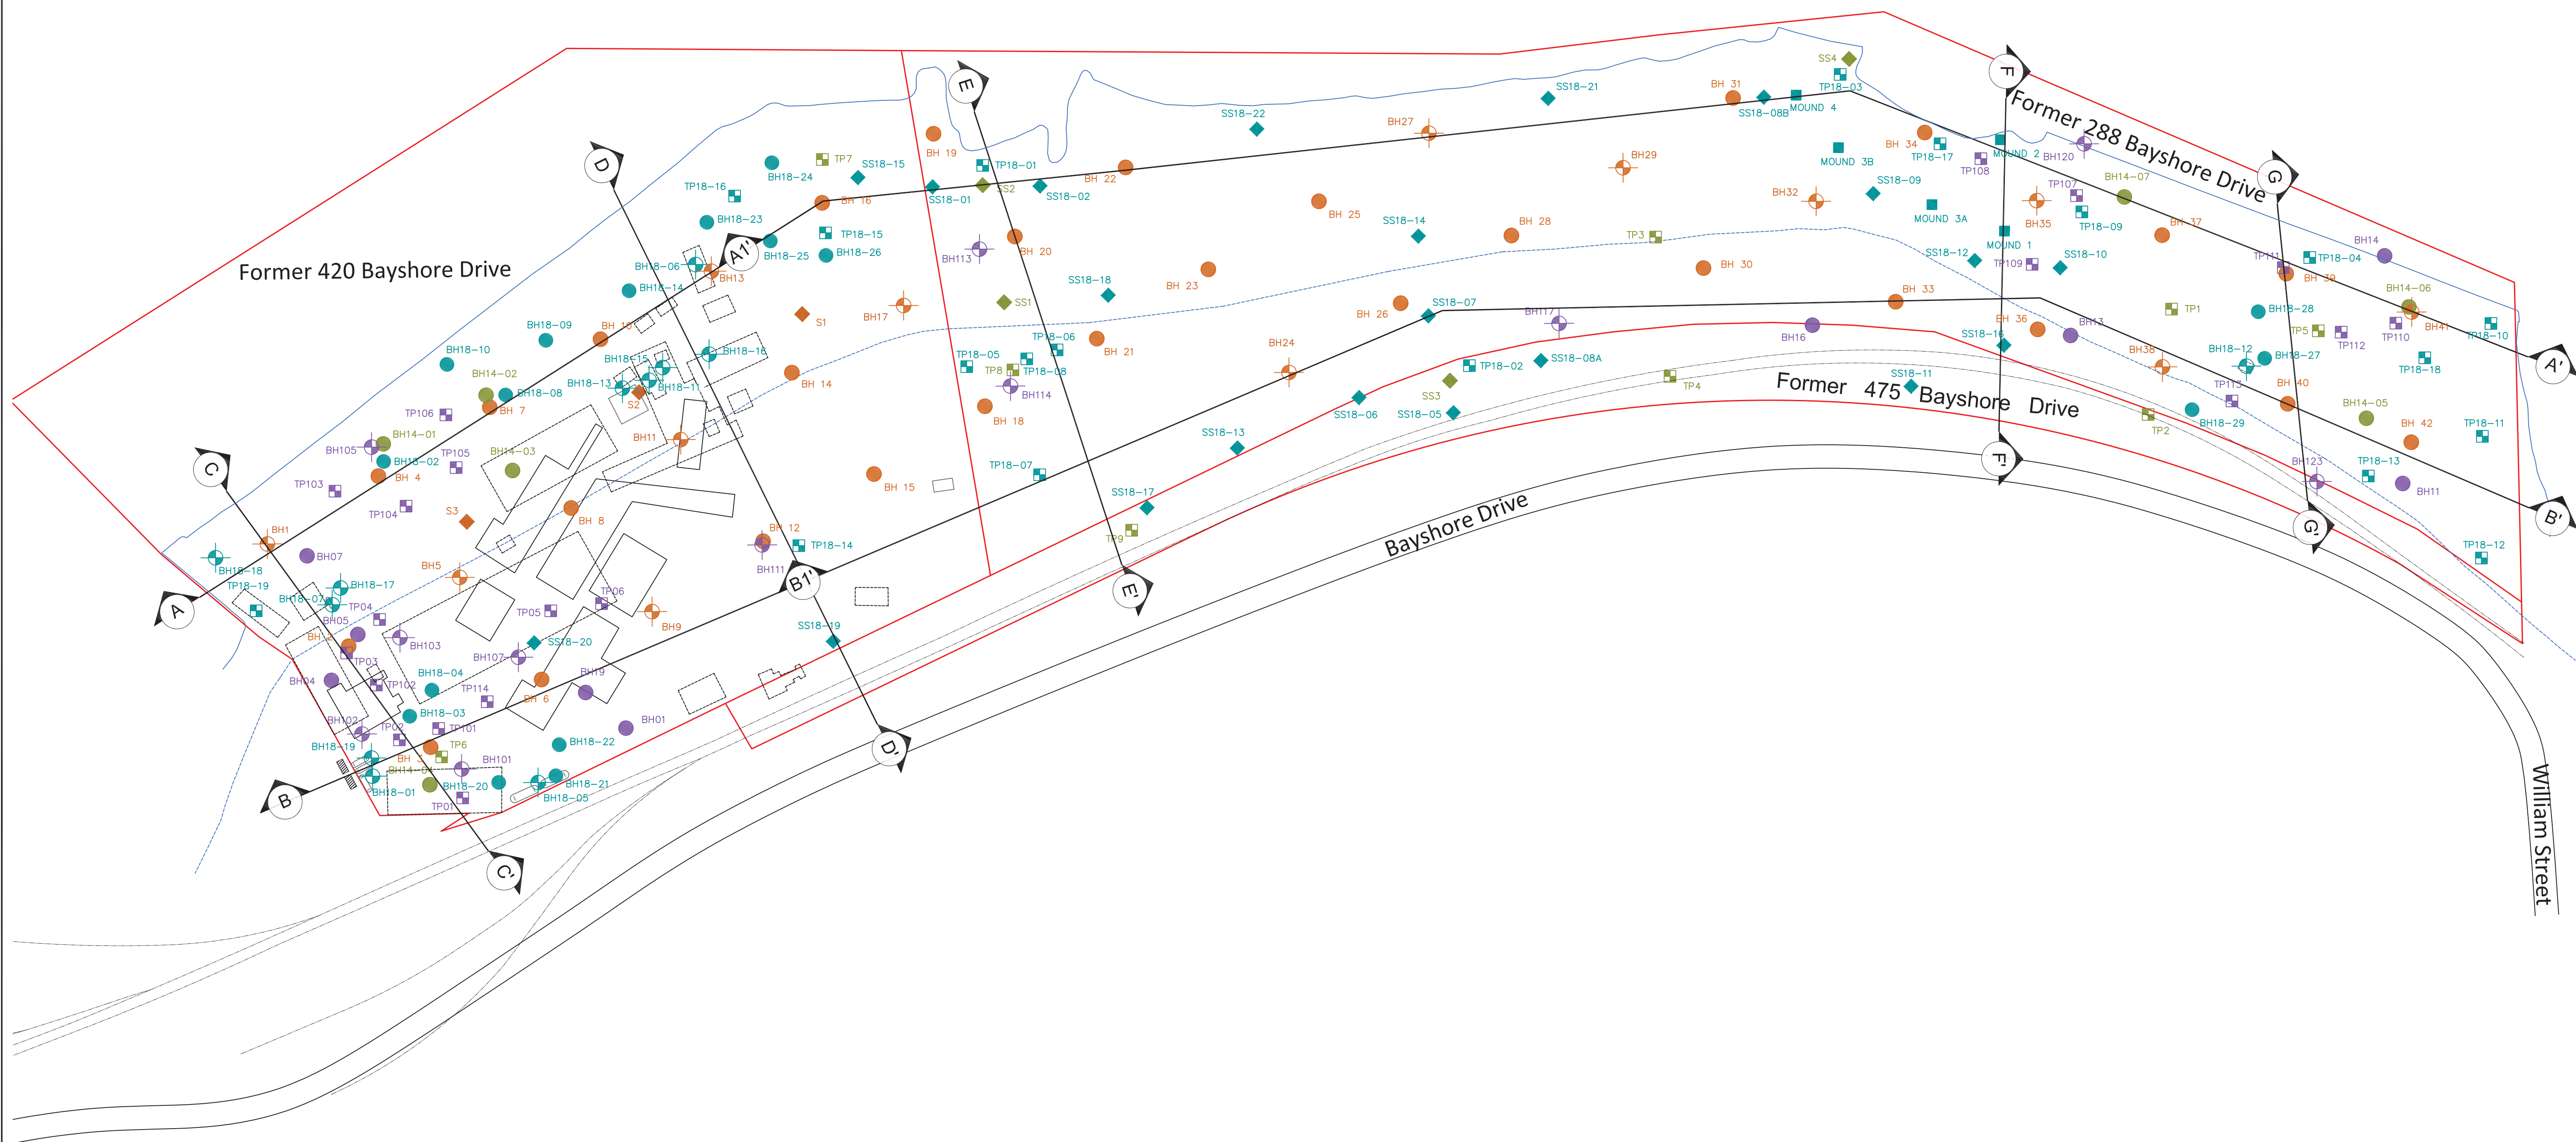
CROSS - SECTION LOCATIONS

- CROSS SECTION**
- VIEWING DIRECTION
- CROSS SECTION ID

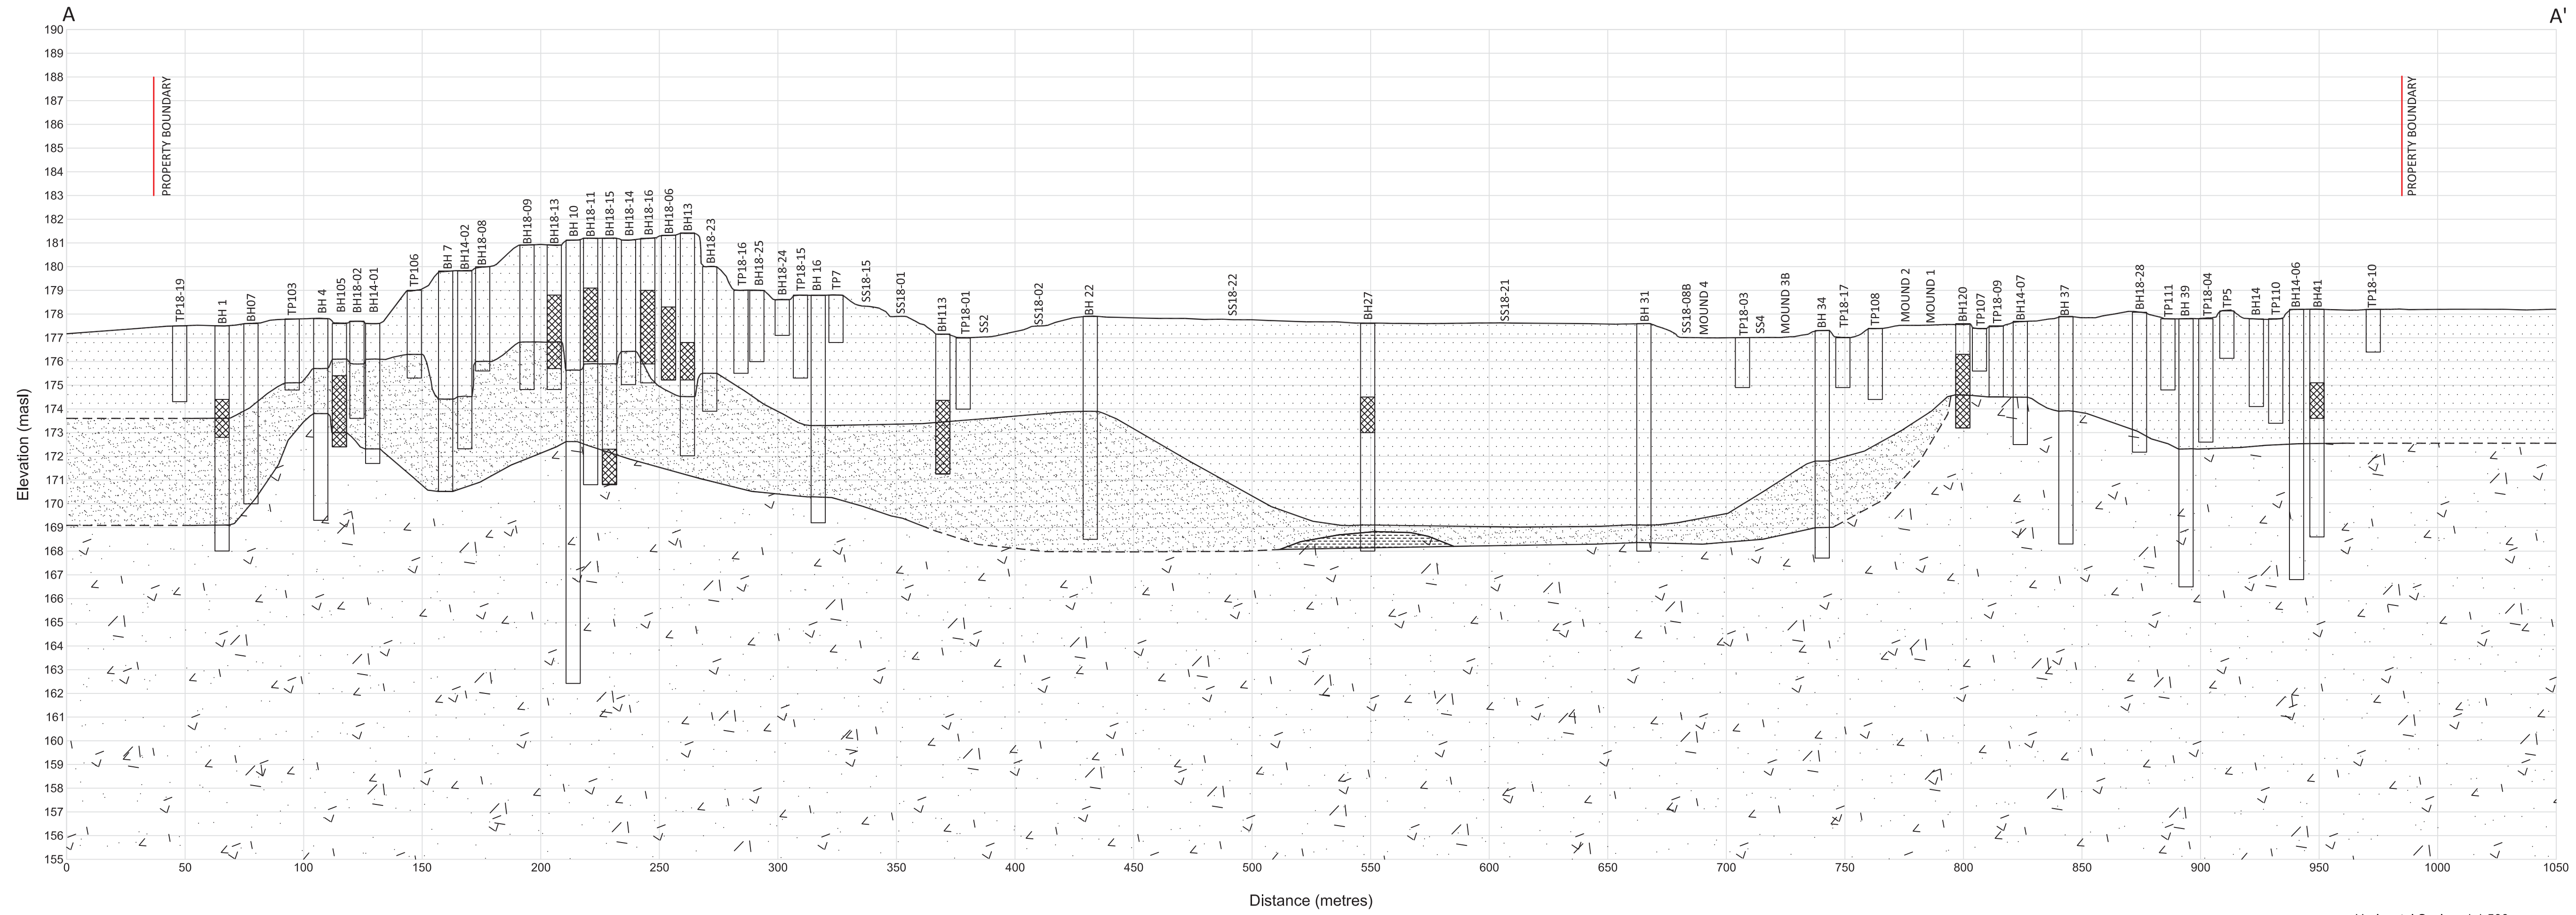
Cross - Section A-A'

Horizontal Scale = 1:1,500
Vertical Scale = 1:150

- Fill - organic topsoil, silty sand, gravel, sand cobbles, boulders, brick, wood/peat
- Till - silty sand, sandy silt, clay, sand
- Sand and Gravel
- Peat
- Sand
- Well Casing
- Well Screen

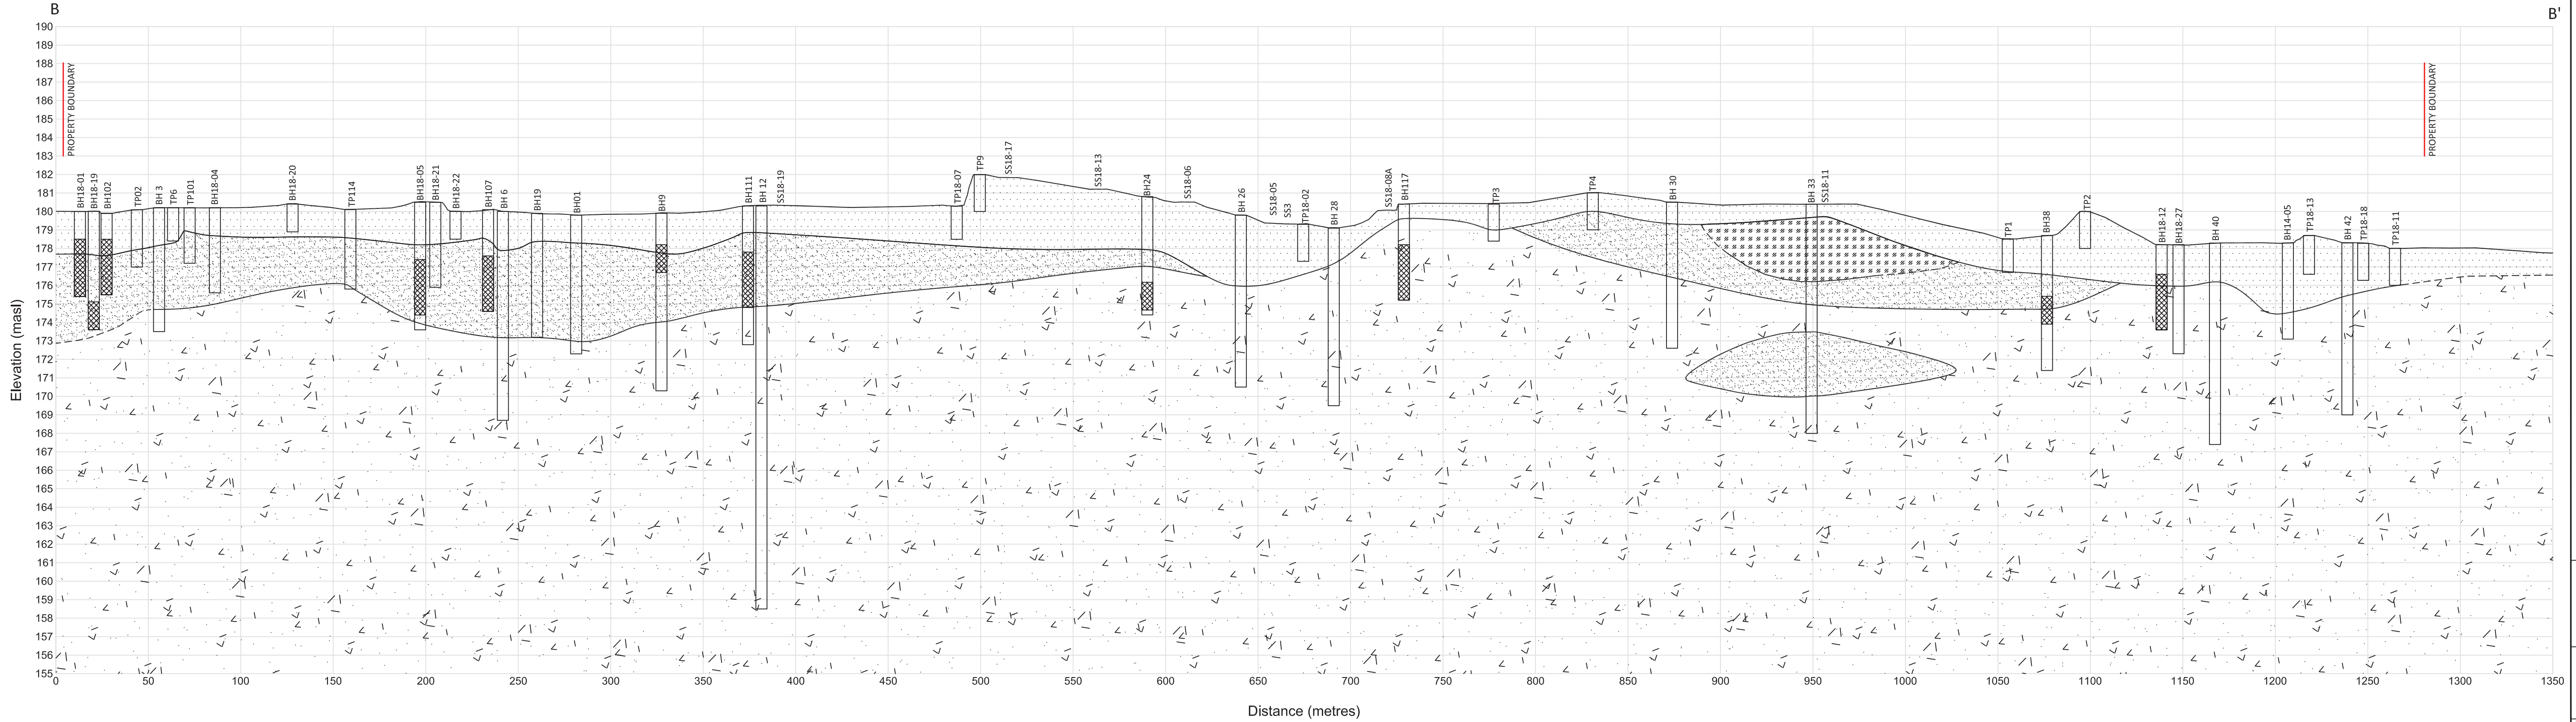
Cross - Section B-B'

Horizontal Scale = 1:1,750
Vertical Scale = 1:175

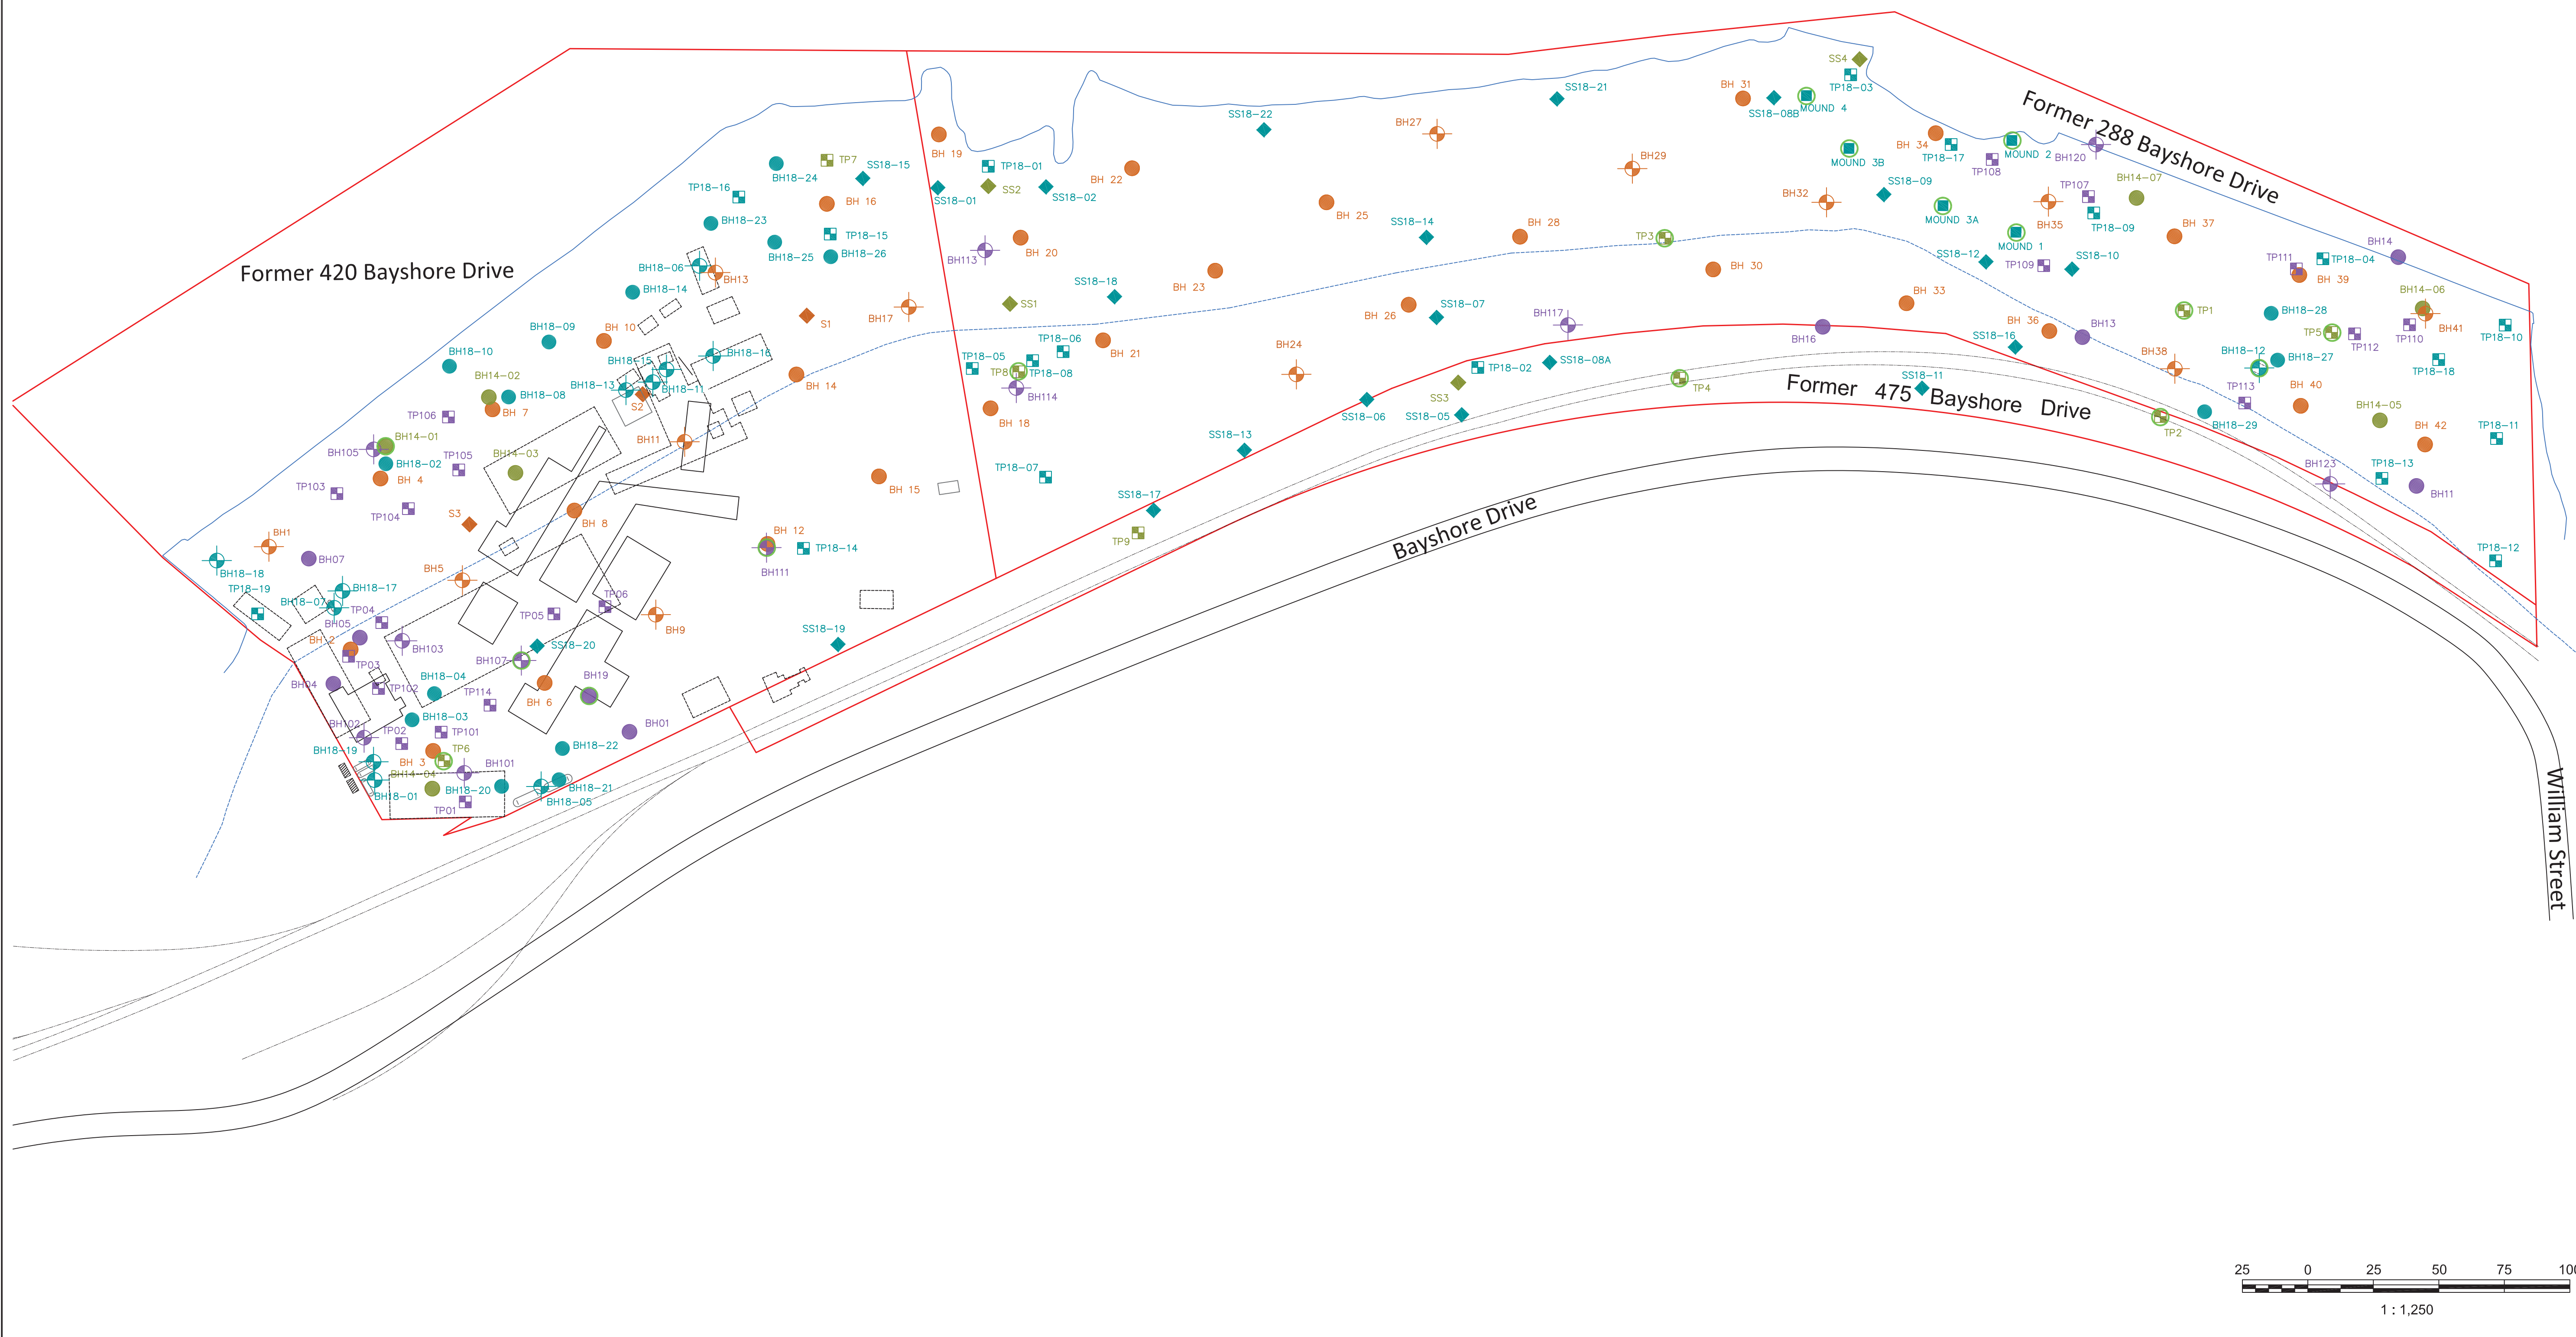
| Figure: | 11 | | |

SOIL RESULTS - PCBs
