Phase Two Conceptual Site Model Midland Bay Landing 420 Bayshore Drive, Midland, Ontario

Cambium Reference No.: 6820-001

2019-04-01

Prepared for: The Town of Midland

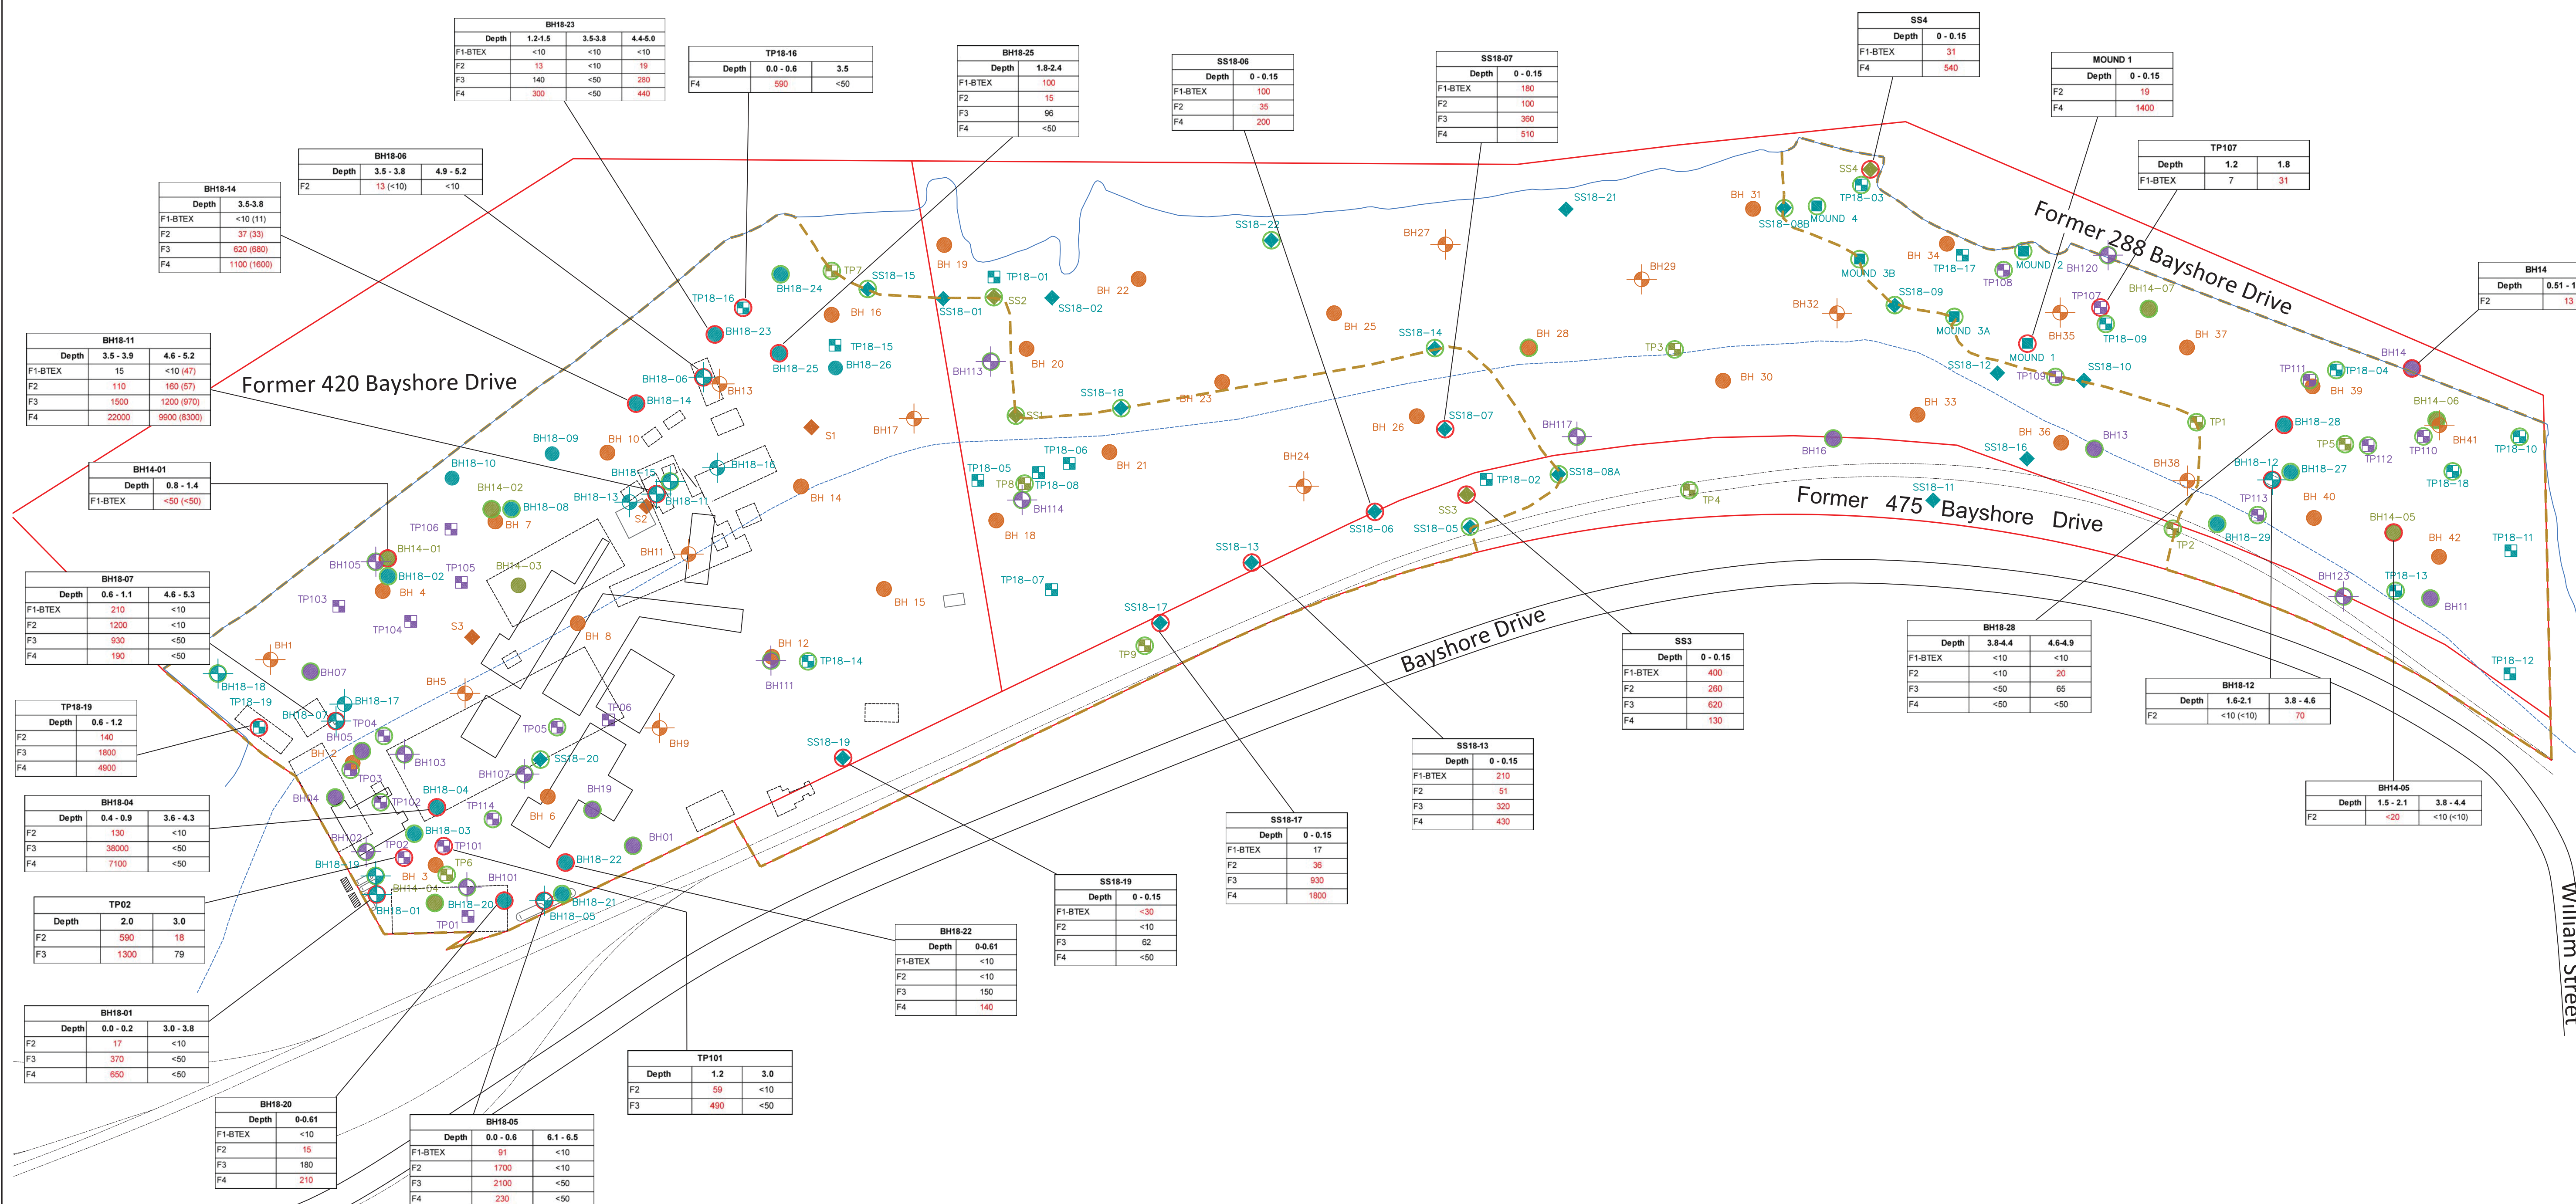
SOIL RESULTS - PHCs

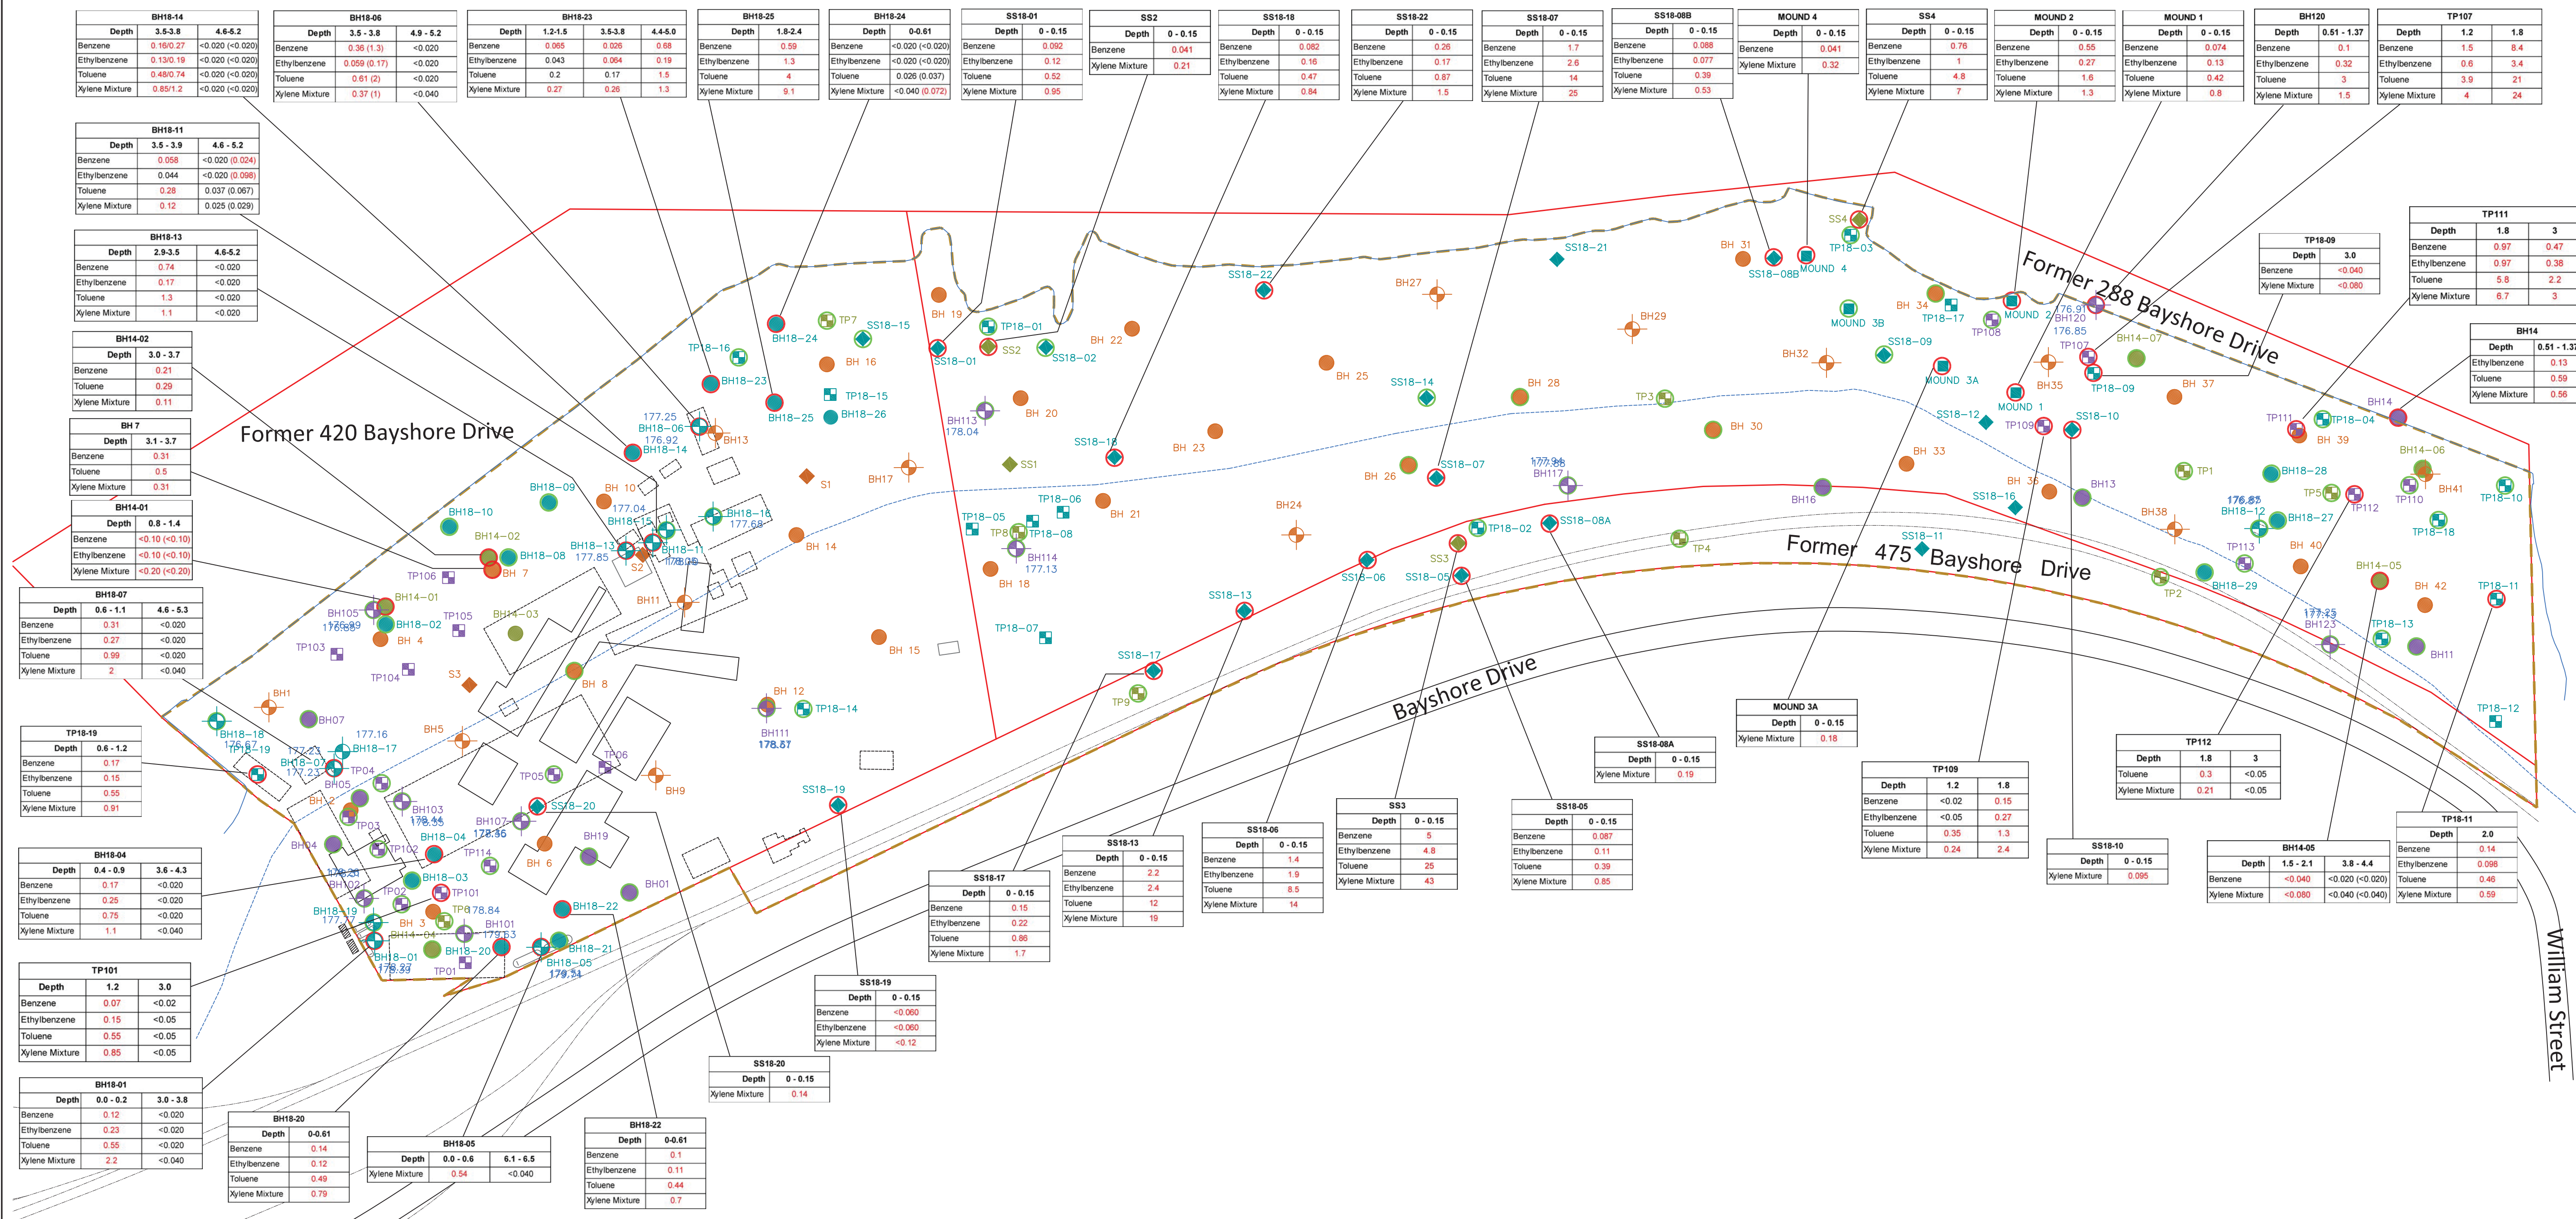
SOIL RESULTS - BTEX

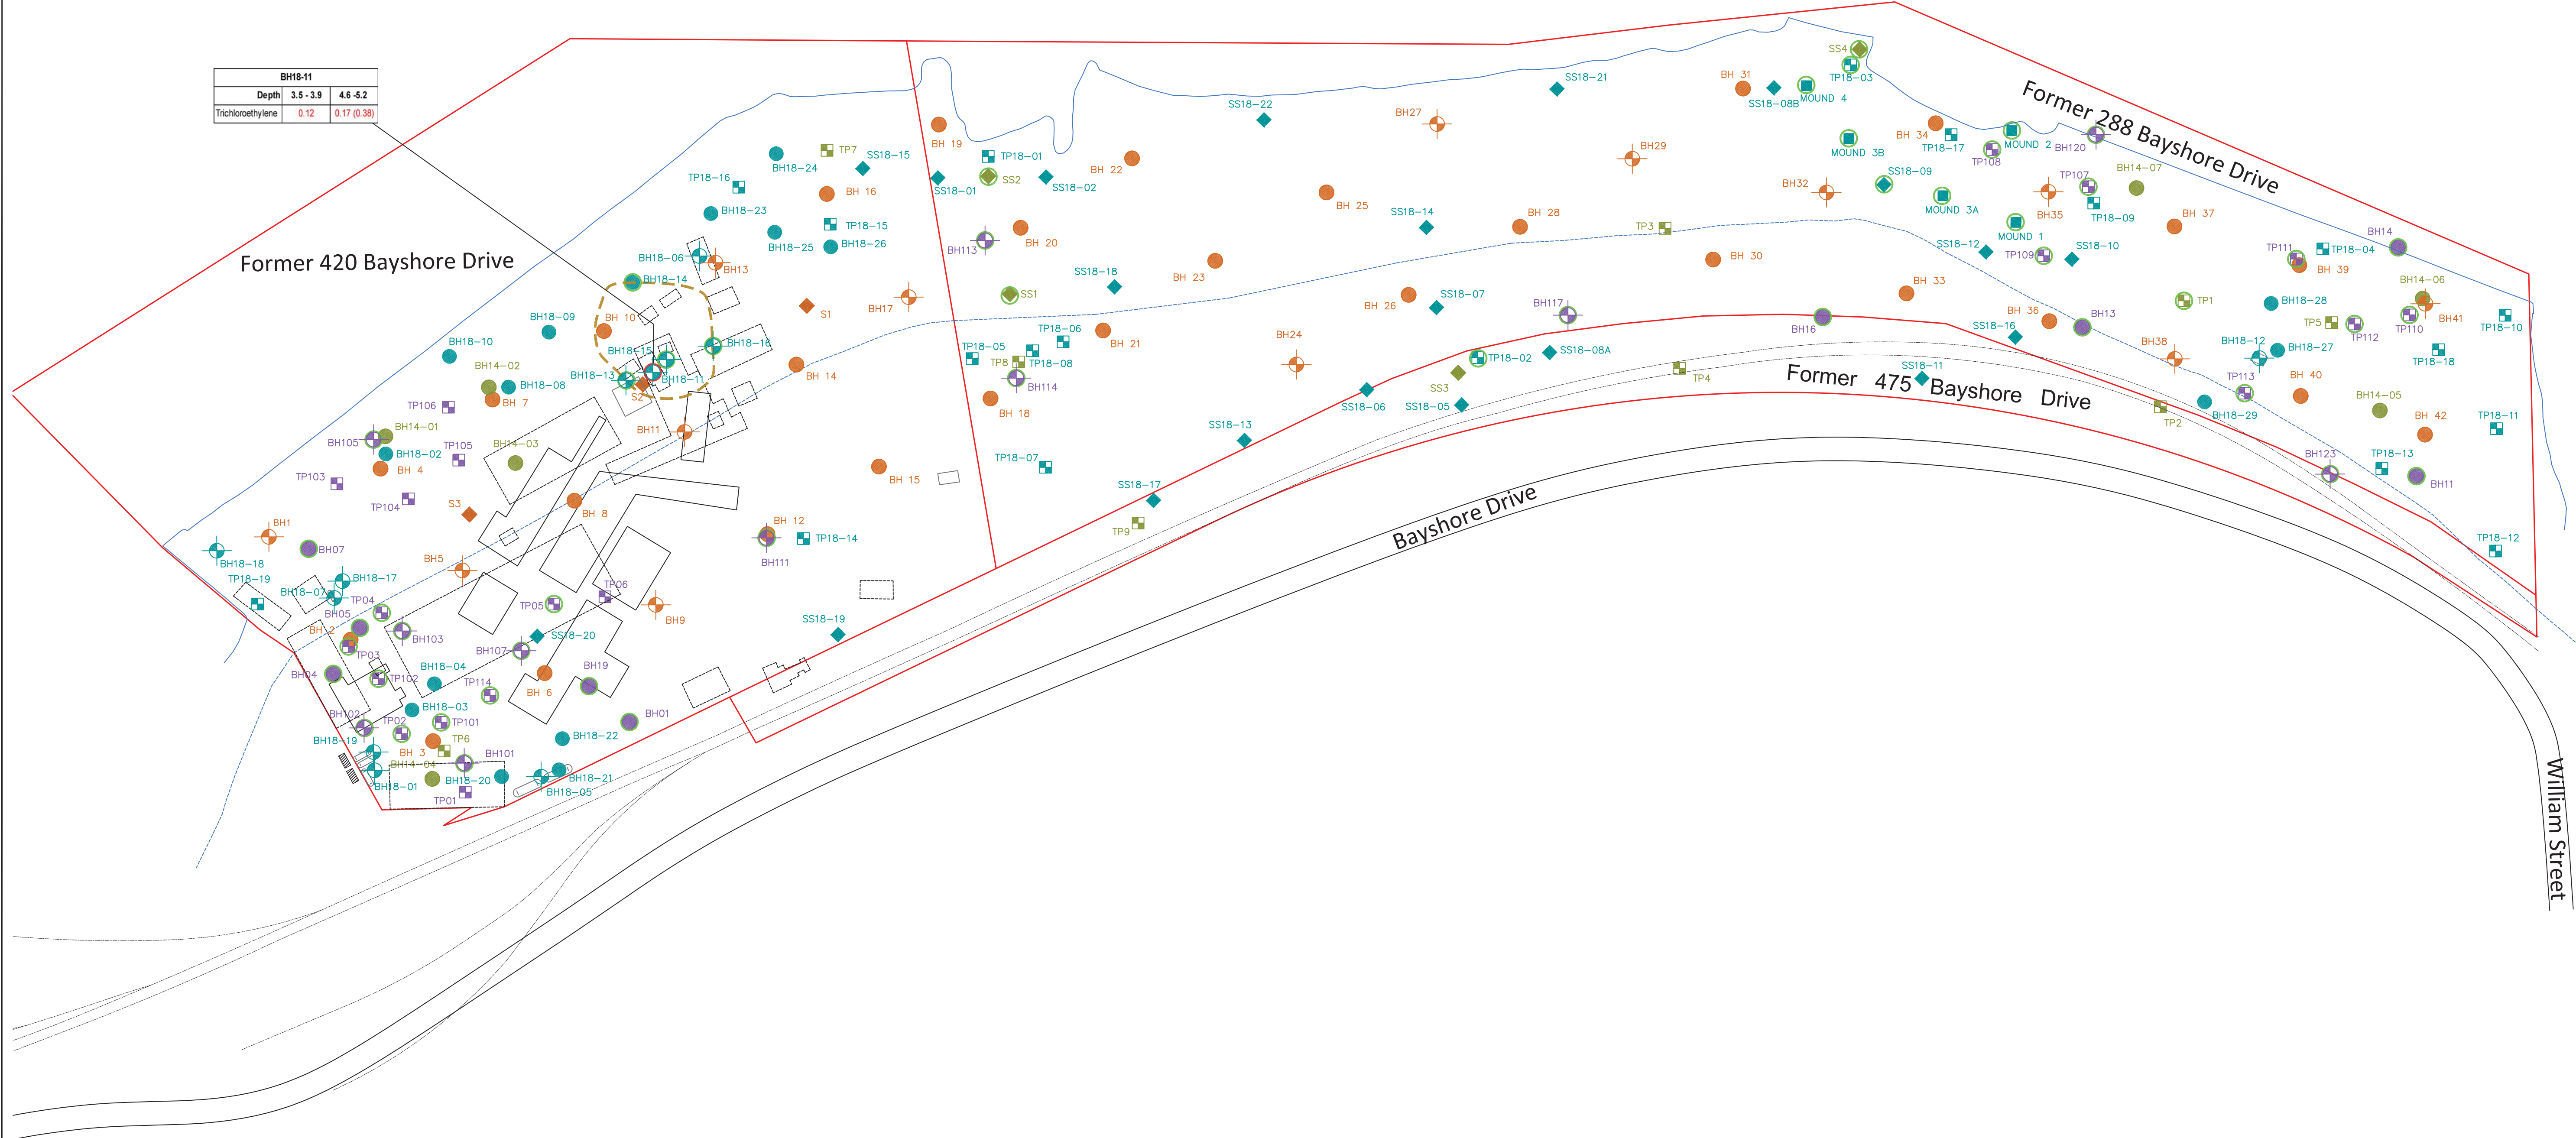
| | | Figure: | 13a |

| BH18-11 | | |
|---|---|---|
| Trichloroethylene | 0.12 | 0.17 (0.38) |

| Table 9 SCS | |
|---|---|
| Trichloroethylene | 0.05 |

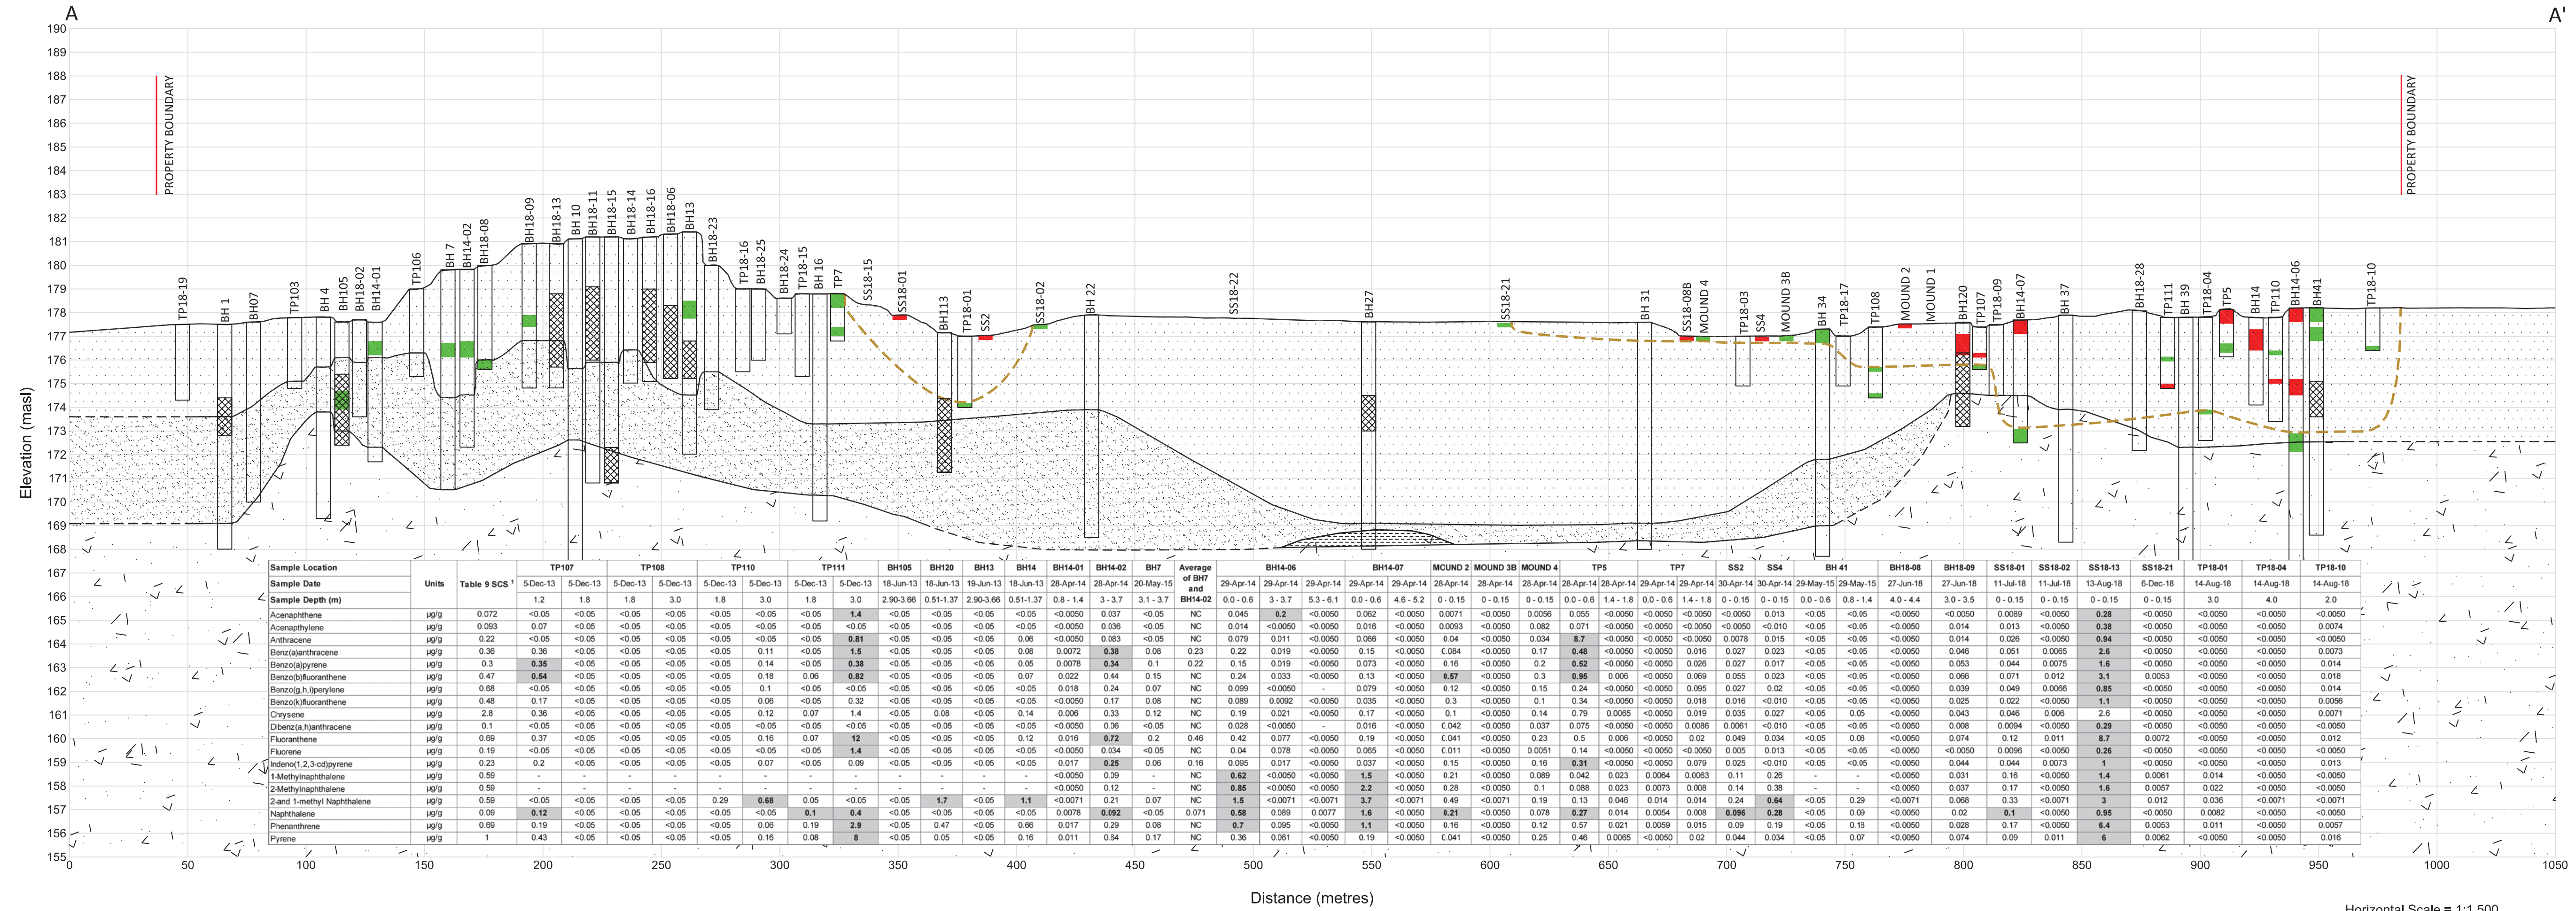
Cross - Section A-A'

Horizontal Scale = 1:1,500
Vertical Scale = 1:150

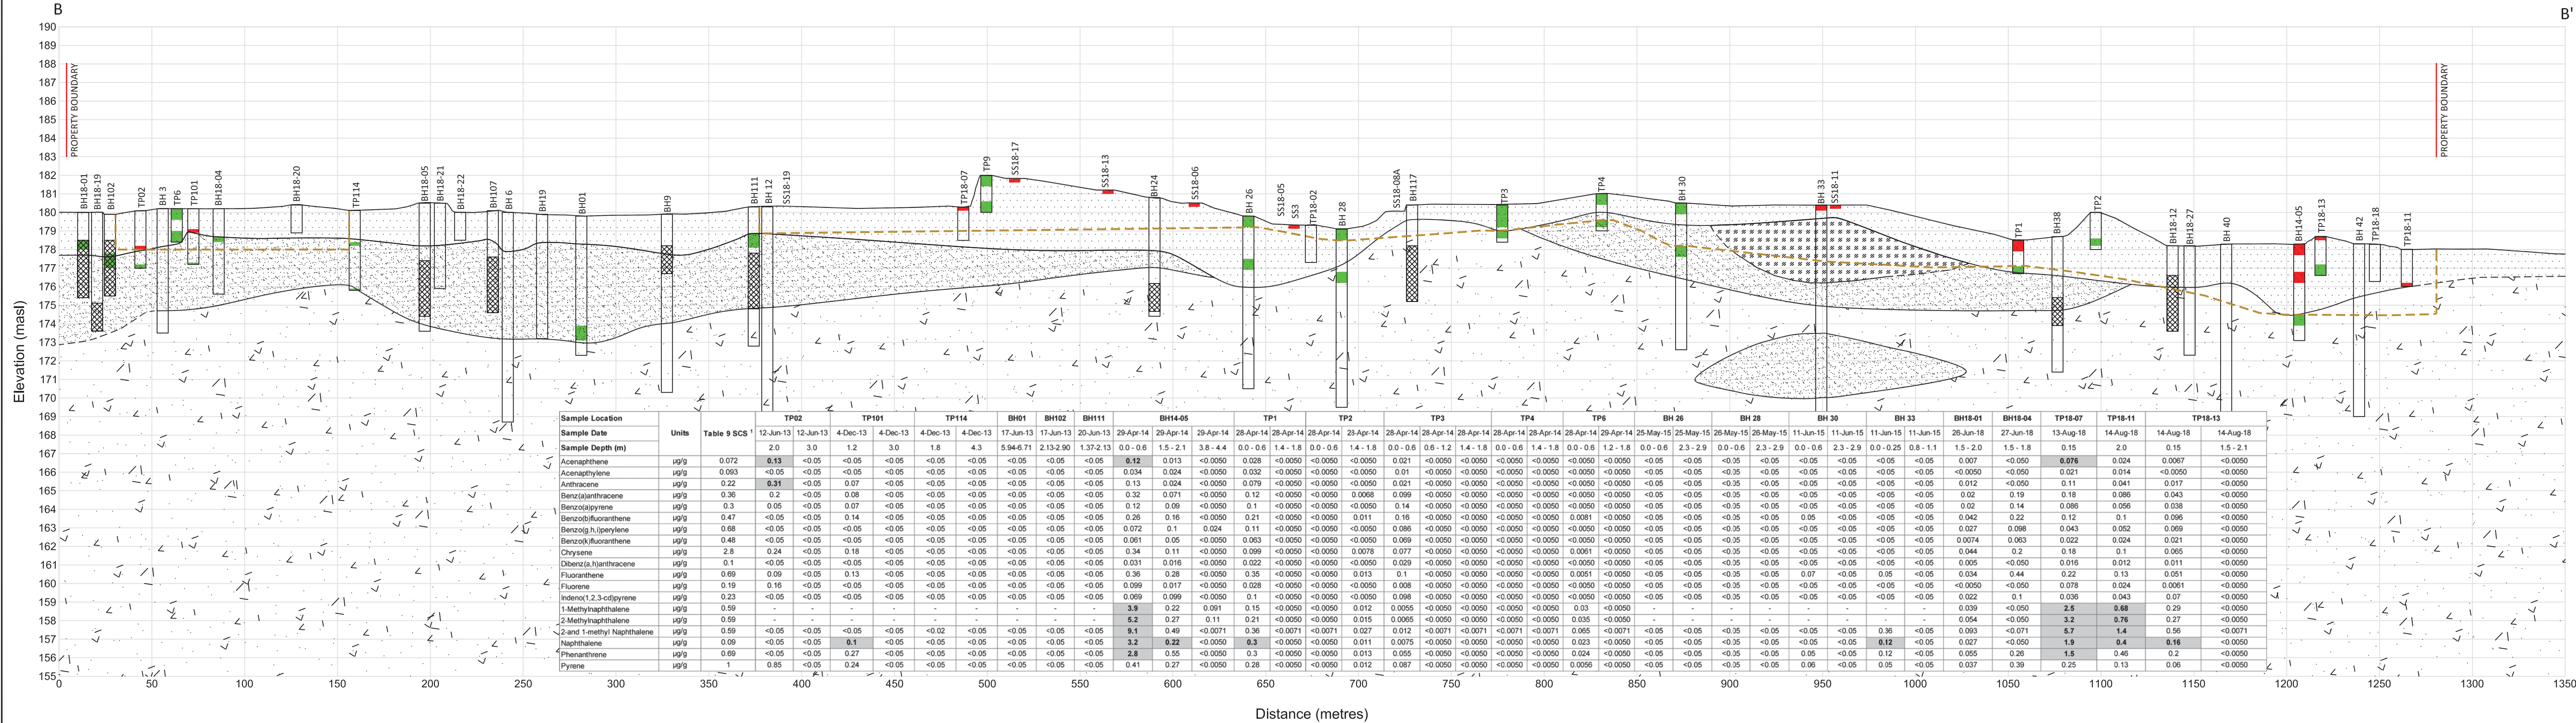
Cross - Section B-B'

- Extent of Impact
- Fill - organic topsoil, silty sand, gravel, sand cobbles, boulders, brick, wood/peat
- Till - silty sand, sandy silt, clay, sand
- Sand and Gravel
- Peat
- Sand
- Well Casing
- Parameters Tested Meet Table 9 Standard
- Parameters Tested Exceed Table 9 Standard
- Well Screen

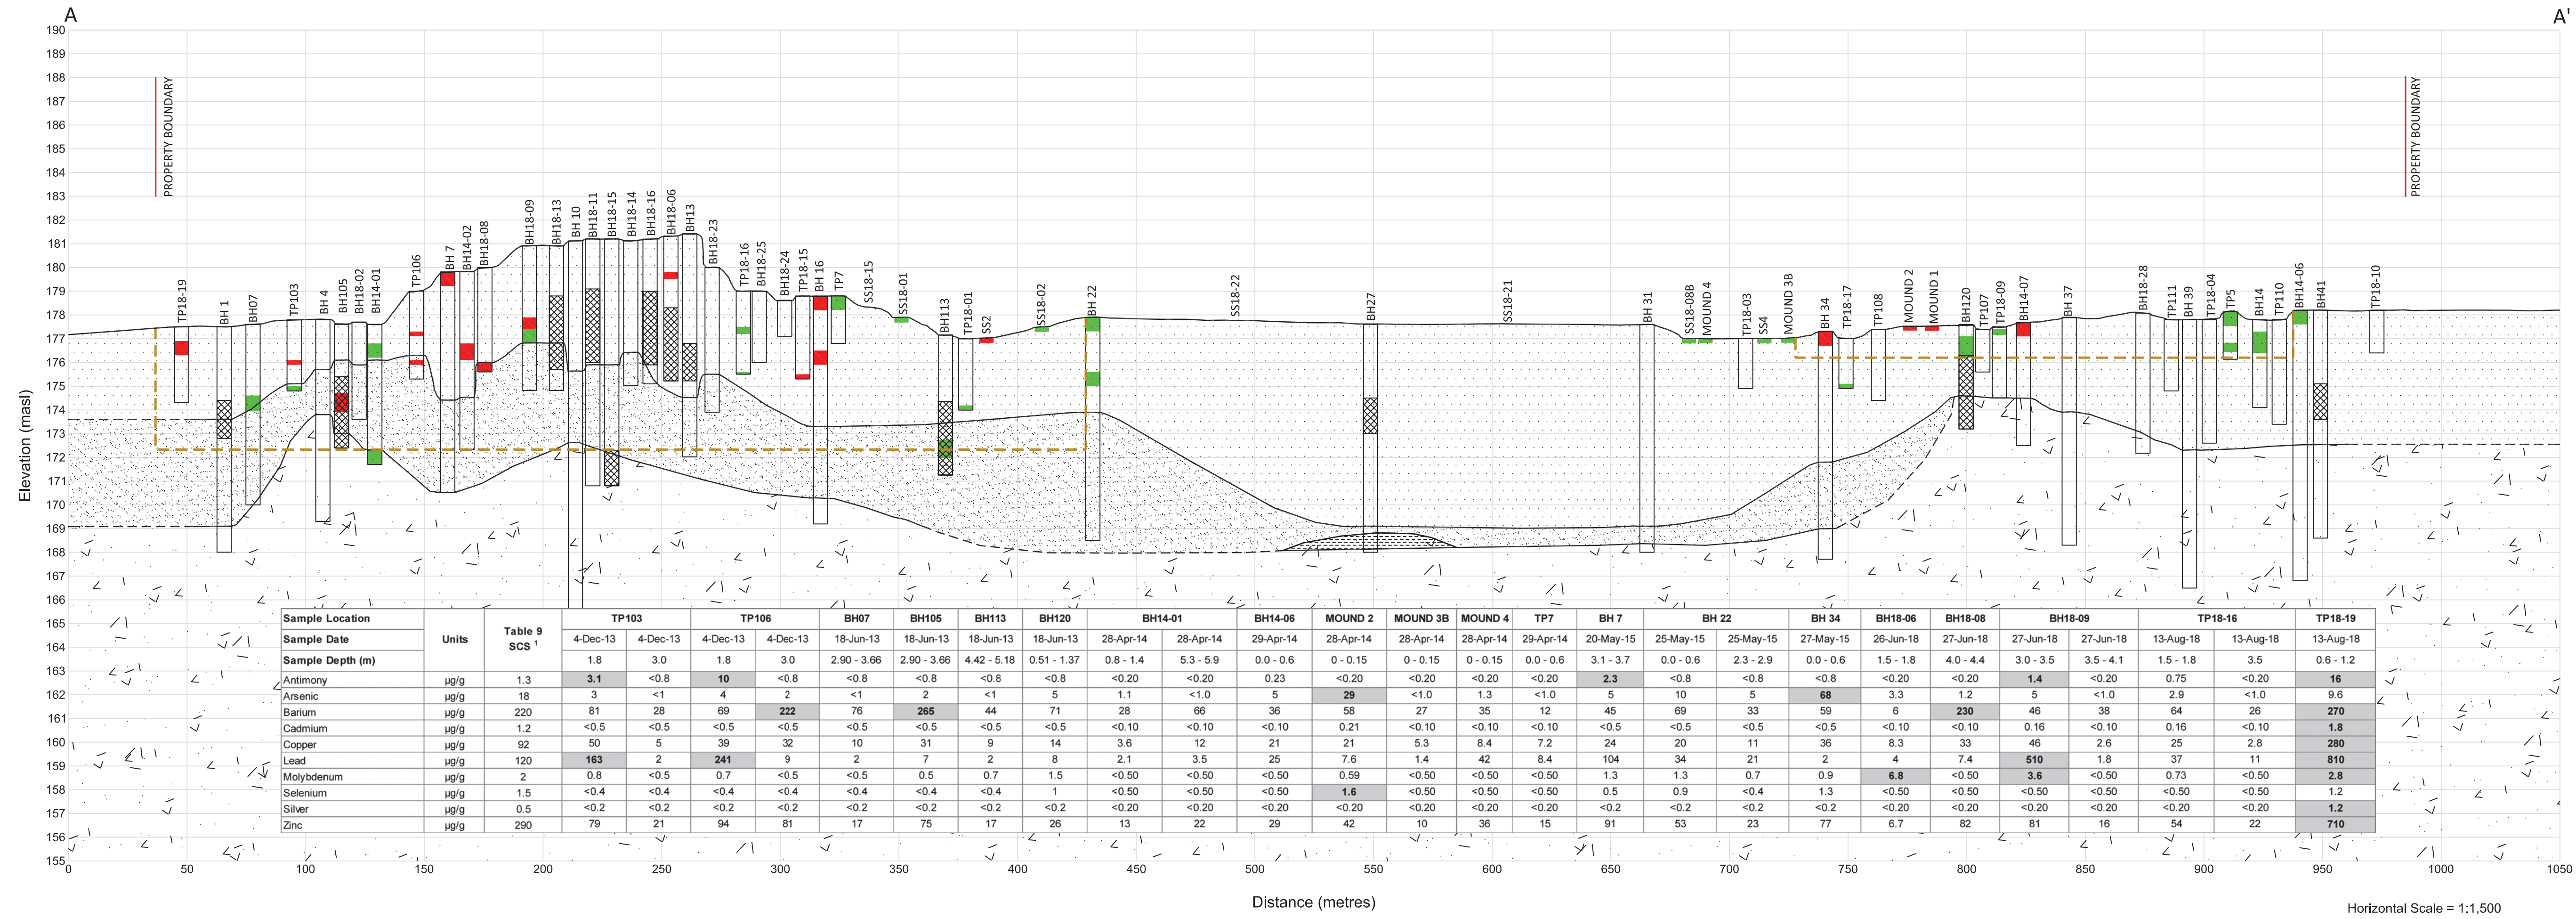
Cross - Section A-A'

CROSS - SECTIONS A-A' AND B-B'
CROSS - GRADIENT METALS IN SOIL
