Phase Two Conceptual Site Model Midland Bay Landing 420 Bayshore Drive, Midland, Ontario

Cambium Reference No.: 6820-001

2019-04-01

Prepared for: The Town of Midland

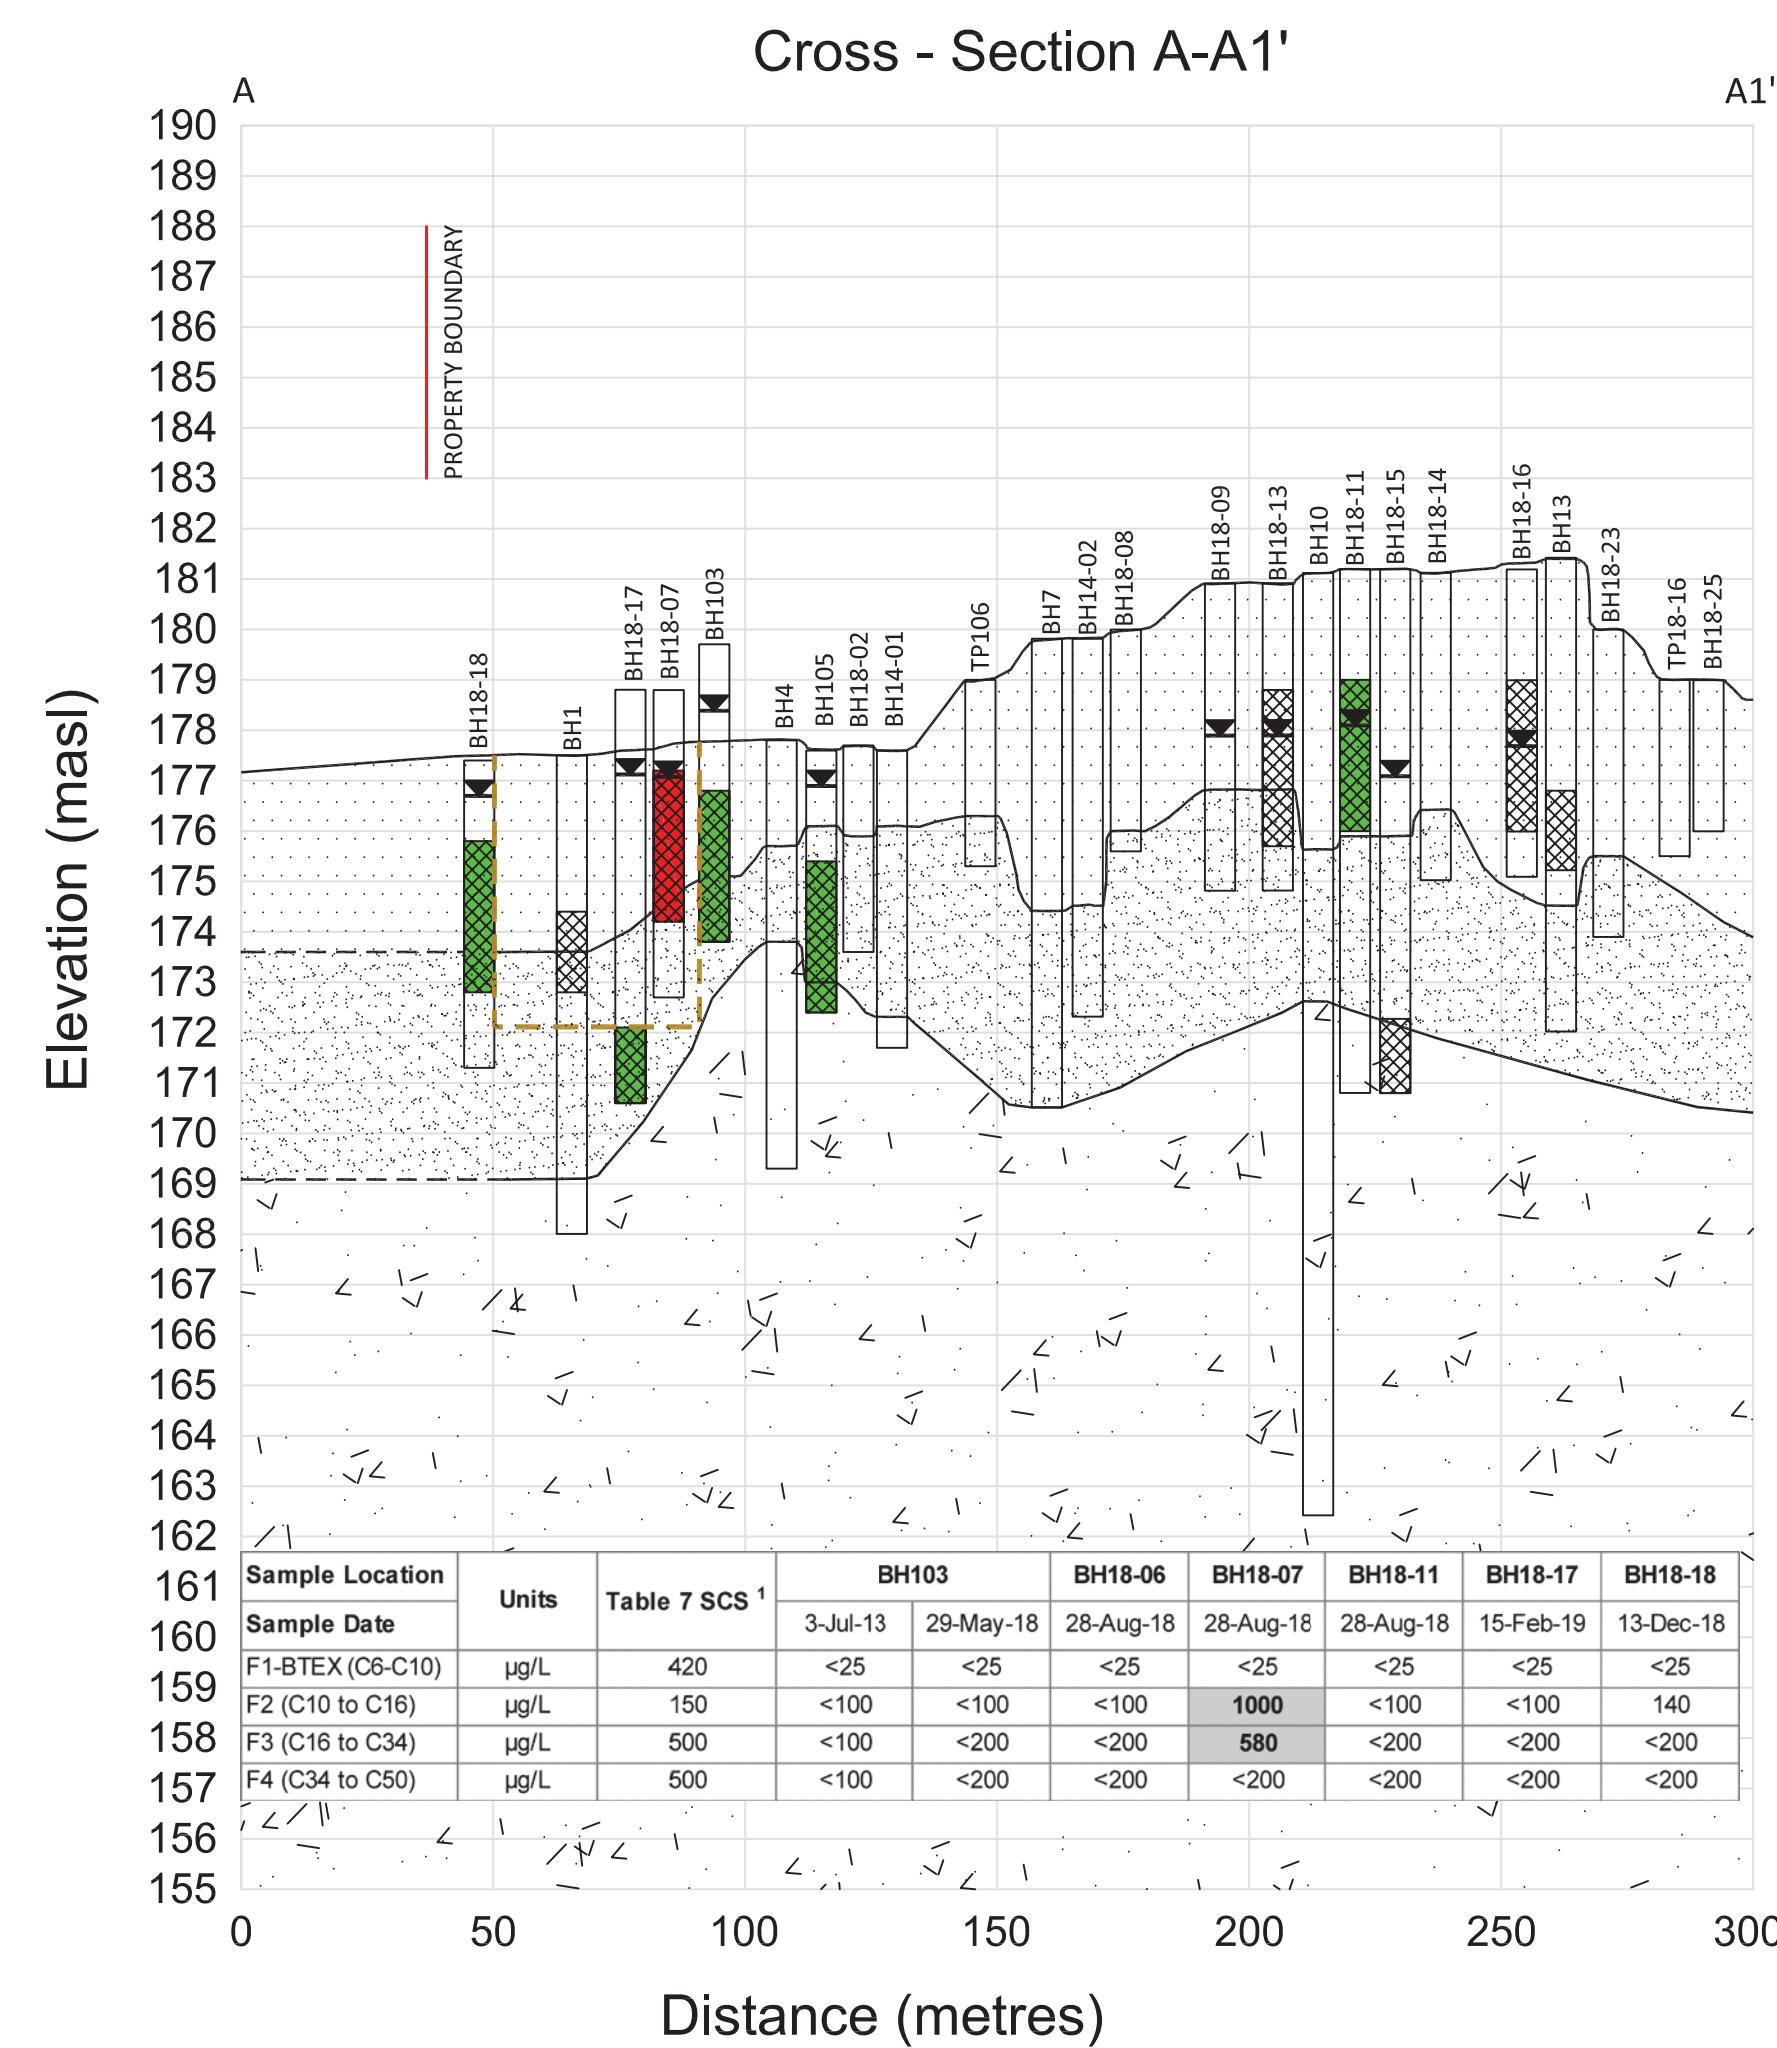
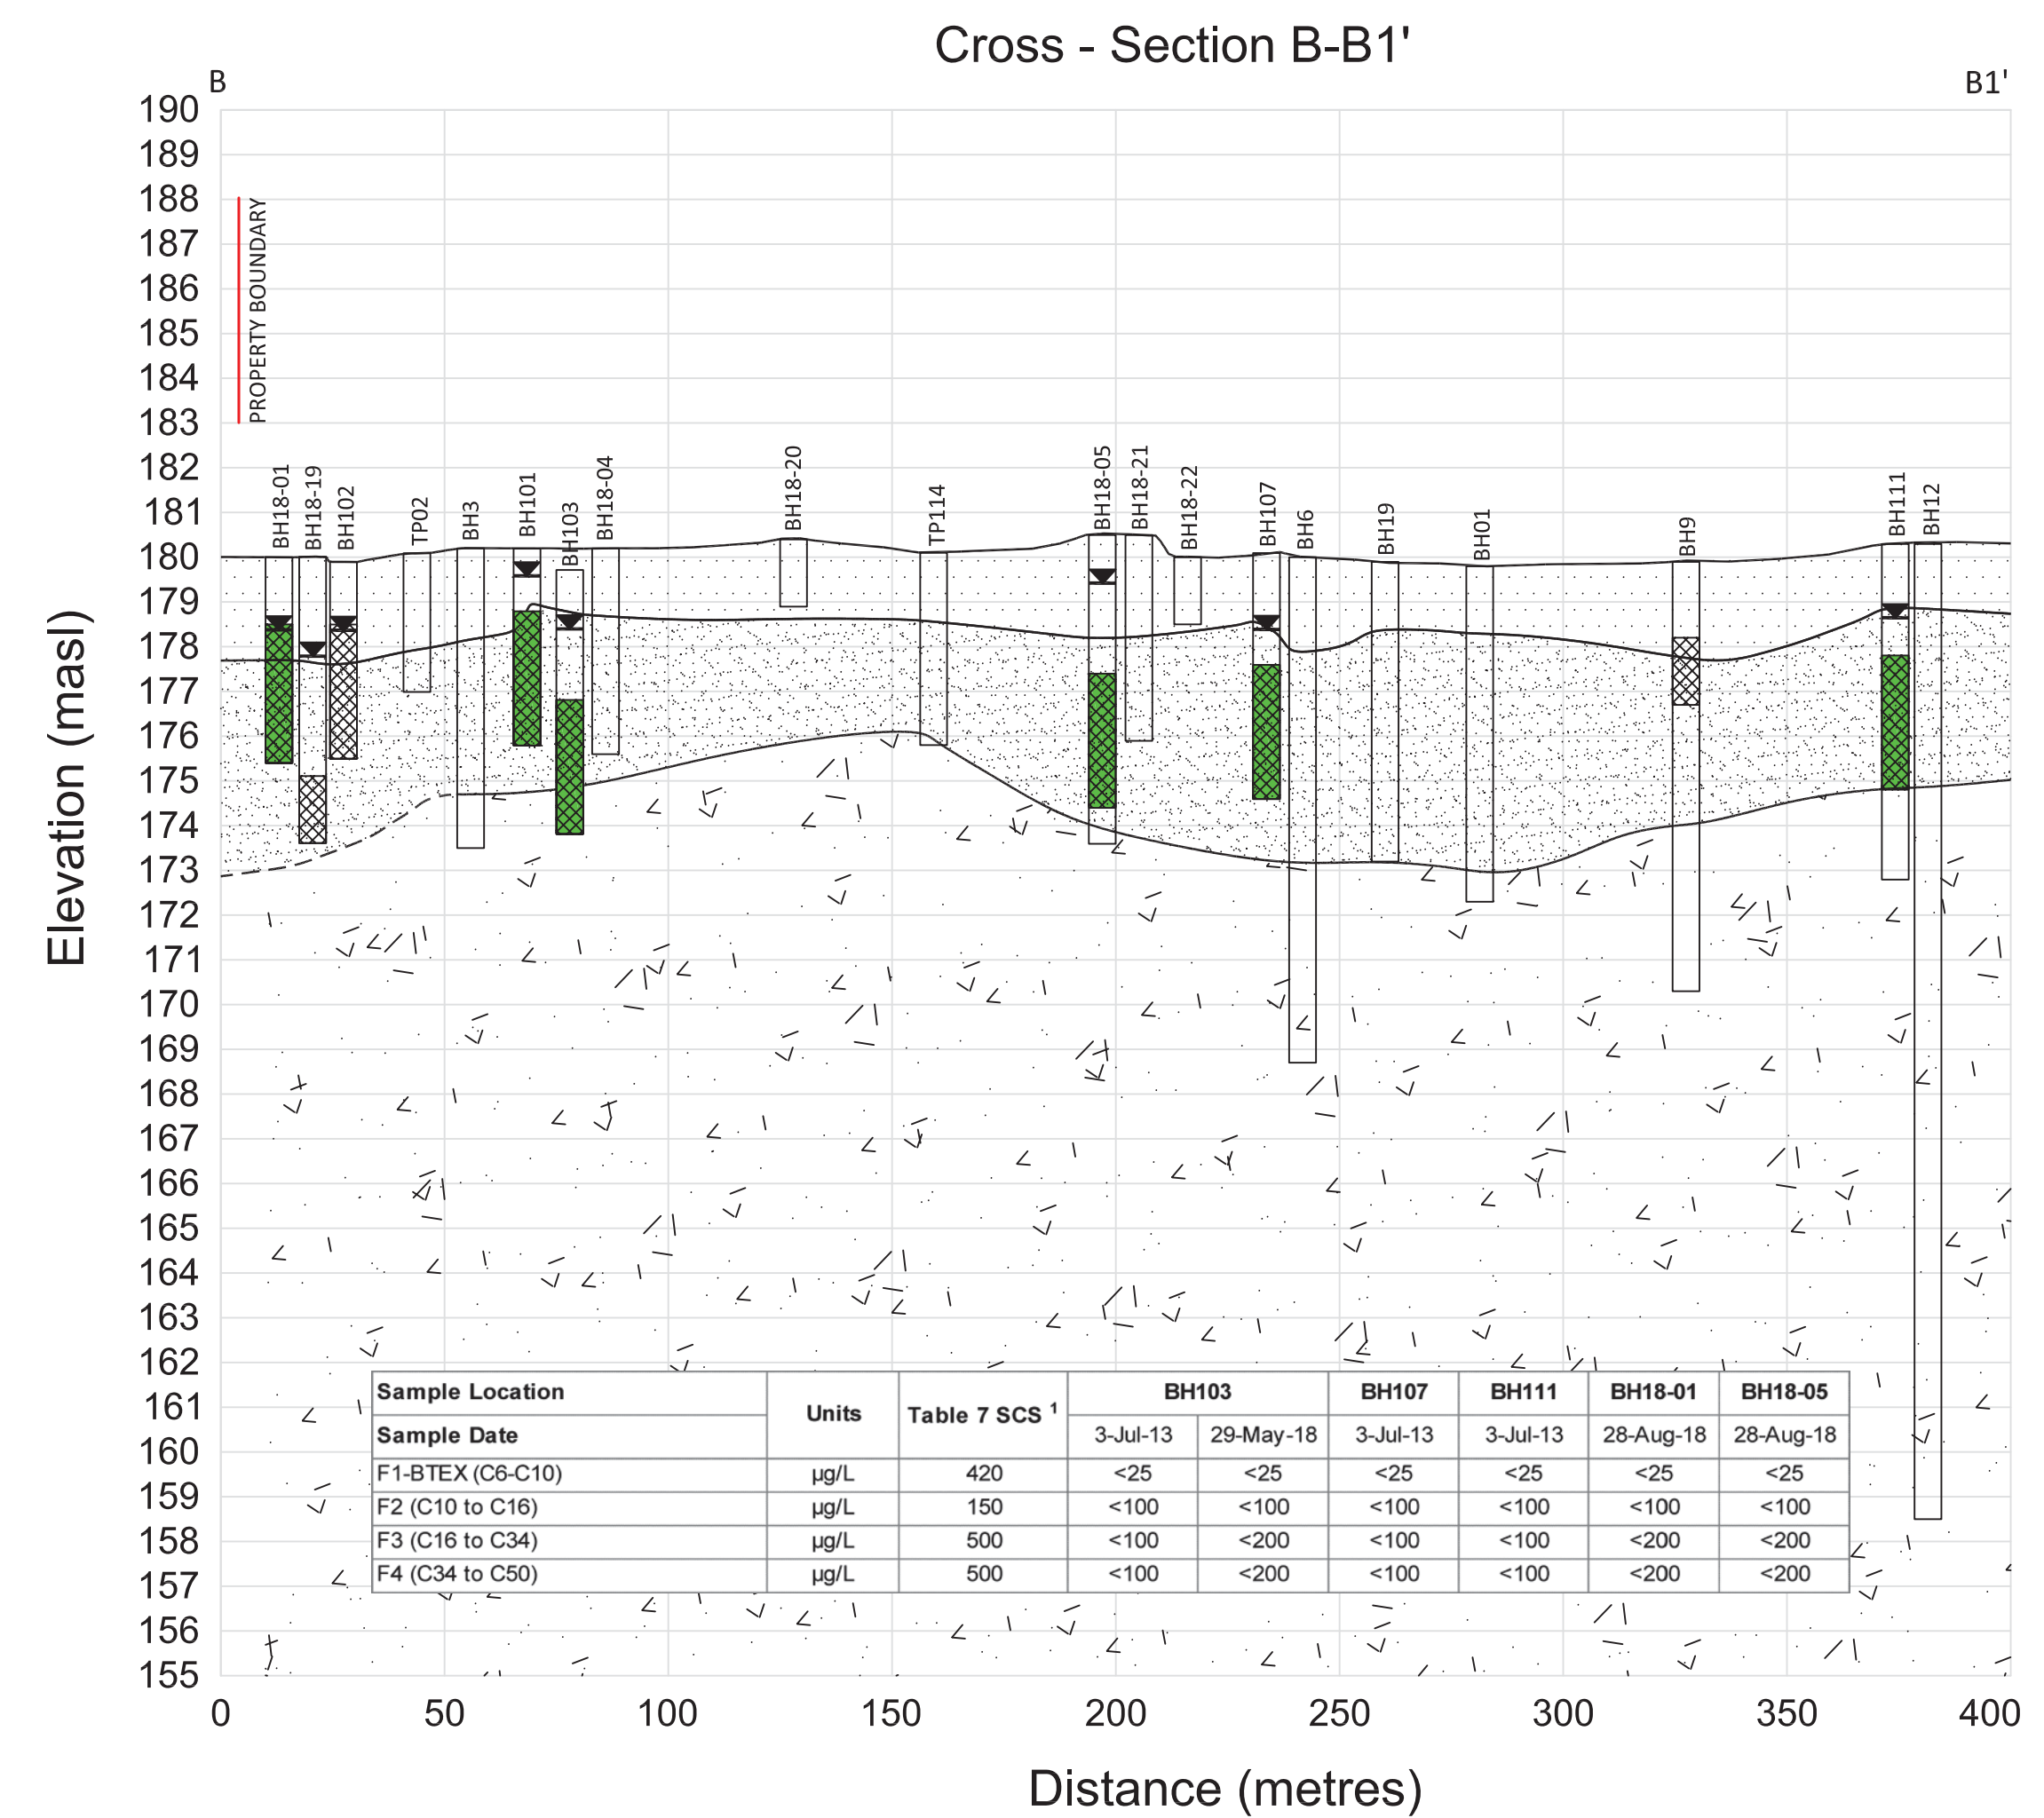
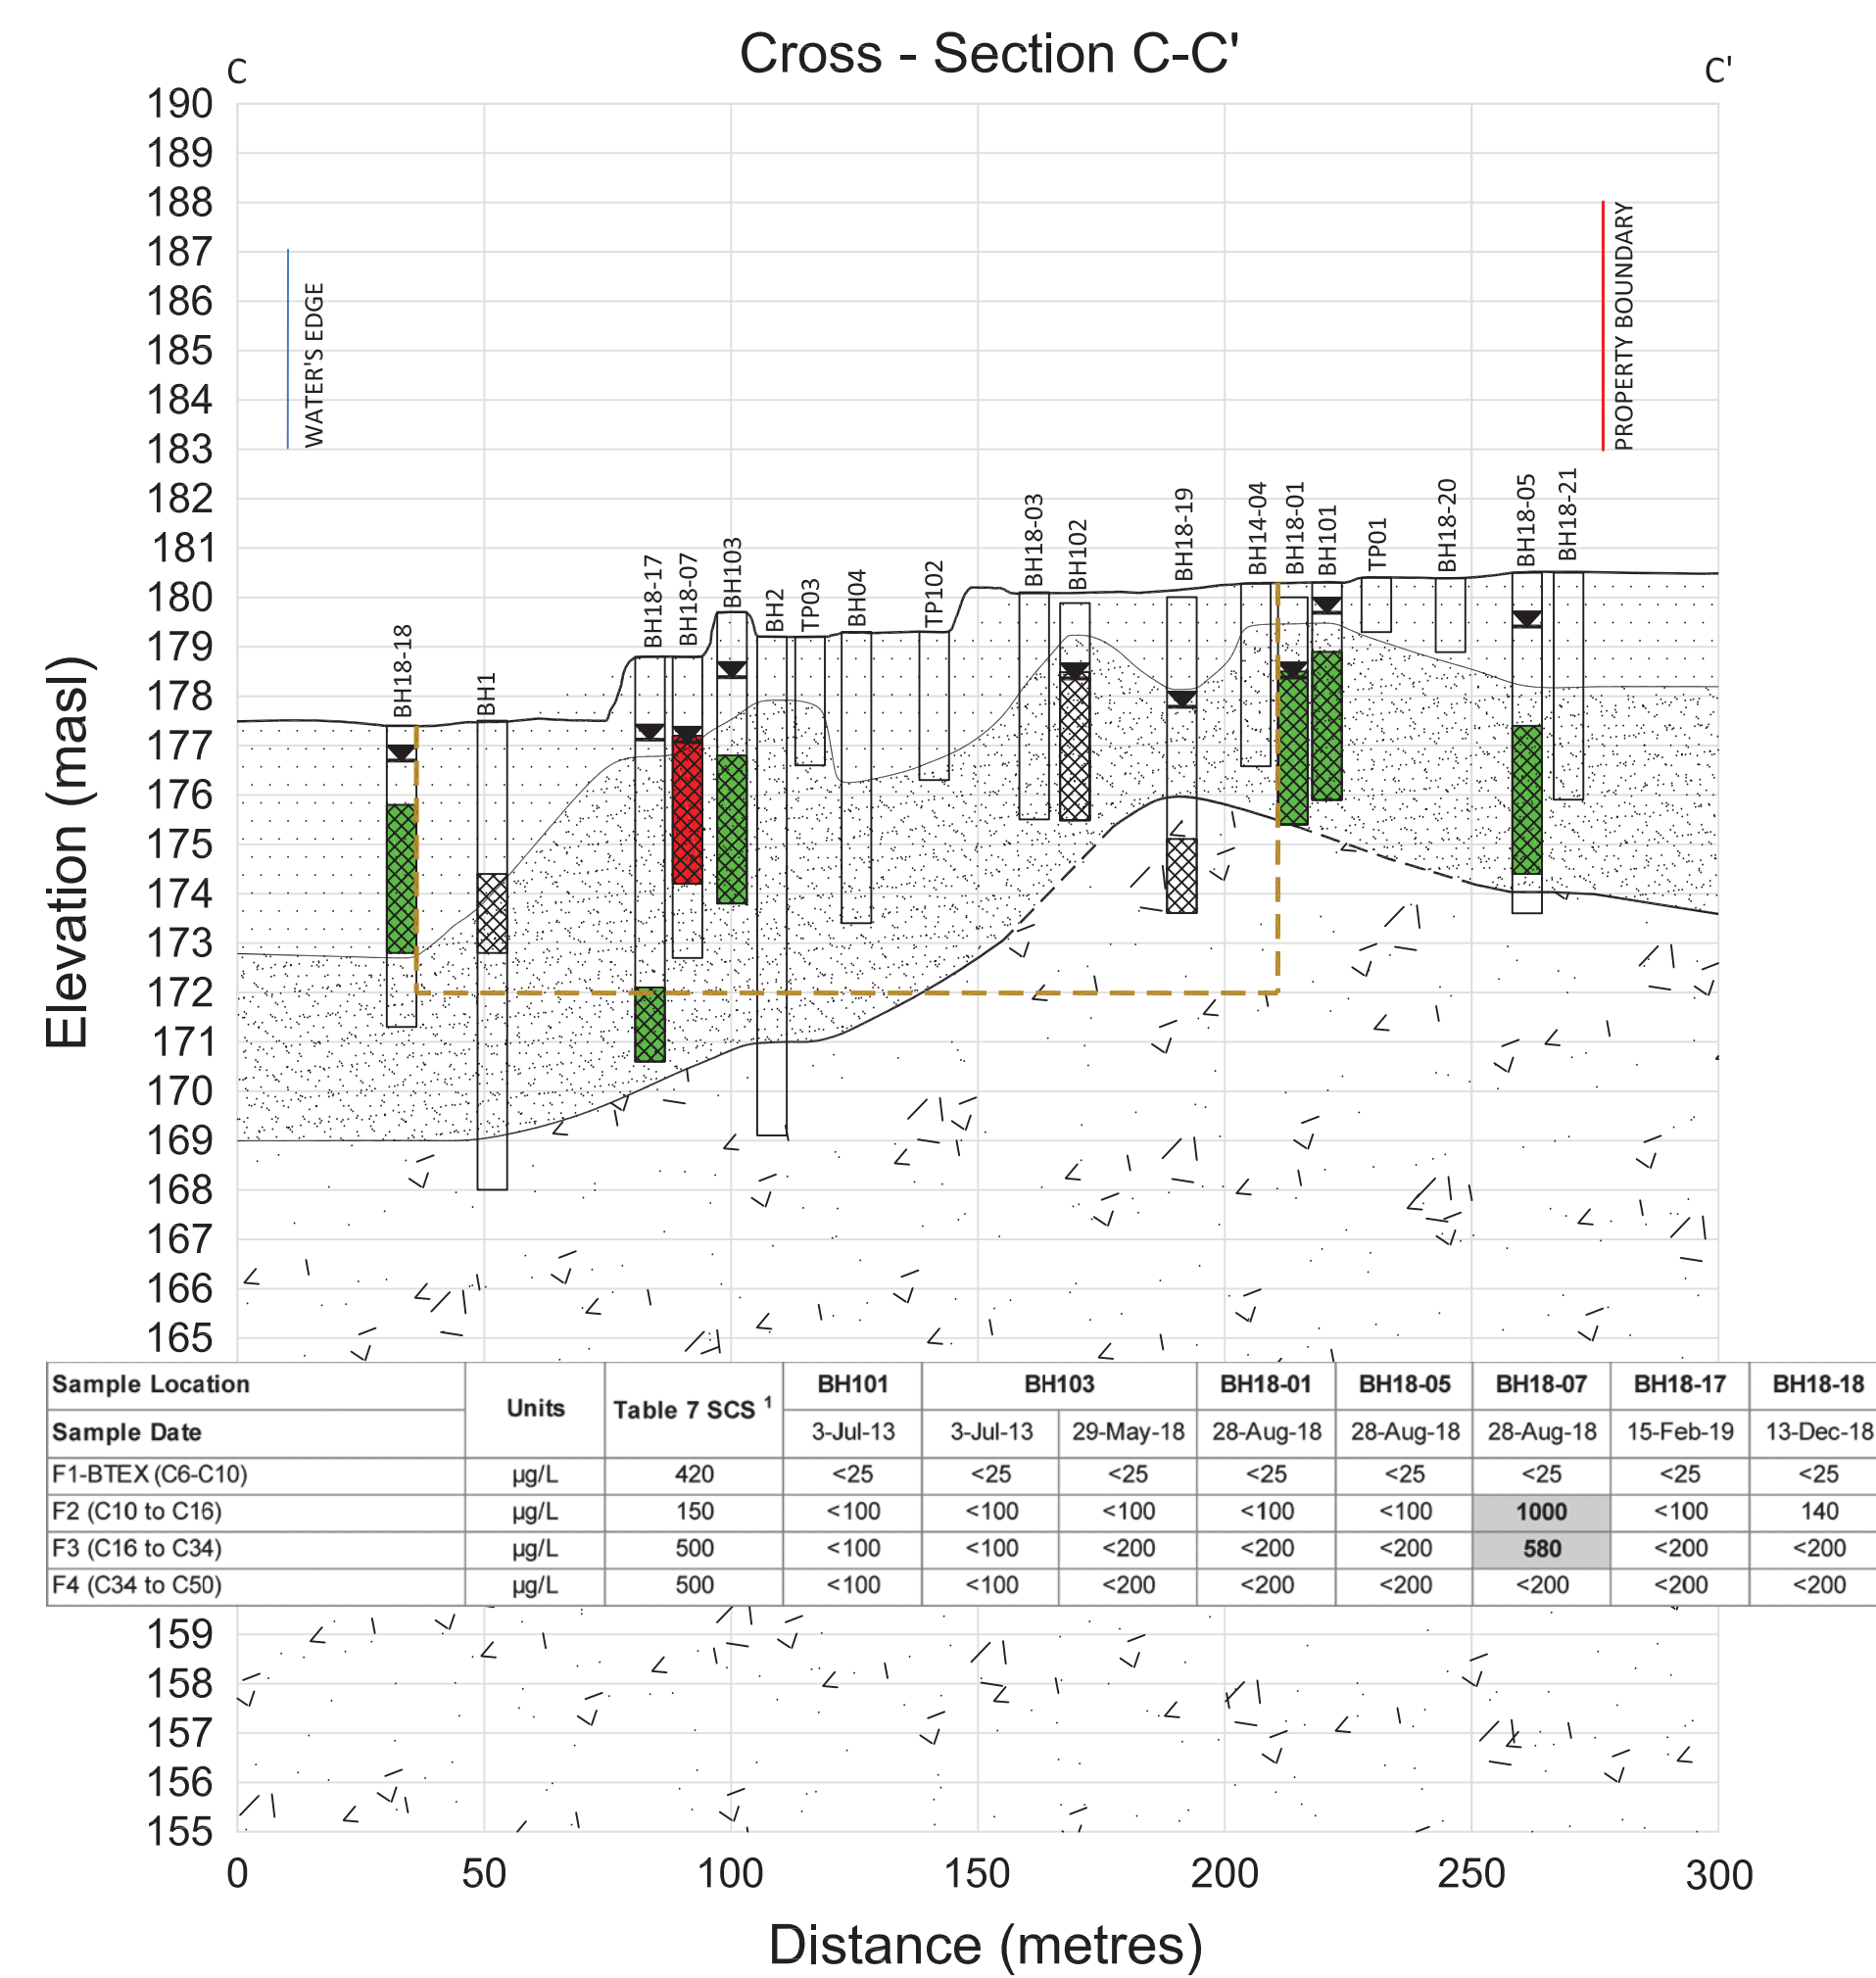
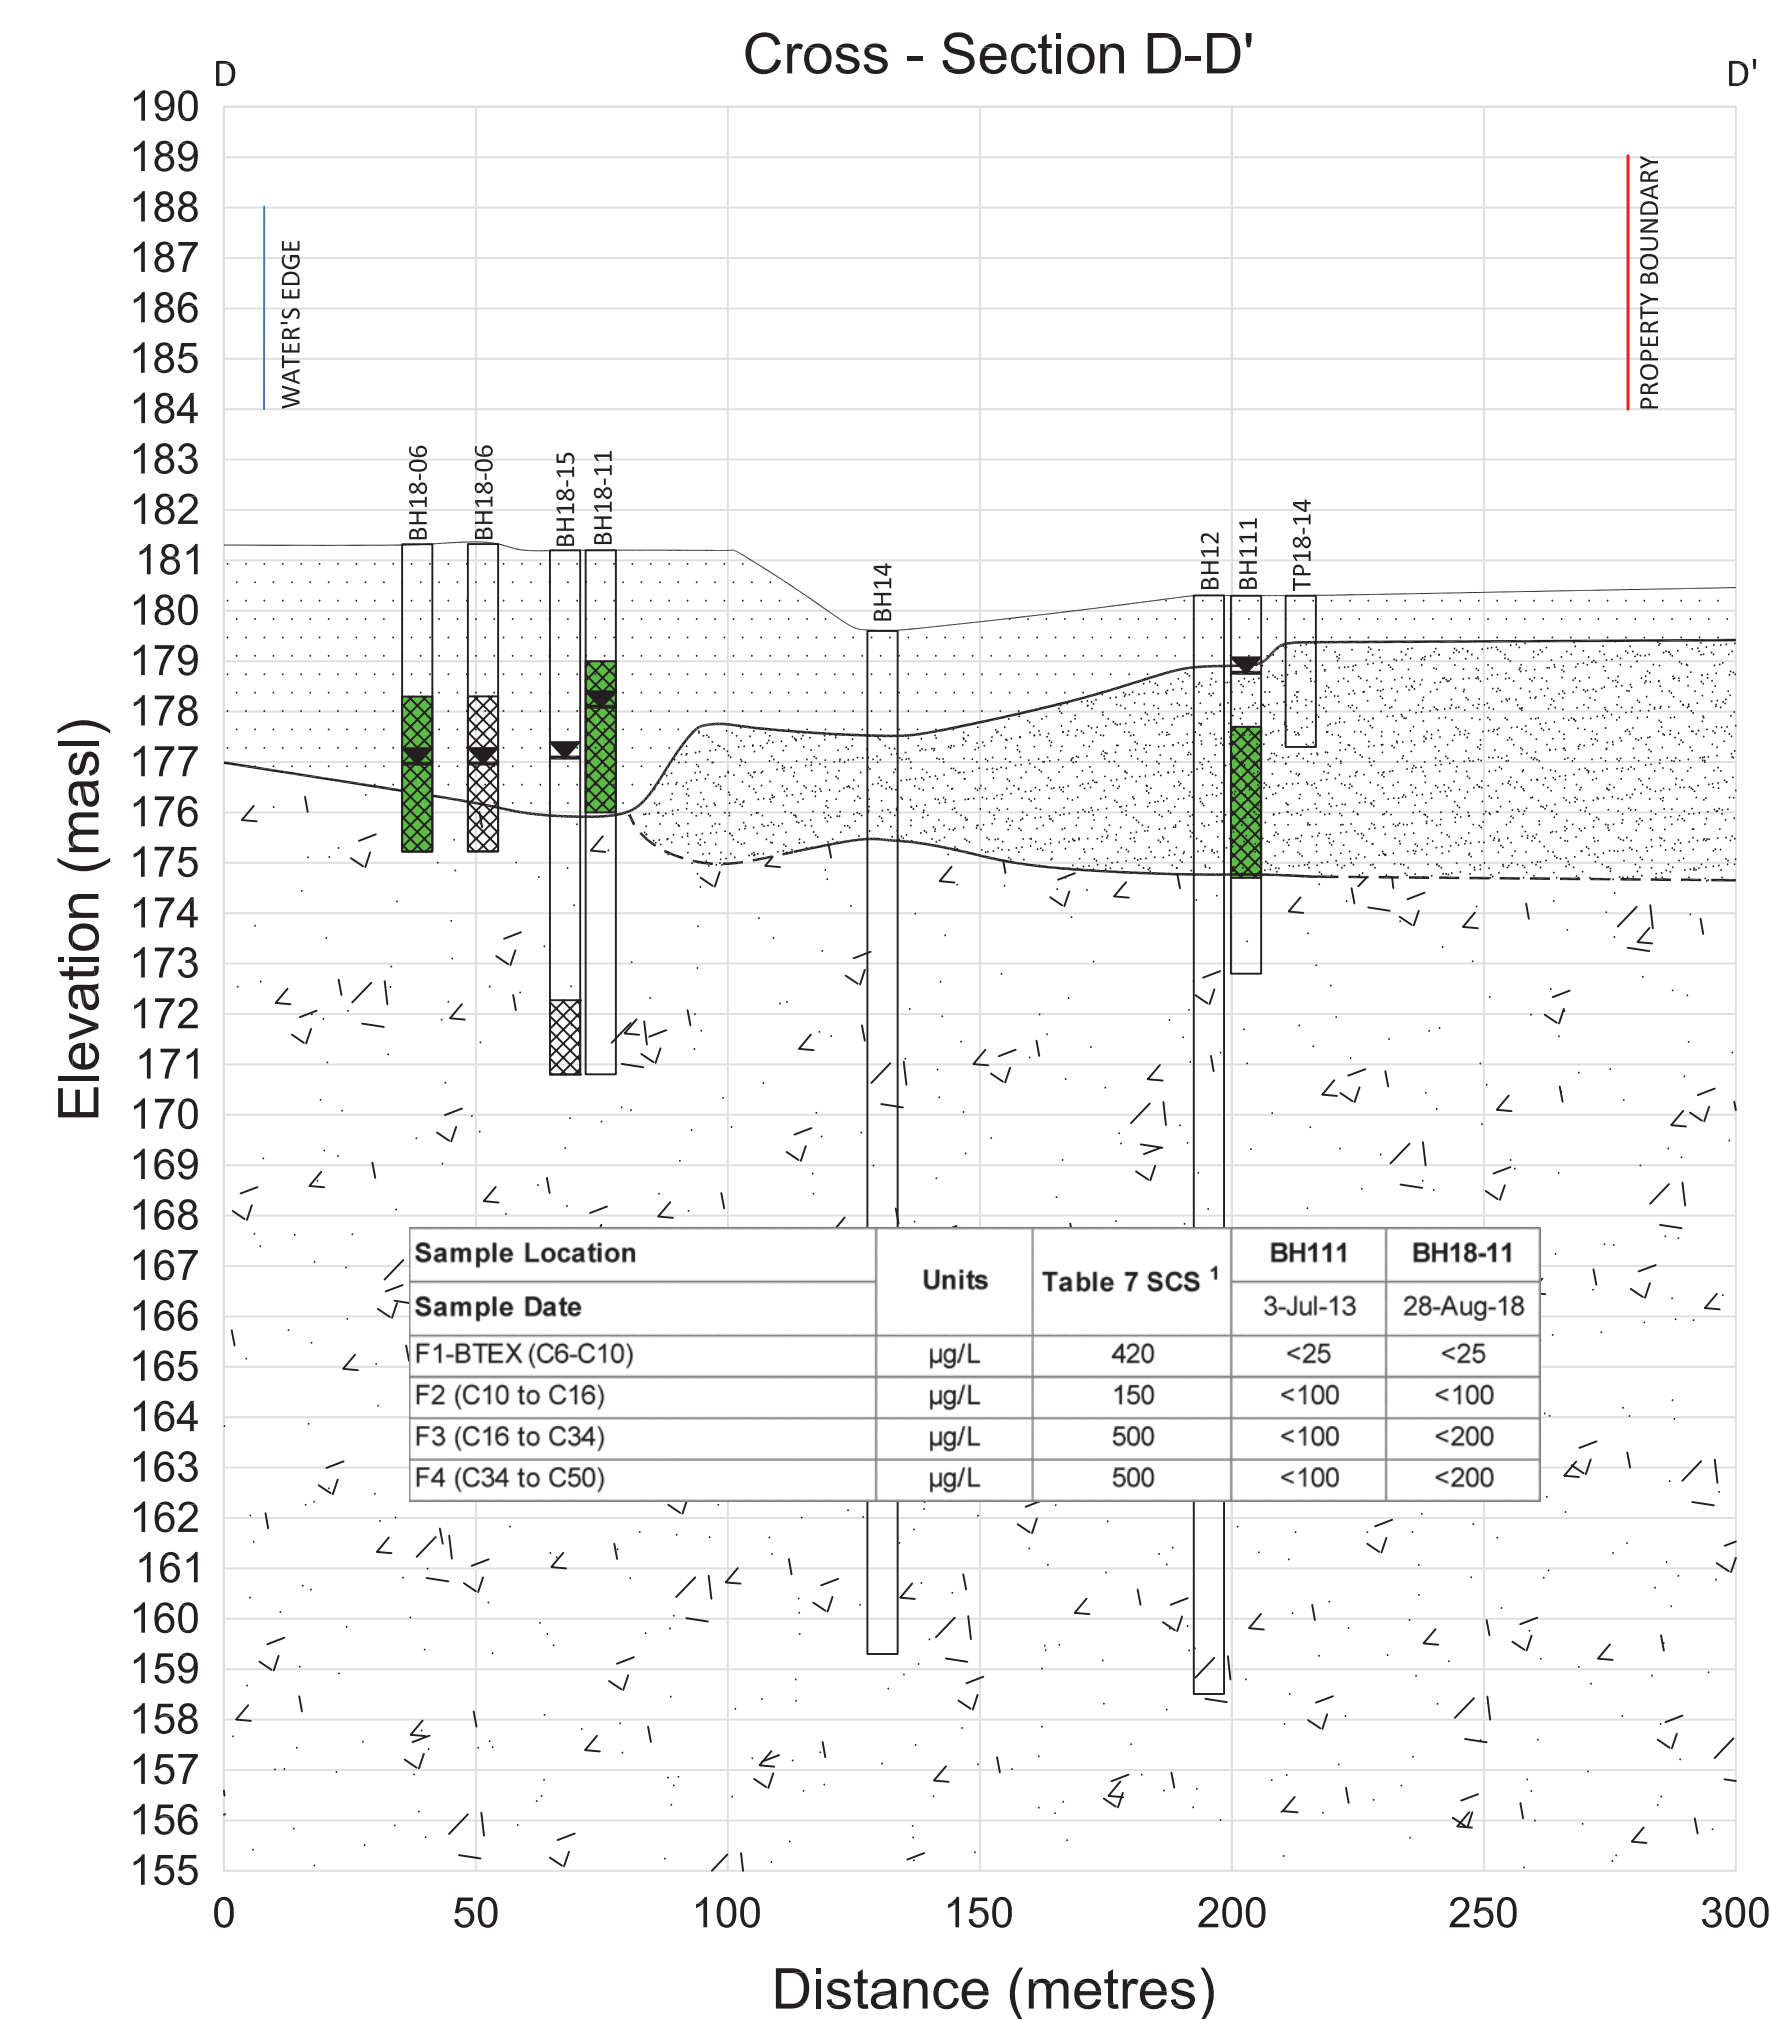
CROSS - SECTIONS
PHCS IN GROUNDWATER

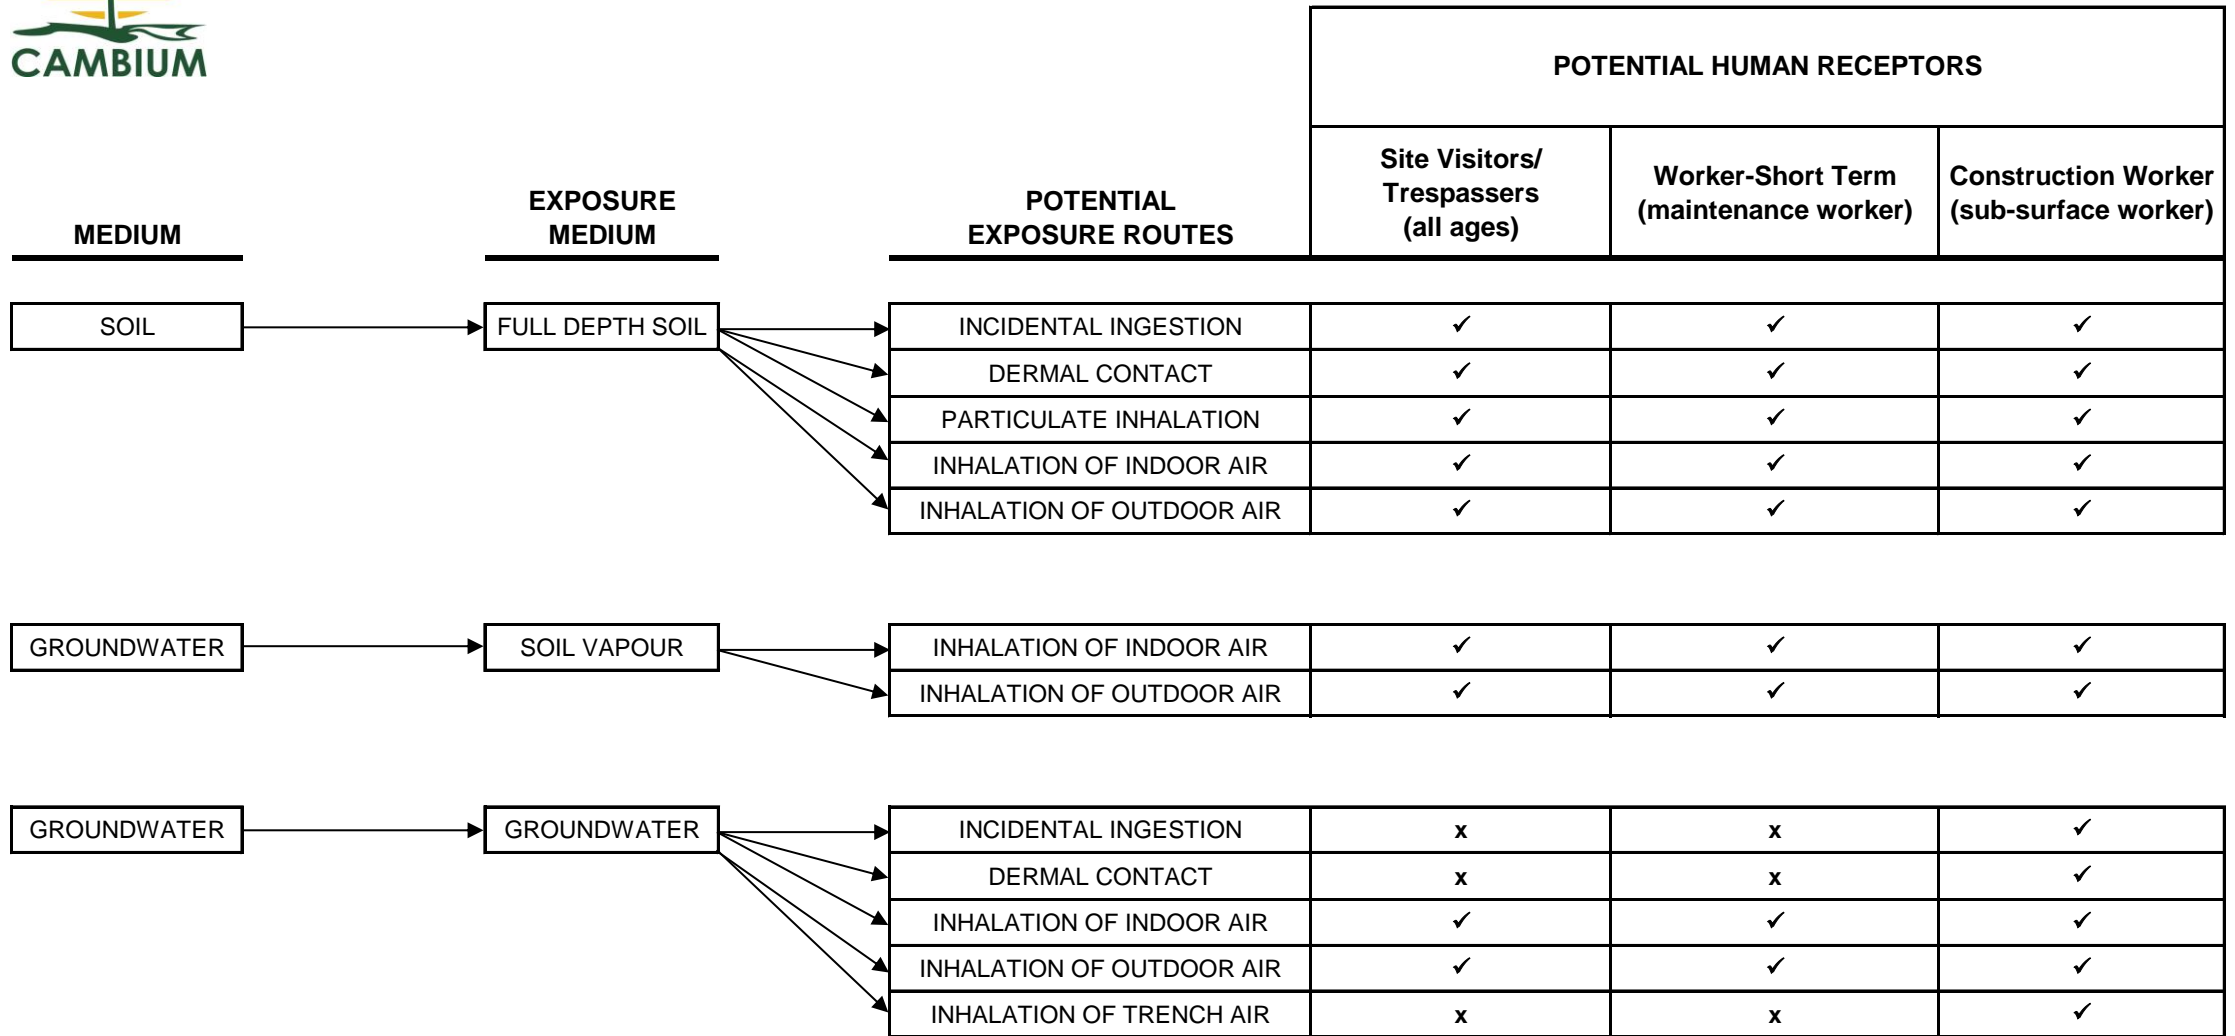
**FIGURE 22a
HUMAN HEALTH CONCEPTUAL SITE MODEL - WITHOUT RISK MANAGEMENT**

- ✓ - Indicates a potential exposure of contaminant of concern to receptor.
- x - Indicates no exposure of contaminant of concern to receptor.
- ▶ Indicates pathway potentially complete
- ▶ Indicates pathway incomplete

The ecological CSM describes the potential exposure pathways that are likely to be present for various ecological receptors at the Site. The ecological CSM provides a basis for examining potential risks in an ecological risk assessment. The ecological CSM, without and with RMMs, are presented as Figure 22a and Figure 22b, respectively, and discussed below.

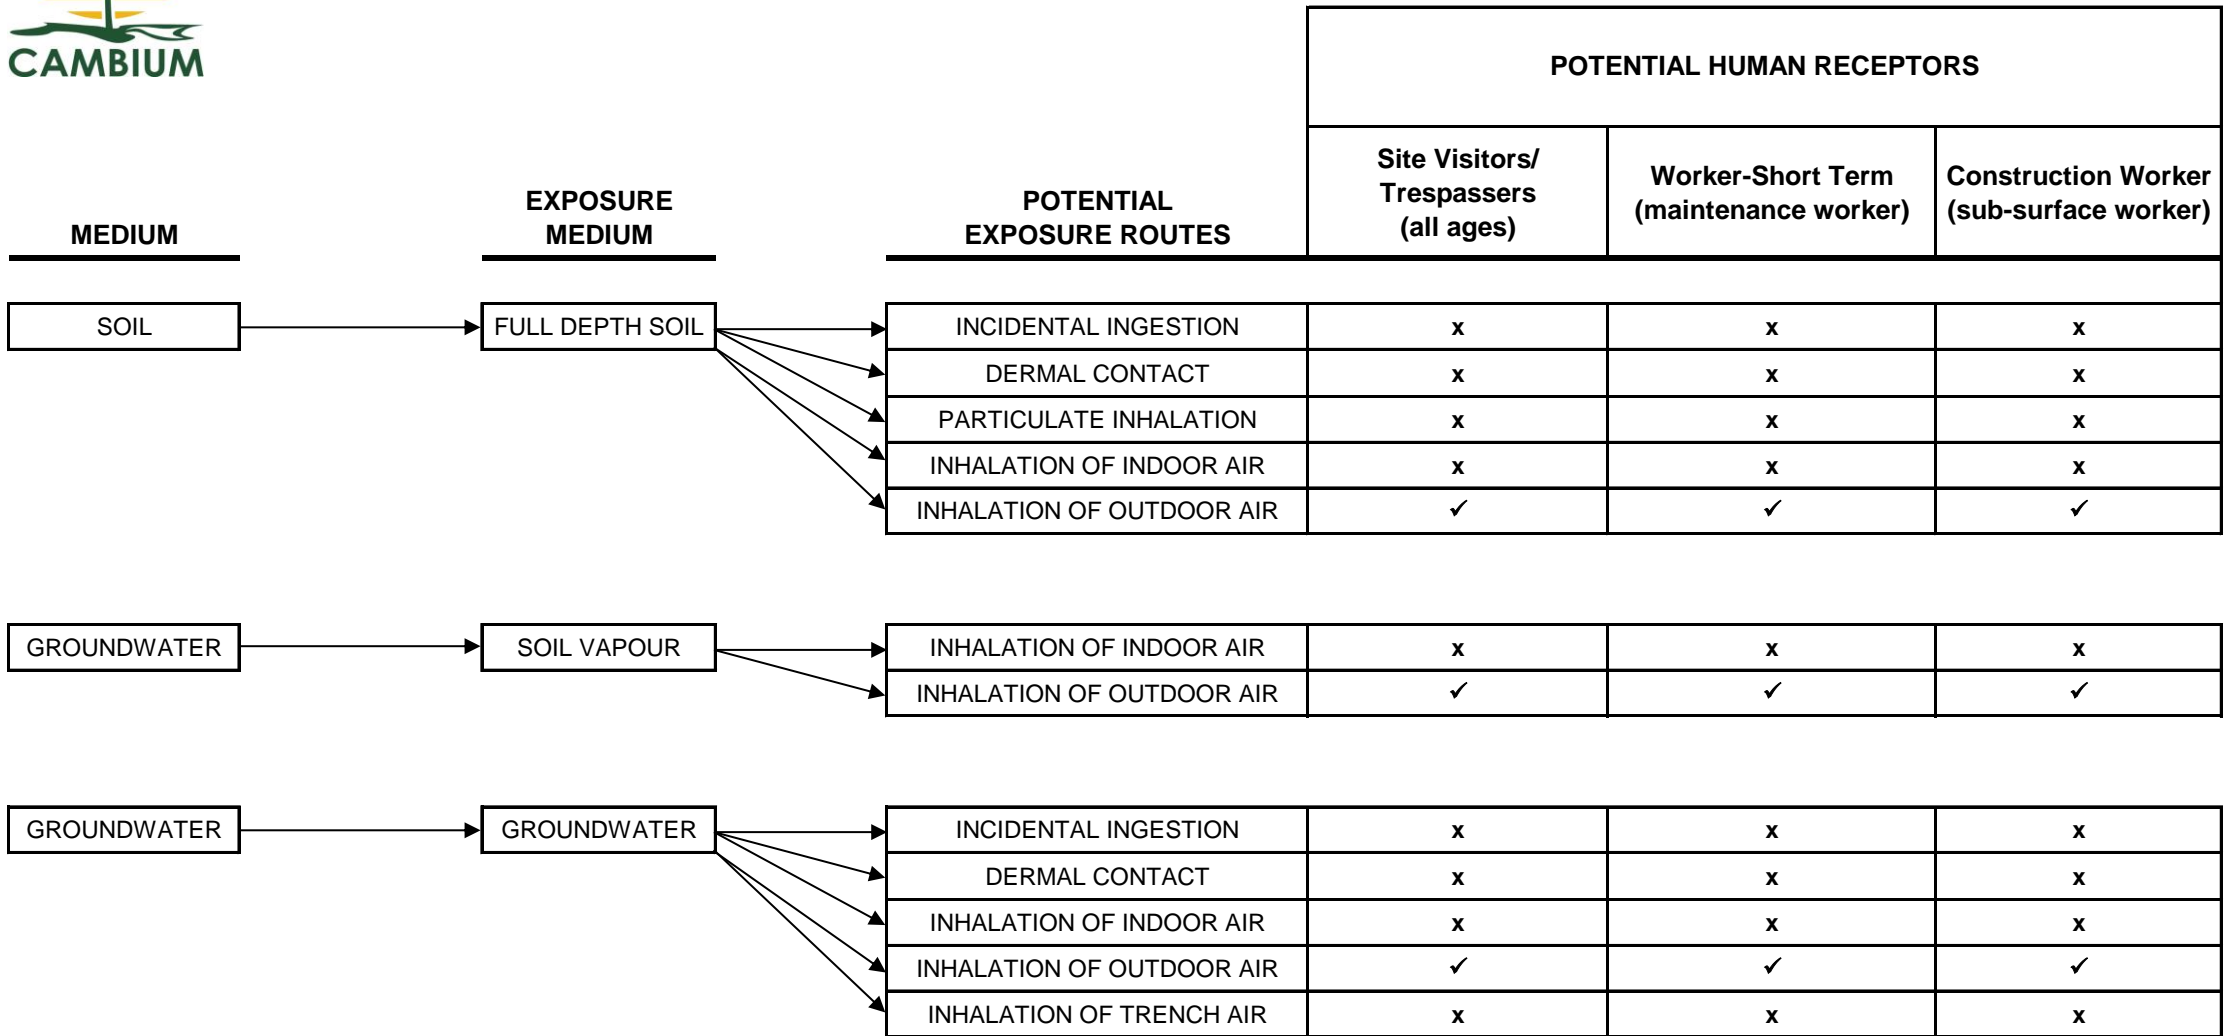
**FIGURE 22b
HUMAN HEALTH CONCEPTUAL SITE MODEL - WITH RISK MANAGEMENT**

- ✓ - Indicates a potential exposure of contaminant of concern to receptor.
- x - Indicates no exposure of contaminant of concern to receptor.
- ▶ Indicates pathway potentially complete
- ▶ Indicates pathway incomplete

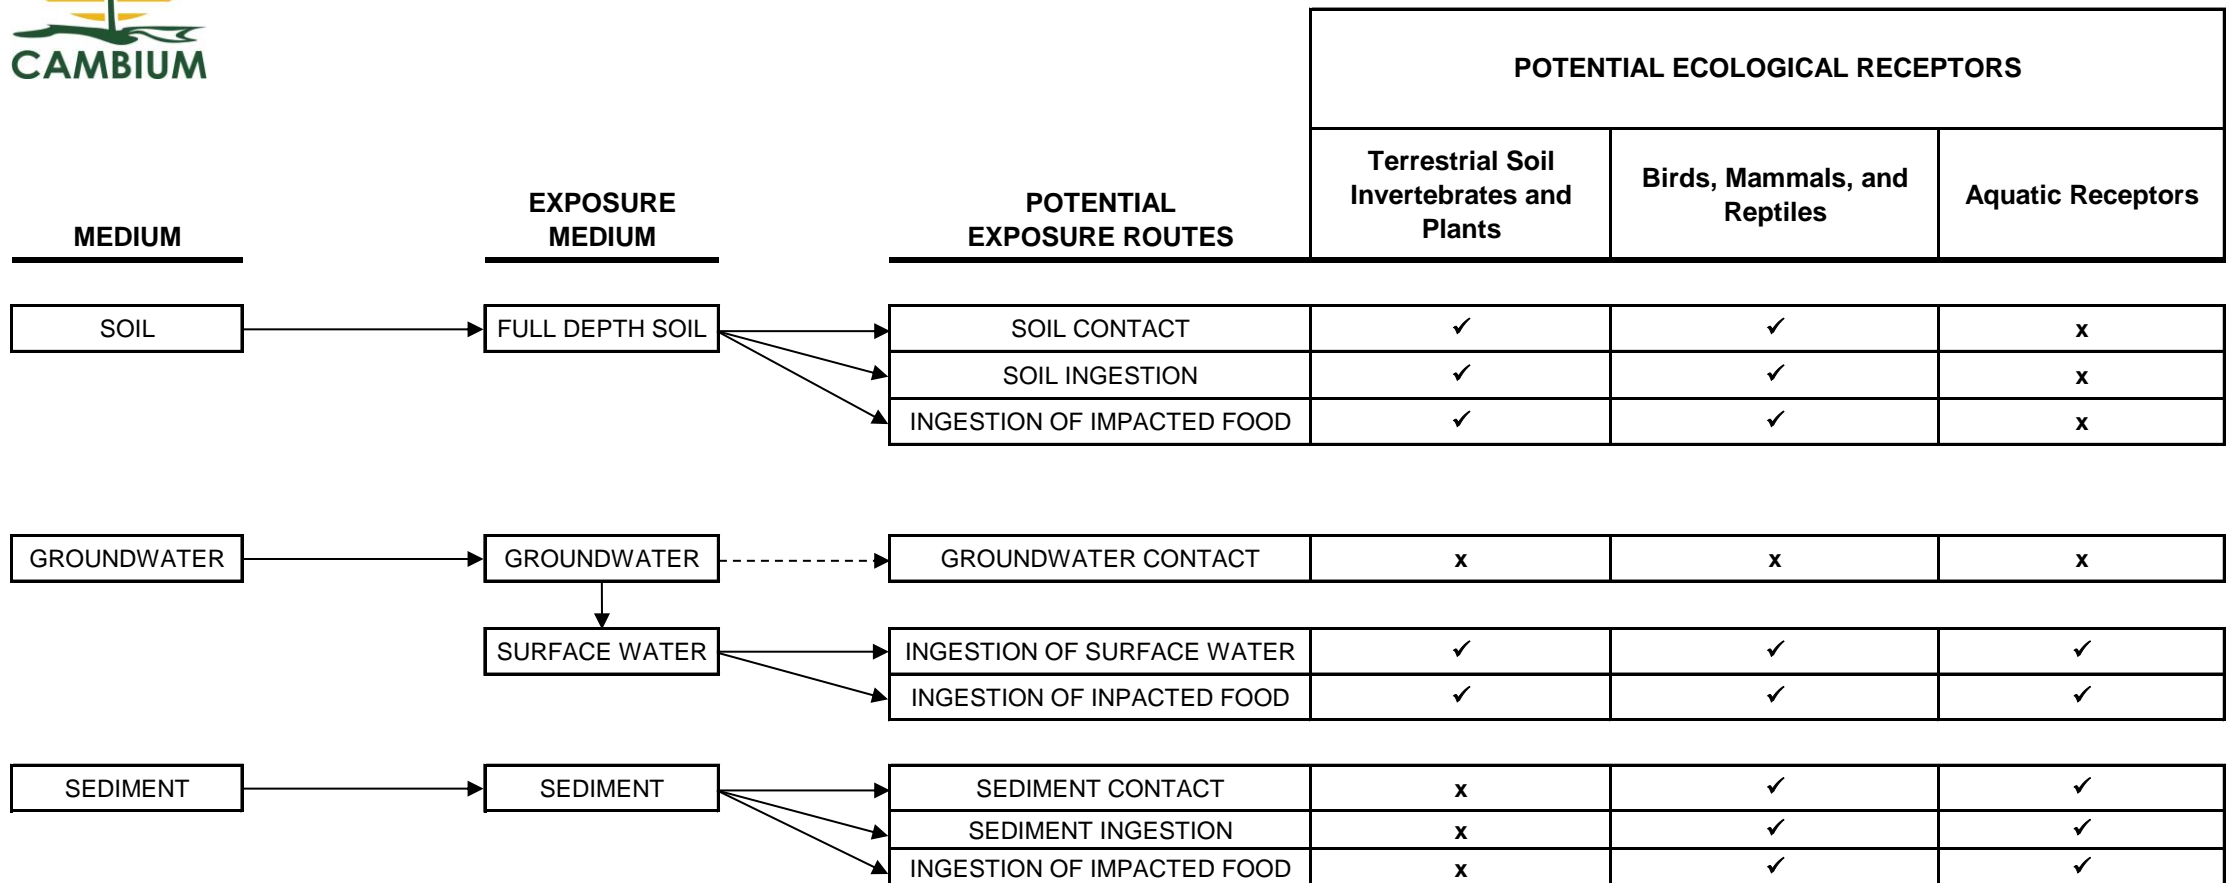
**FIGURE 23a
ECOLOGICAL CONCEPTUAL SITE MODEL - WITHOUT RISK MANAGEMENT**

- ✓ - Indicates a potential exposure of contaminant of concern to receptor.
- x - Indicates no exposure of contaminant of concern to receptor.
- ▶ Indicates pathway potentially complete
- - - - -▶ Indicates pathway incomplete

| Figure 23a | Ecological Conceptual Site Model – Without Risk Management Measures |

| Mandatory Conceptual Site Model Component | Location in CSM (Section and/or Figure No.) |
|--|--|
| <p>i. the release mechanisms,</p> | <p>Section 7.0 Figure 22 and Figure 23</p> |
