Phase Two Conceptual Site Model Midland Bay Landing 420 Bayshore Drive, Midland, Ontario

Cambium Reference No.: 6820-001

2019-04-01

Prepared for: The Town of Midland

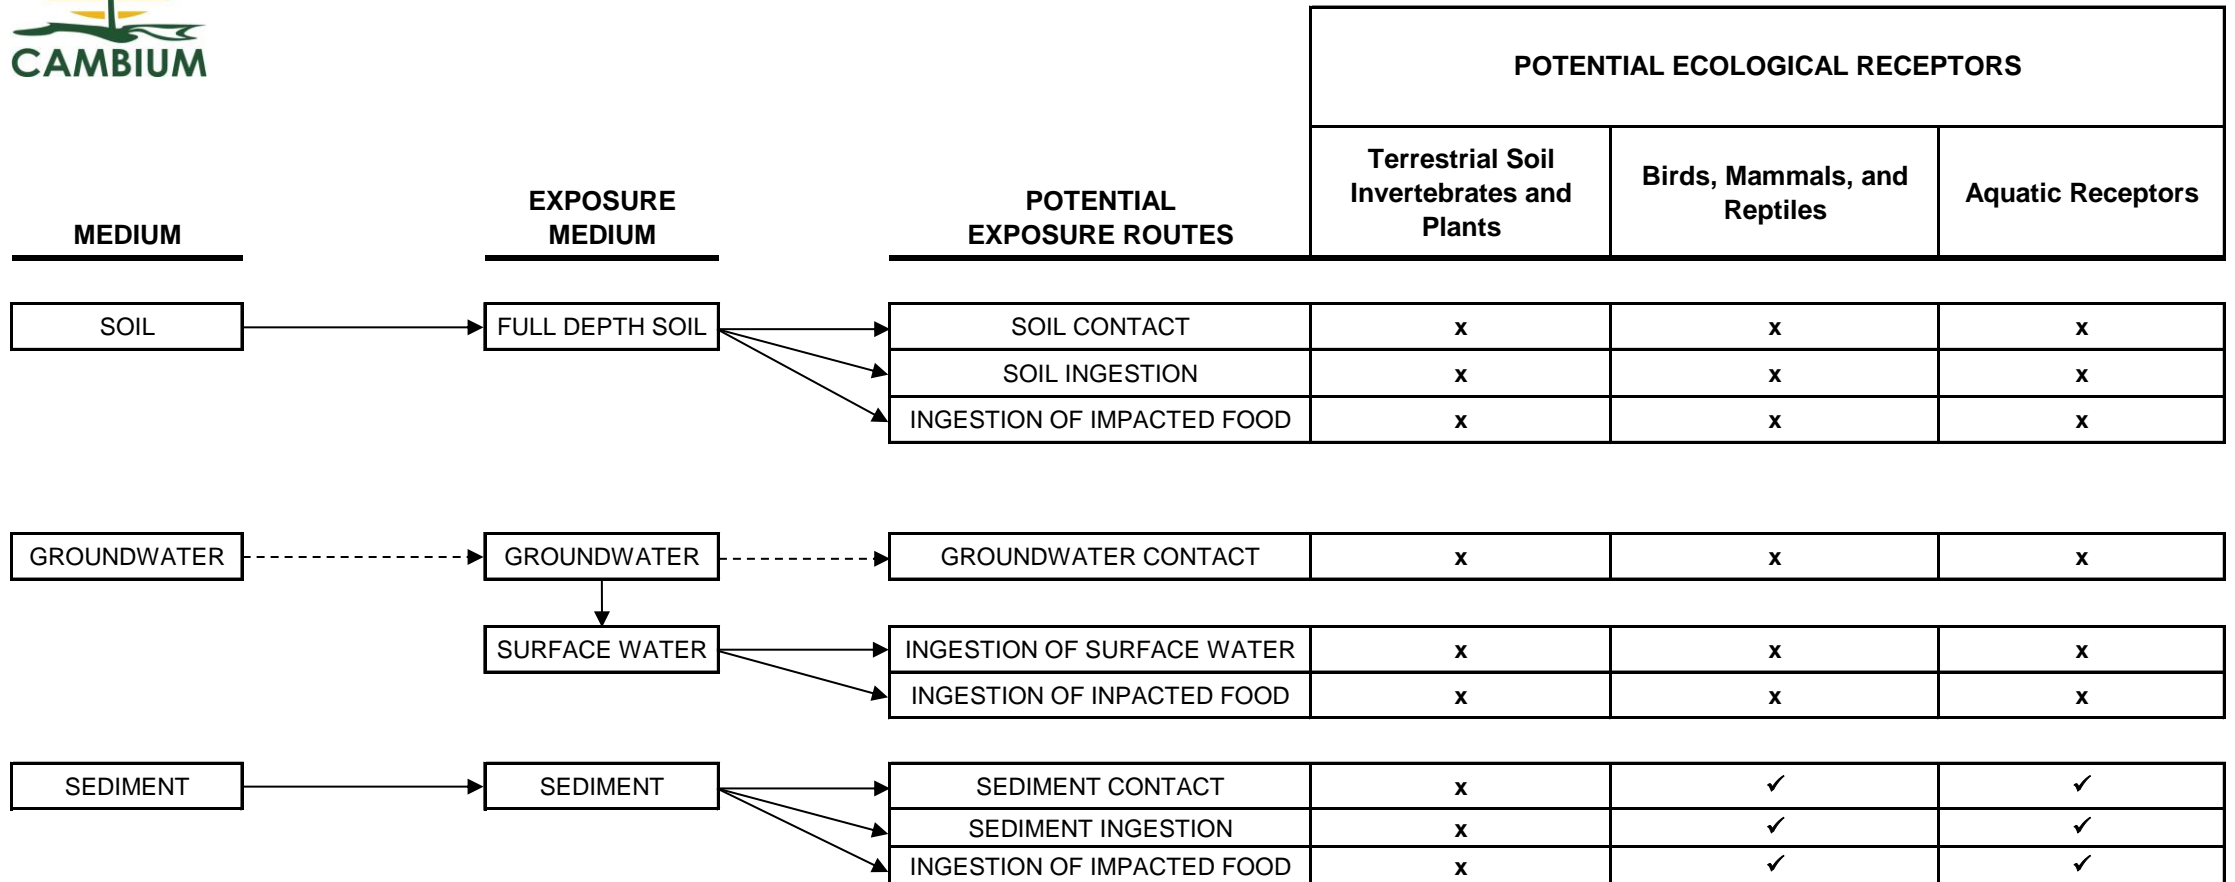
**FIGURE 23b
ECOLOGICAL CONCEPTUAL SITE MODEL - WITH RISK MANAGEMENT**

- ✓ - Indicates a potential exposure of contaminant of concern to receptor.
- x - Indicates no exposure of contaminant of concern to receptor.
- ▶ Indicates pathway potentially complete
- - - - -▶ Indicates pathway incomplete

| Figure 23b | Ecological Conceptual Site Model – With Risk Management Measures |

| Mandatory Conceptual Site Model Component | Location in CSM (Section and/or Figure No.) |
|--|--|
| <p>i. the release mechanisms,</p> | <p>Section 7.0 Figure 22 and Figure 23</p> |
