## Midland Bay Landing

### Assessment of Shoreline Conditions and Treatments

prepared by  
**Shoreplan  
Engineering Limited**

**November 2017**

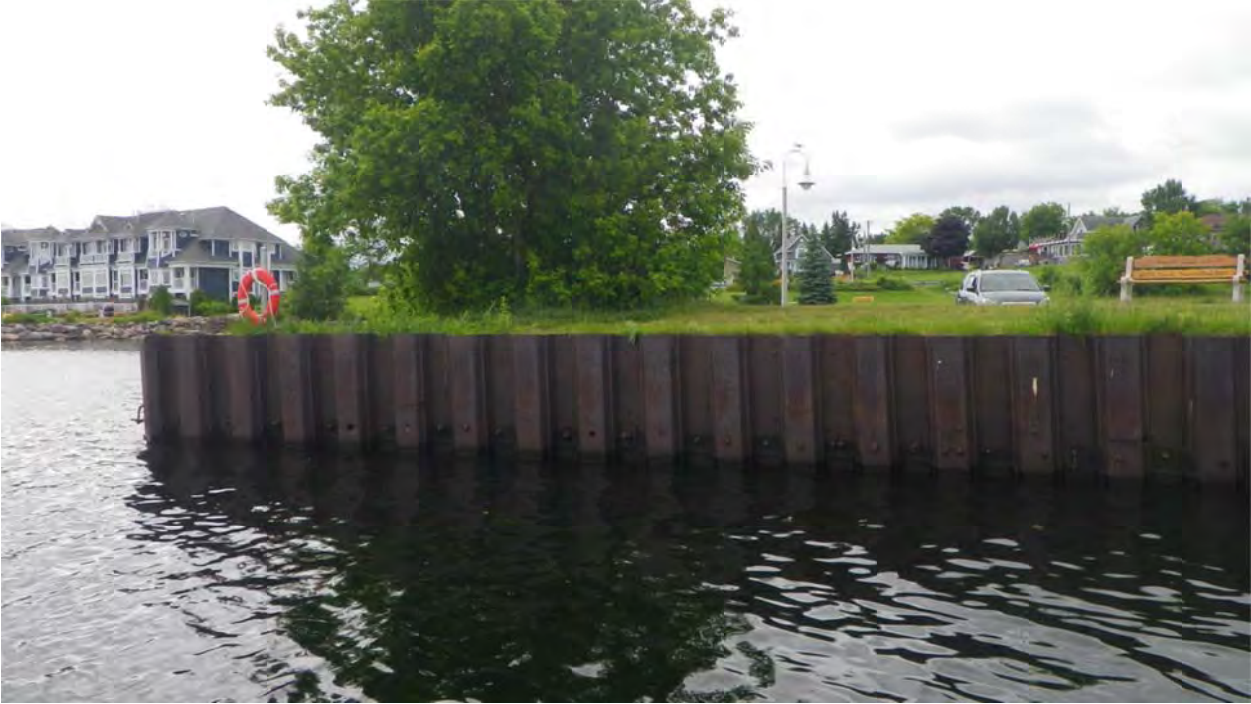
The top of the existing steel sheet pile (see Photo 1 to Photo 3) wall is approximately 178.0 m. No construction drawings of the steel sheet pile wall were provided to us and the age of the wall is unknown. The SSP is an Algoma sheet pile. Based on measurements taken during the surface inspection, the steel sheet piling appears to be section A-9. The thickness of the steel sheet pile measured was 14 mm. Anchor rods are located, on average, every 5 m. The anchor rods are 63.5 mm (2.5") diameter and are located at approximately 176.7 m to 176.9 m. The wall is a steel rail with a railway track profile. It is placed on its side with the base of the rail up against the steel sheet pile.

**Photo 1: East end of East Reach**

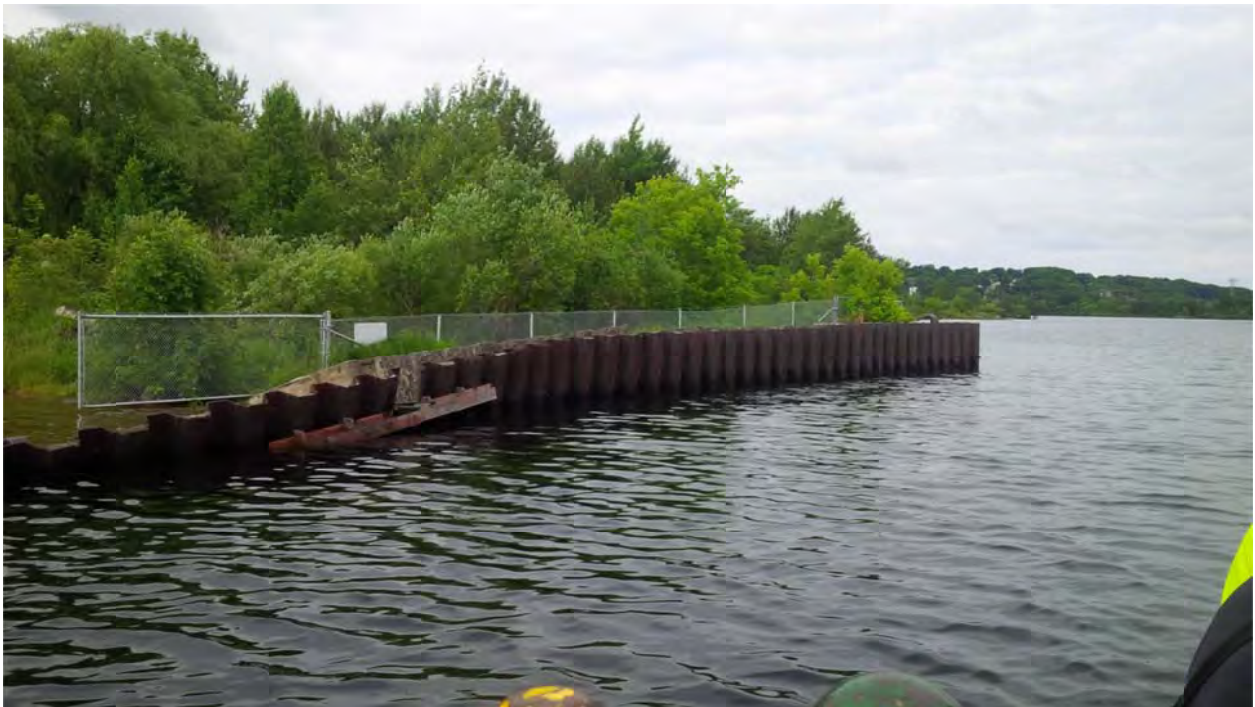
**Photo 12: East SSP wall**

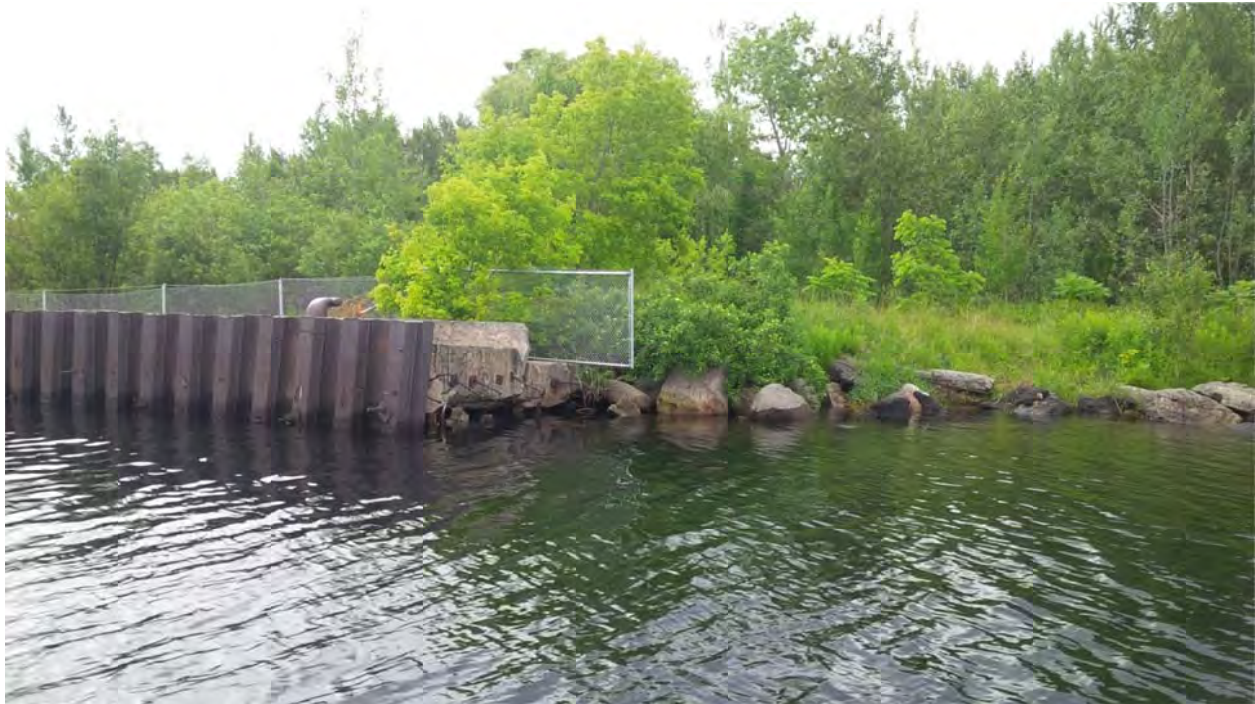
**Photo 13: End of west SSP, East Reach**

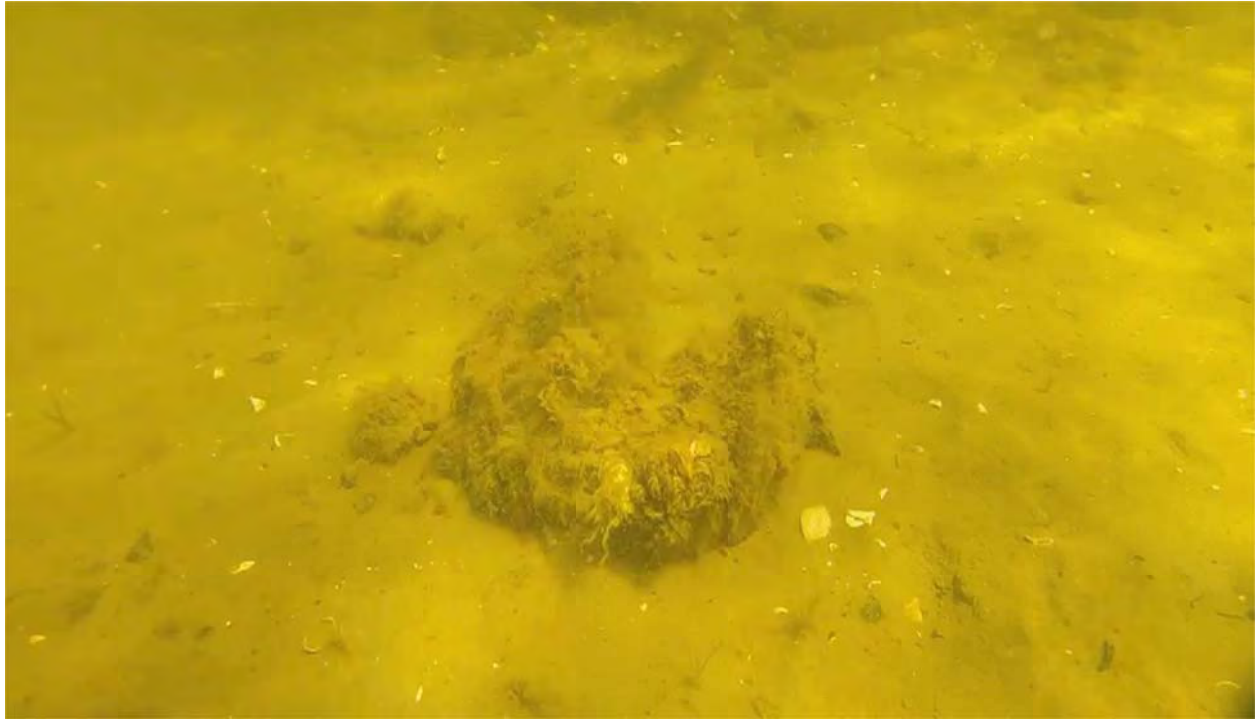
**Photo 17: Timber pile in lakebed in Centre Reach (Day 1, Dive 1, 1:59:13)**

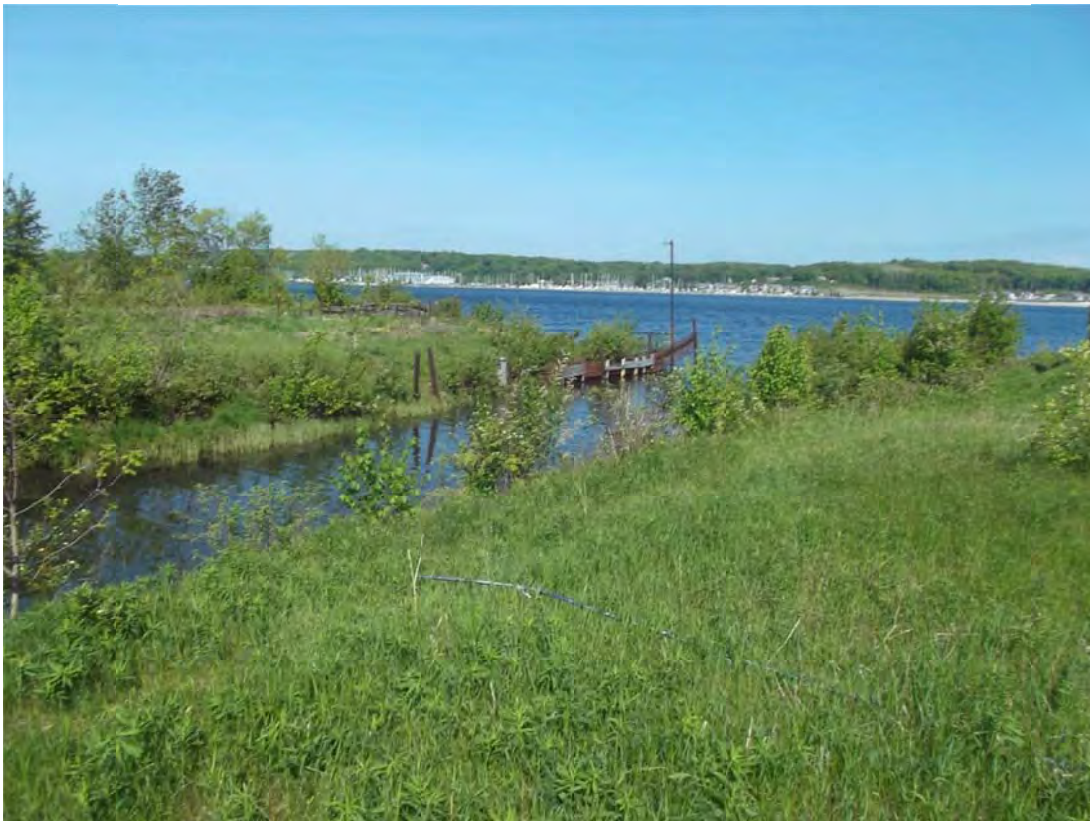
**Photo 20: Small embayment in Centre Reach**

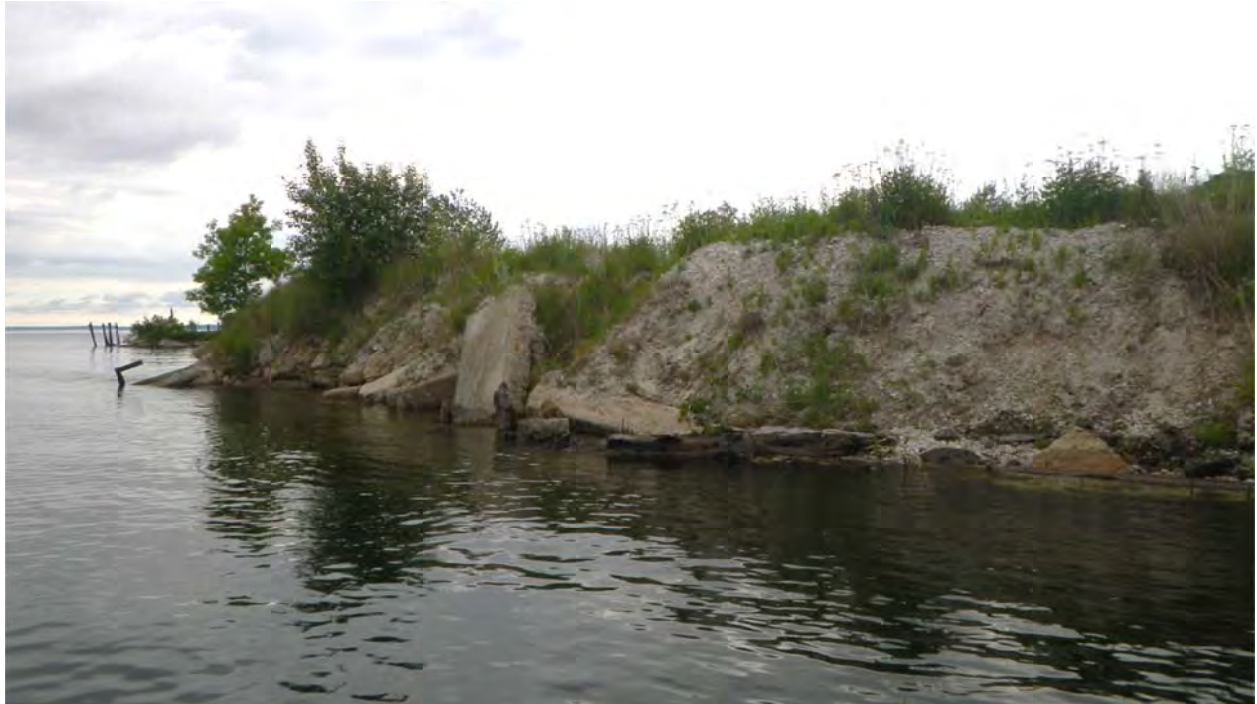
Starting at the east end of the west reach, a timber structure, similar to that described above was observed. The vertical piles were more intermittent in this location than in the west part of the reach and the second row of piles was not observed. Evidence of loss of stone fill through the piles was observed. From the front row of piles, the profile slopes up to the backshore. Large pieces of concrete slab were observed on the slope just above the water level (Photo 25). A typical profile through this section of the shoreline is shown on Section 7, Figure 3-7.

**Photo 25: East end of West Reach**

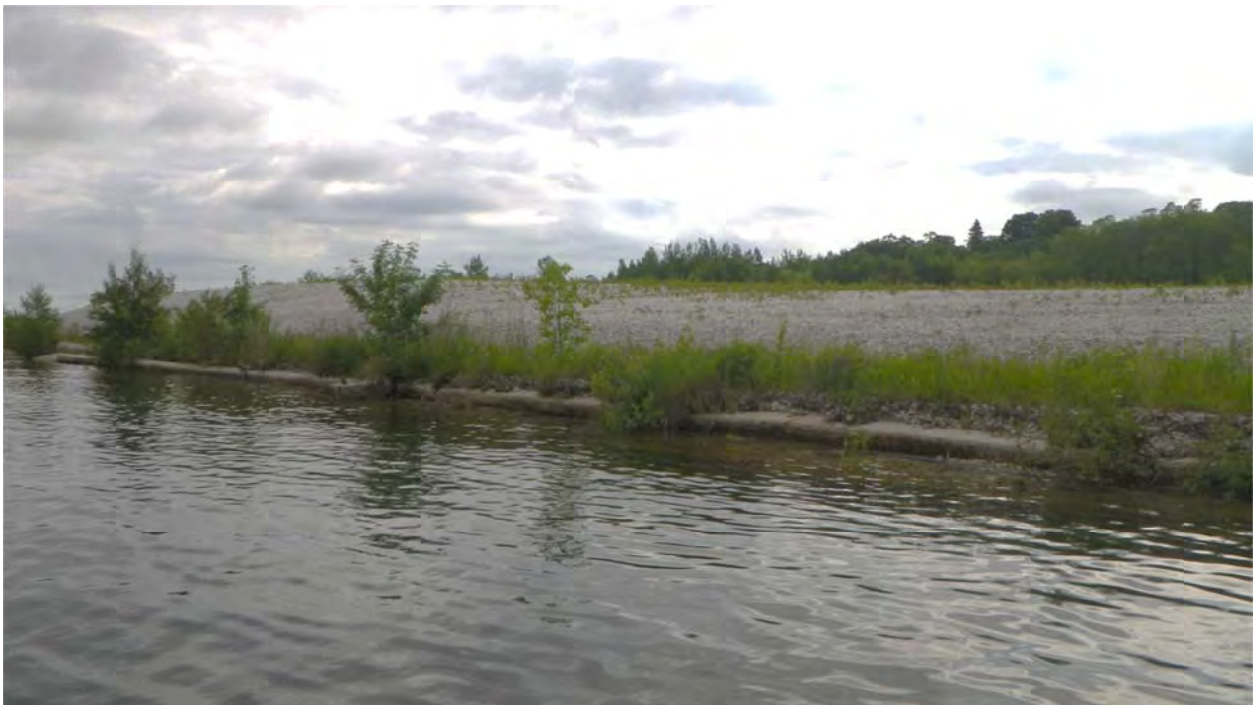
**Photo 28: West Reach**

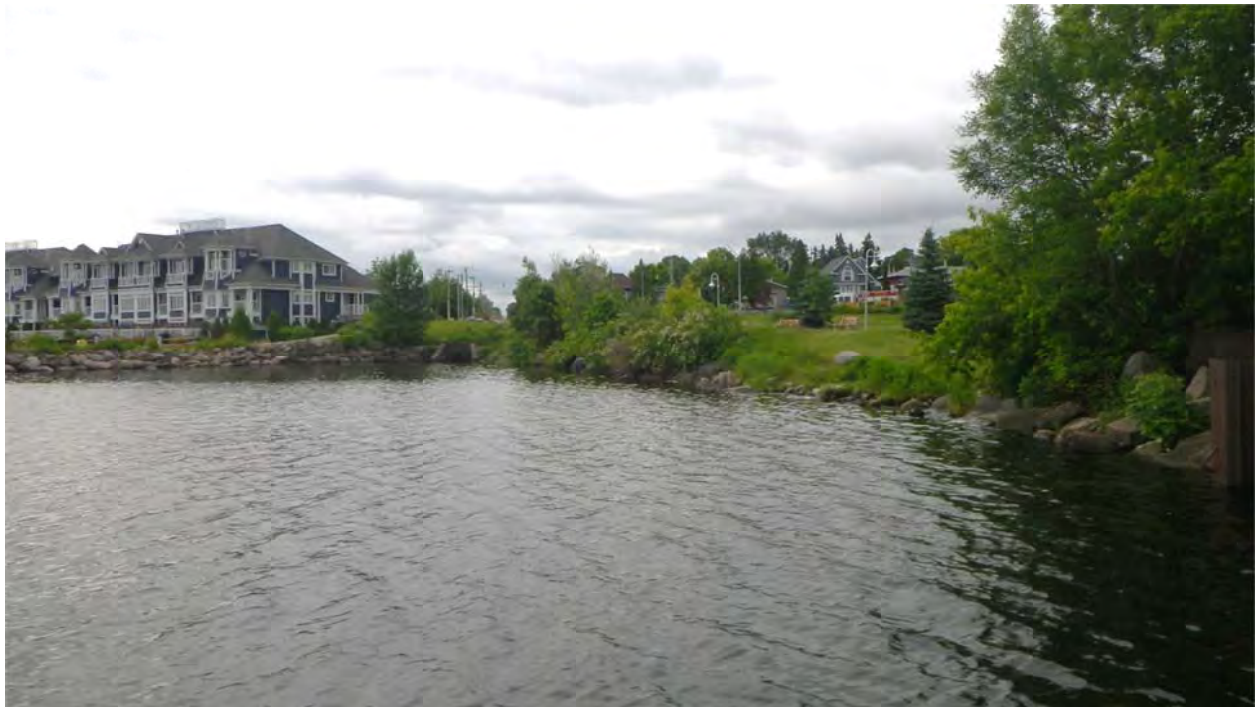
The shoreline east of the property limit faces approximately the north-east direction and is, for the most part, located outside the property line (see site plan, Figure 3-2). A brief description is provided for any future work that may be considered that may need to connect to works within the study area. At the northern end of this reach, there is an approximately 4 metre long section of SSP wall (see Photo 32). This is the return wall for the SSP wall in the East Reach. A storm sewer outfall is located at the end of shoreline (Photo 33) and is shown on the site plan on Figure 3-2. The shoreline between the end of the SSP wall and outfall is approximately 84 metres long and is protected by informal shoreline protection. Above the water line, the shoreline is vegetated with some informal concrete rubble and stone protection visible (Photo 33). There is an informal launch ramp in approximately the middle of this section of shoreline.

**Photo 33: Shoreline east of property limit**

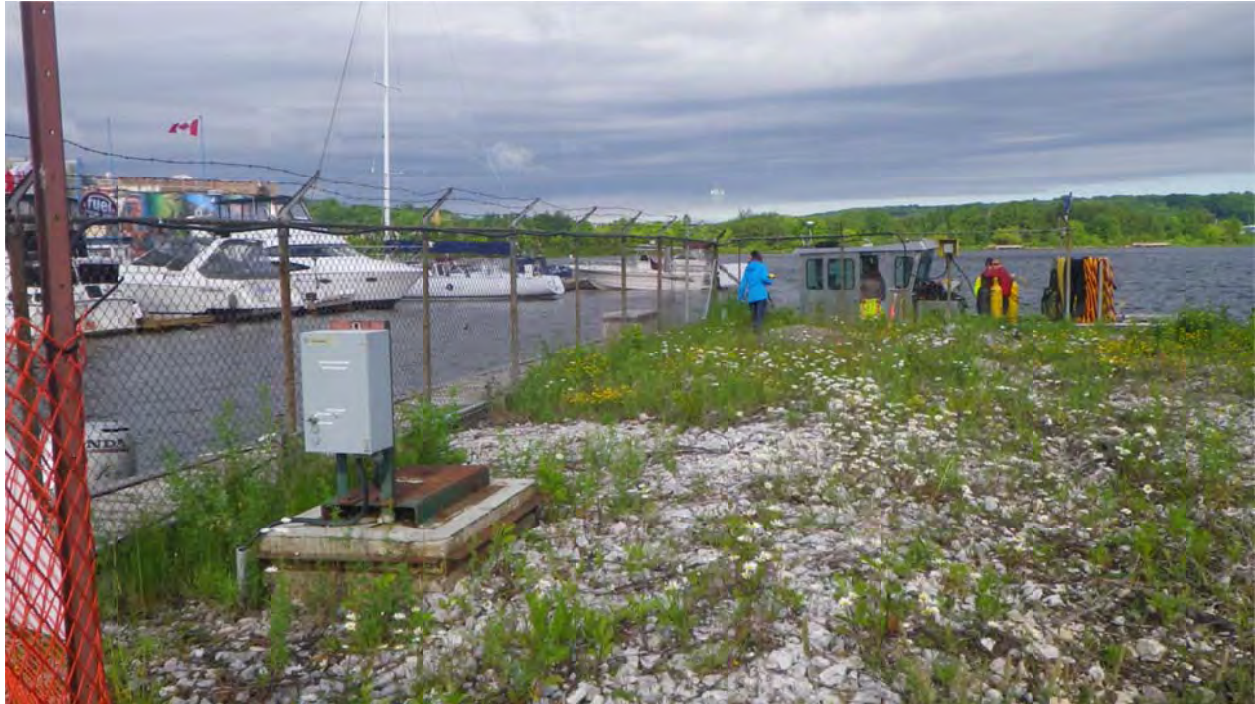
To the south of the end of the SSP wall, the shoreline consists of an unprotected gravel slope (see Photo 35). At the south end of this section of shoreline, there is a boat launch ramp within the marina (Photo 37).

**Photo 35: Shoreline west of property limit**

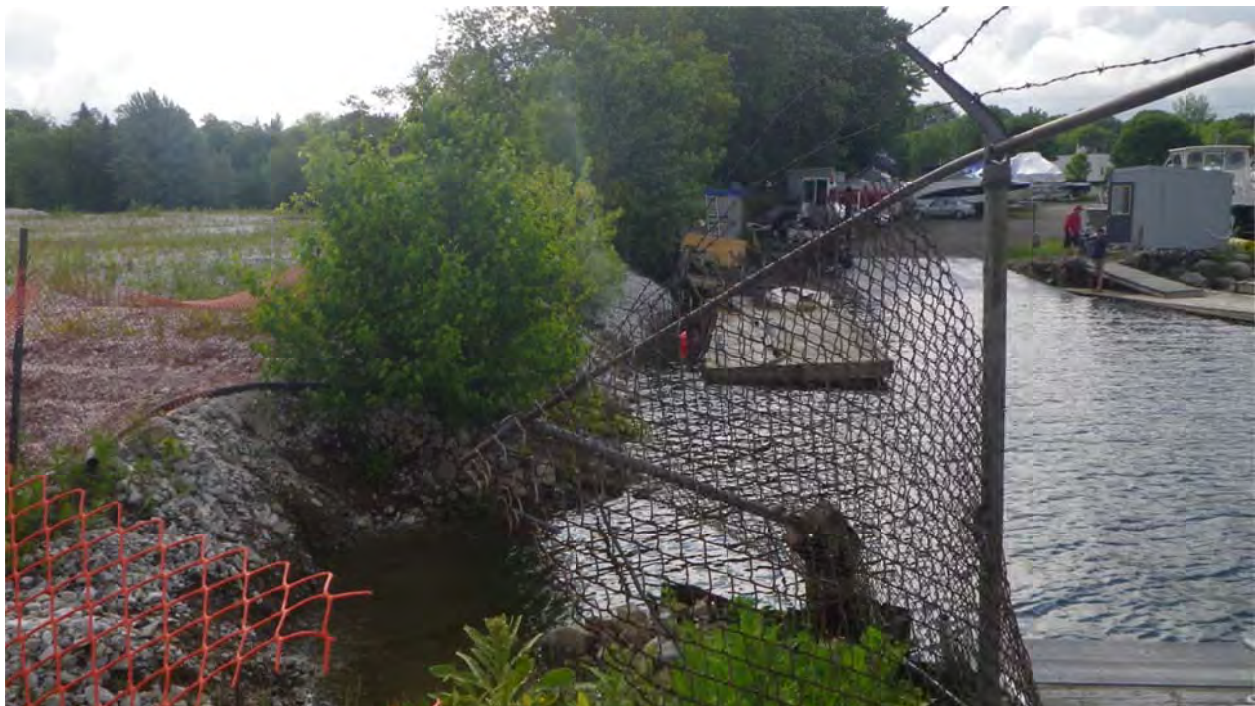
**Photo 36: Shoreline west of property limit**

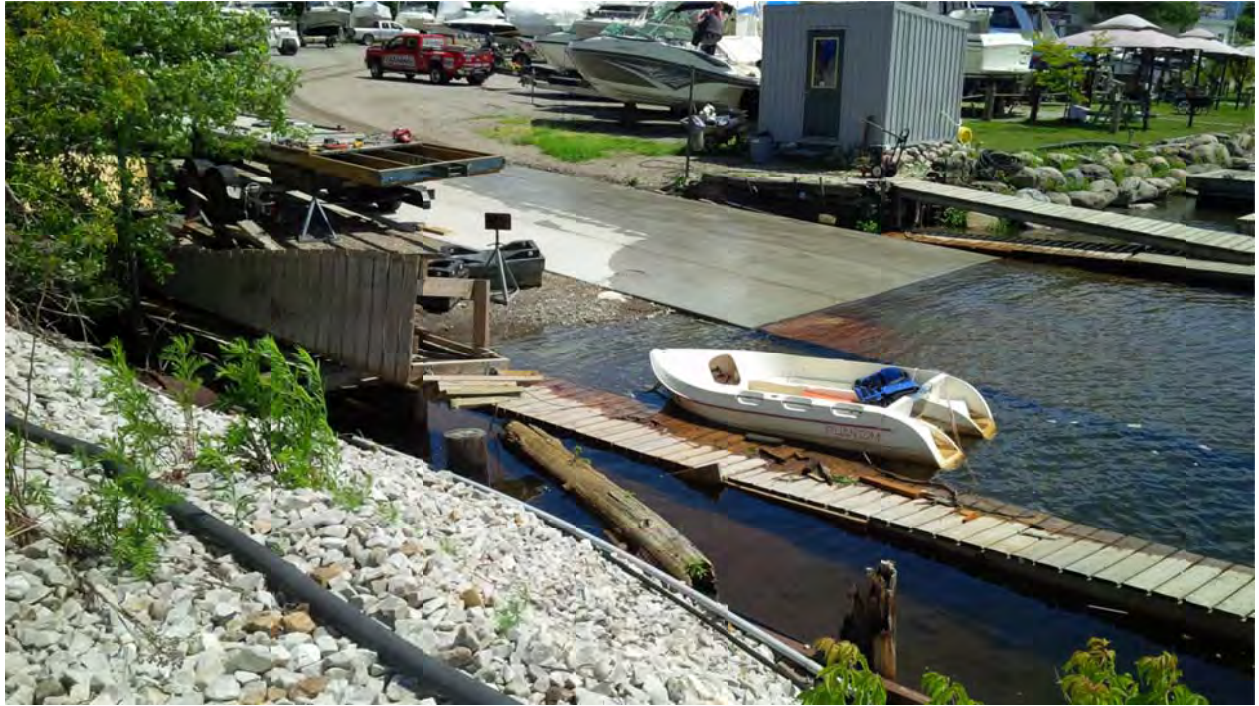
**Photo 37: Boat launch ramp at end of shoreline west of property limit**
